Name: Keybridge Weir

River: De Lank River

Reach DL07 – Key Bridge Weir – NGR SX088737

Extract from the River Camel Restoration Plan - Geomorphological assessment of physical modifications, 23rd March 2012, P40

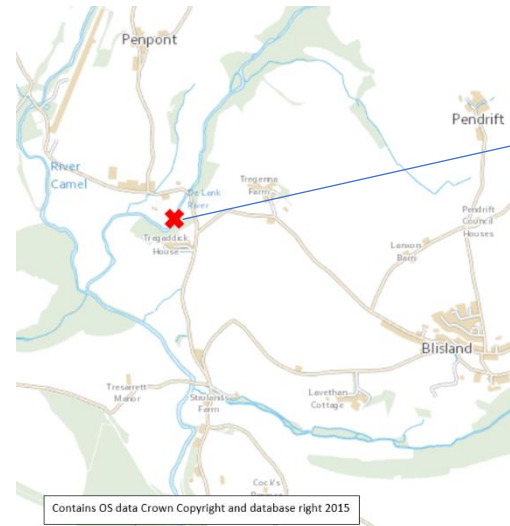
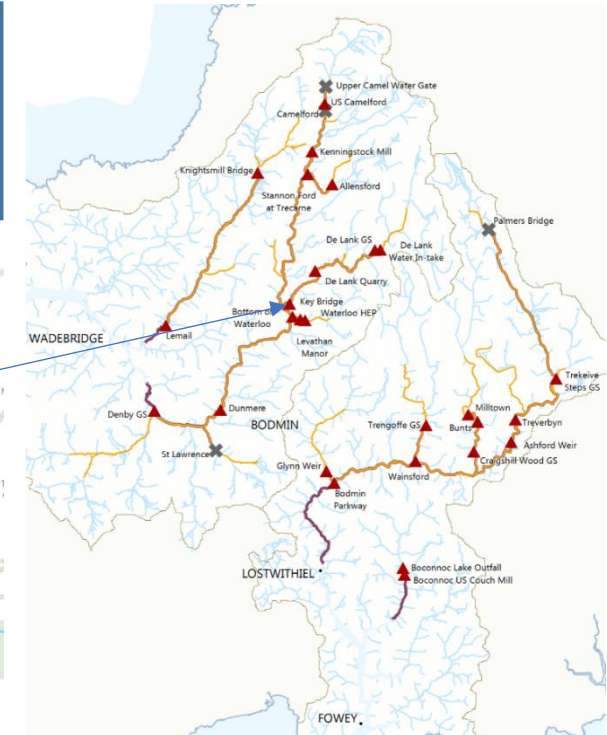
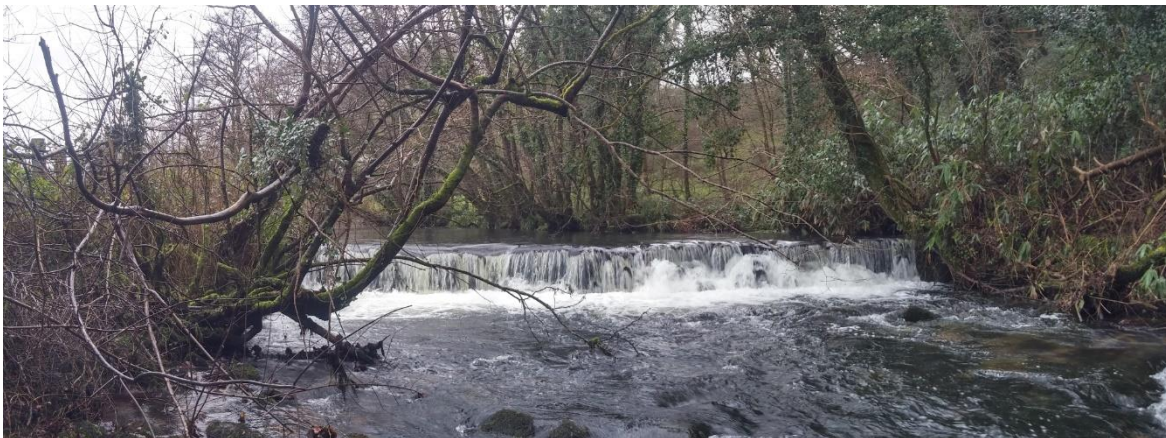
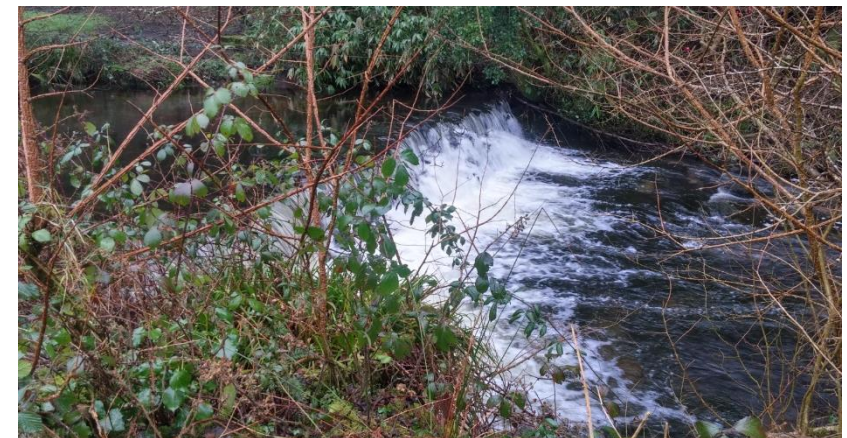
The weir appears to be constructed from rounded granite stones, possibly sourced from the granite quarries that once operated in the area. From a visual inspection, the hydraulic head difference over the structure appears to be at least 500mm, as such the structure is likely to be a high impact obstruction for salmonids both up and downstream. Atlantic Salmon populations, a Qualifying Species for the SAC designation, are at historically low levels within the catchment.

Removal of the weir would, following renaturalisation, allow the reinstatement of channel form and function. This approach aligns with the River Camel Restoration Plan, please refer to the River Camel Restoration Plan - Geomorphological assessment of physical modifications, 23rd March 2012 (site specific extract included overleaf). Discussions are currently taking place with the landowner in this regard.

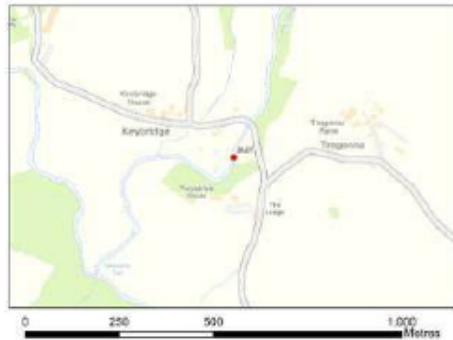
Key Bridge Weir

Boulder weir approximately 15m across and 1.5m high at the downstream end of the De Lank. The De Lank Quarry is ca. 2.5km upstream. The River Camel is ca. 0.5km downstream. Grazed right bank with limited riparian vegetation. Steep, wooded left bank. High levels of woody debris present.

- Flow impounded for approximately 70m upstream
- Sediment significantly attenuated upstream–reduced downstream supply
- Channel bank scour and local channel width increase
- Channel bed scour downstream
- Barrier to migratory fish passage – especially during low flows
- Fish spawning downstream affected by reduced gravel supply

To improve the sediment and biological continuity between the De Lank and the River Camel
