BRIDGETOWN WEIR

EXTON

SOMERSET

Heritage Statement and Statement of Significance

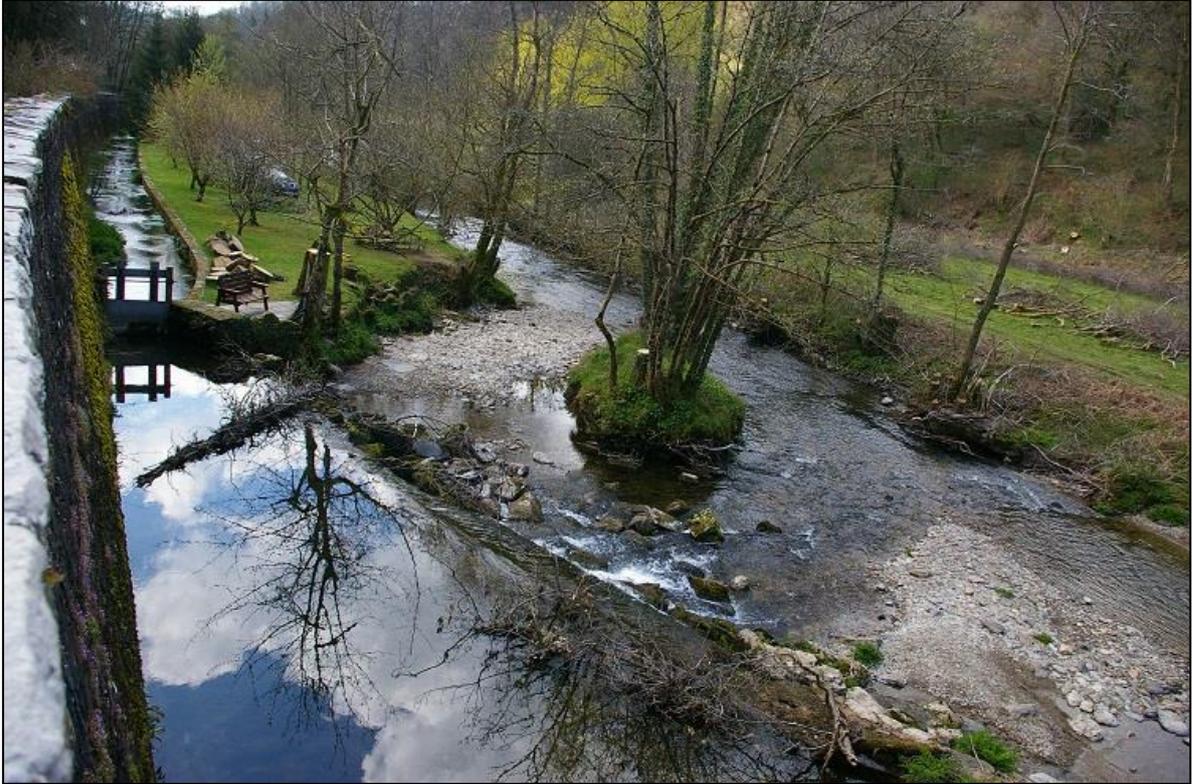
FIGURE 2: VIEW OVER THE RETAINING WALL ALONGSIDE THE ROAD, SHOWING THE DROP-WEIR ELEMENT AND LEAT (TO THE LEFT OF SHOT) LEADING TO THE MILL; FROM THE NORTH-EAST.

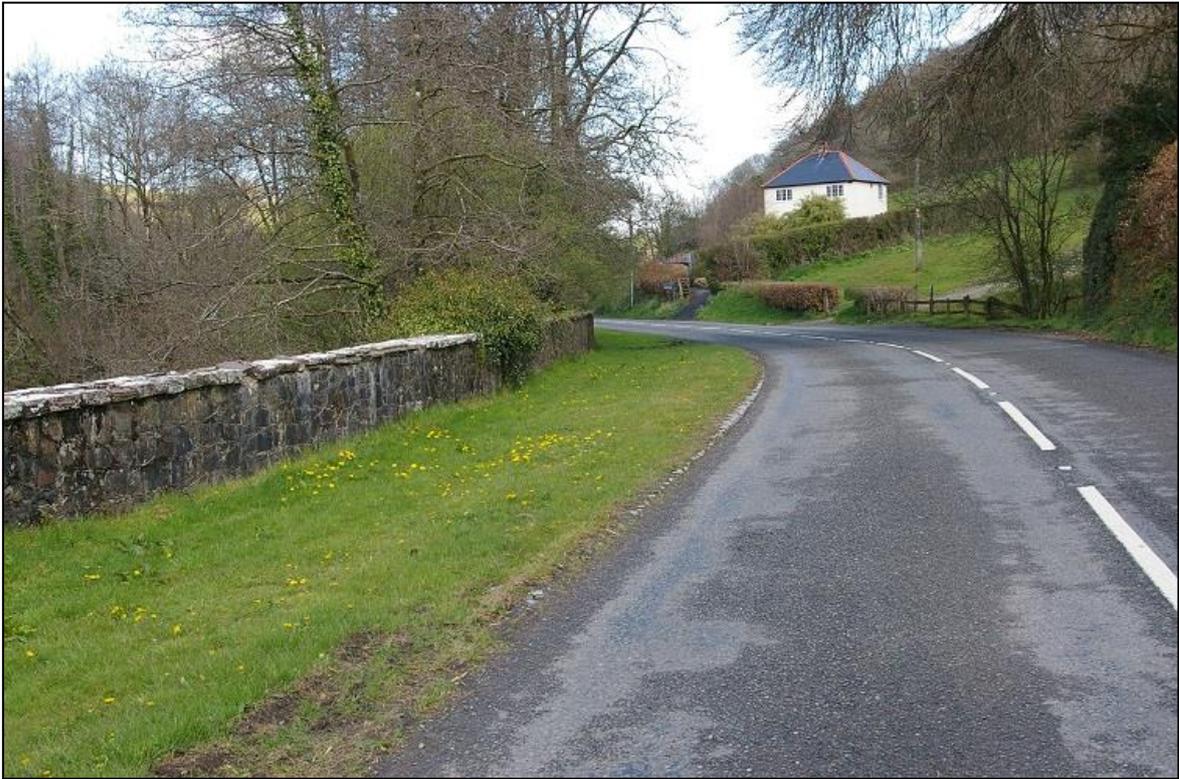
FIGURE 3: THE A396 ROAD, WITH RETAINING WALL TO THE WEIR AND WIDE GRASS VERGE, WITH 19TH CENTURY WEIRSIDE COTTAGE; VIEWED FROM THE SOUTH.

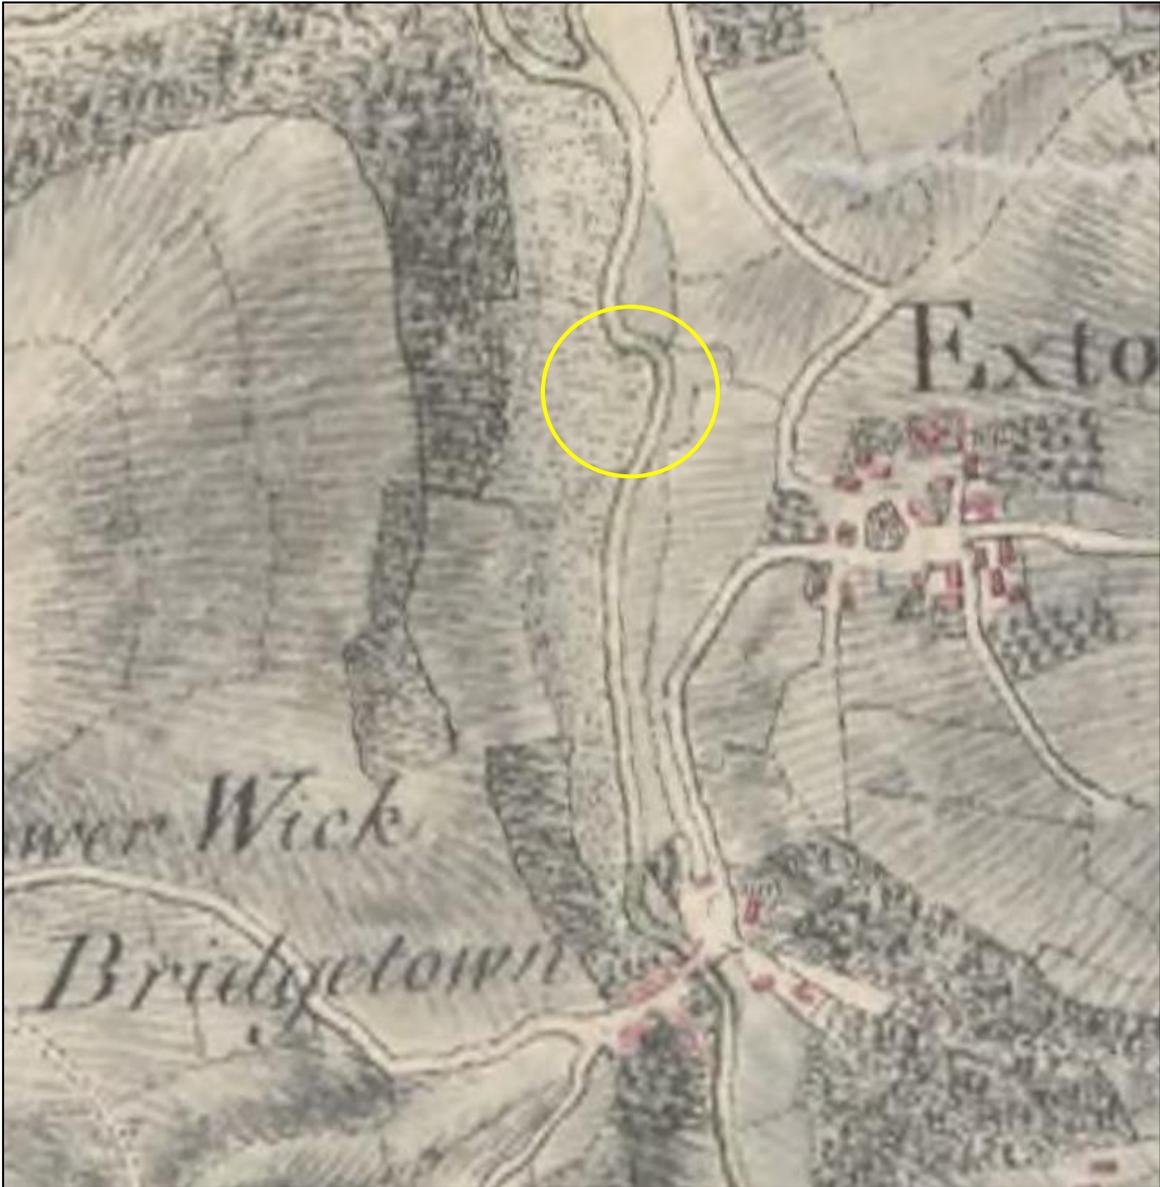
The 1802 Ordnance Survey draft map for Minehead appears not to show either Bridgetown Weir or the leat leading off it from the east. The settlement of Bridgetown appears relatively well developed although it is not clear whether a building is shown in the location of the mill. Certainly there is no evidence of a leat supplying this location.

FIGURE 4: EXTRACT FROM THE 1802 ORDNANCE SURVEY SURVEYOR'S DRAFT MAP (BL). THE SITE OF THE WEIR IS INDICATED.

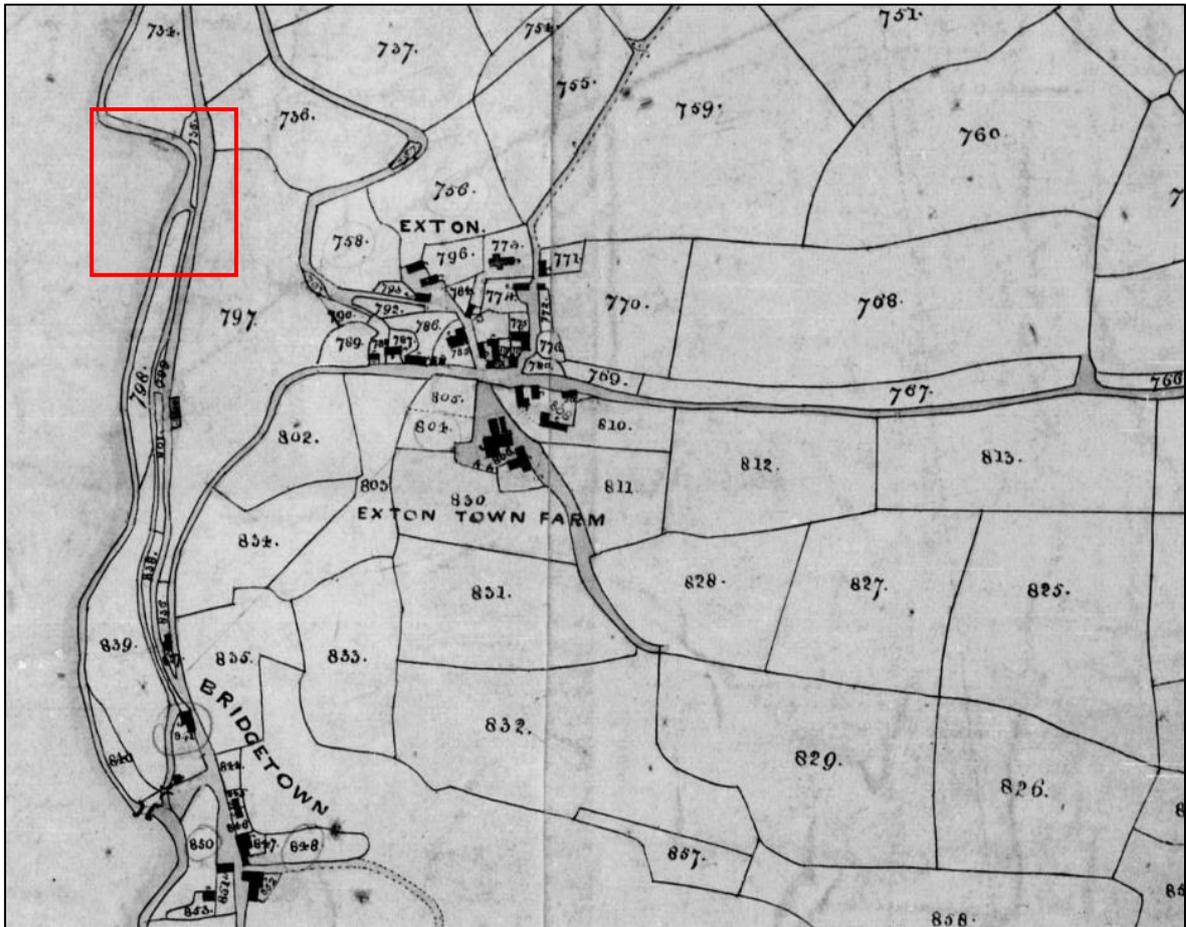
The 1840 Tithe map for Exton shows the location of the weir, although a weir is not depicted, however the pool to the south of the weir and the mill leat running parallel to the river down to Bridgetown Mill can clearly be seen, which suggests the weir and leat is likely to have both been constructed between 1802 and 1840.

FIGURE 5: EXTRACT FROM THE 1840 EXTON TITHE MAP (PRO). THE SITE OF THE WEIR IS INDICATED.

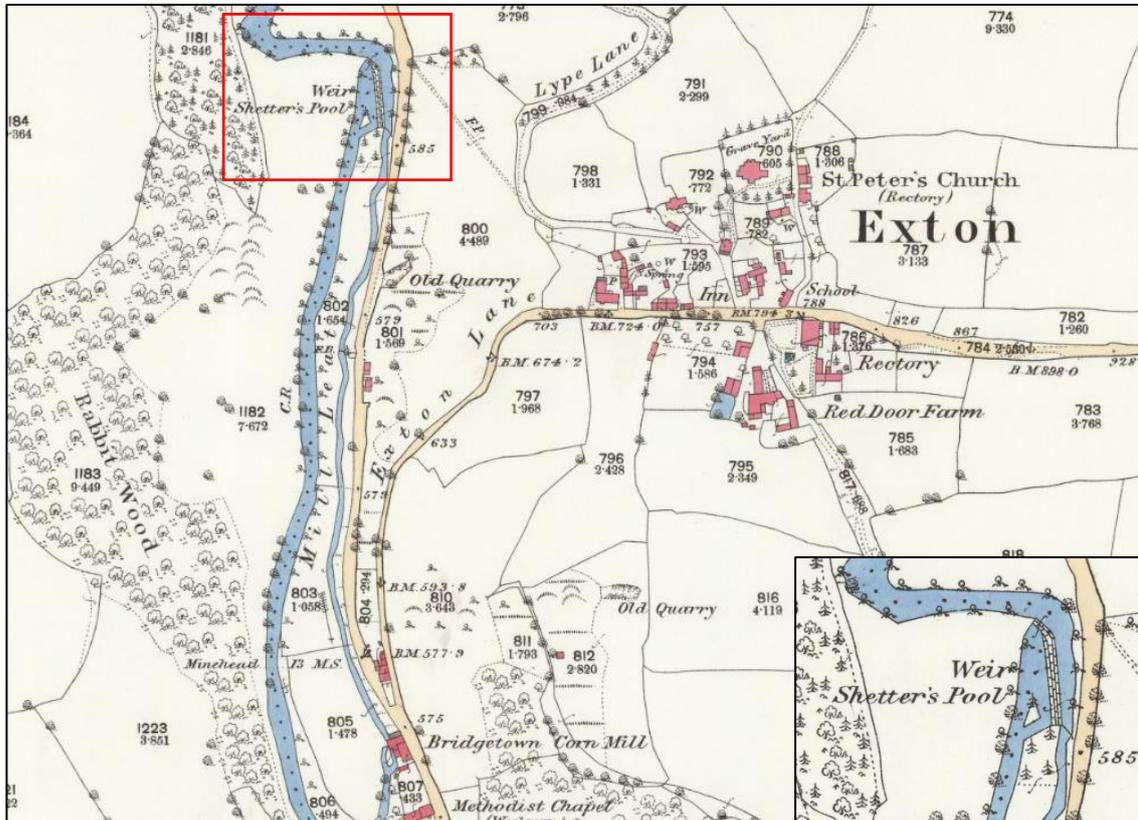
The 1888 Ordnance Survey First Edition map clearly shows the form of Bridgetown Weir with Shetter's Pool labelled. The leat running south from the eastern side of the weir is also visible. The parish boundary is shown running down the centre of the river Exe, with the northern part of the weir appearing to be in Winsford Parish. Bridgetown Corn Mill is labelled with the leat running down to the mill and re-joining the River Exe to the south of Bridgetown Bridge. The Ordnance Survey Second Edition map shows little change to this area with the Weir and Shetter's Pool depicted as they are shown on the First Edition map.

FIGURE 6: EXTRACT FROM THE 1888 1ST EDITION 25" OS MAP WITH INSET (NLS).

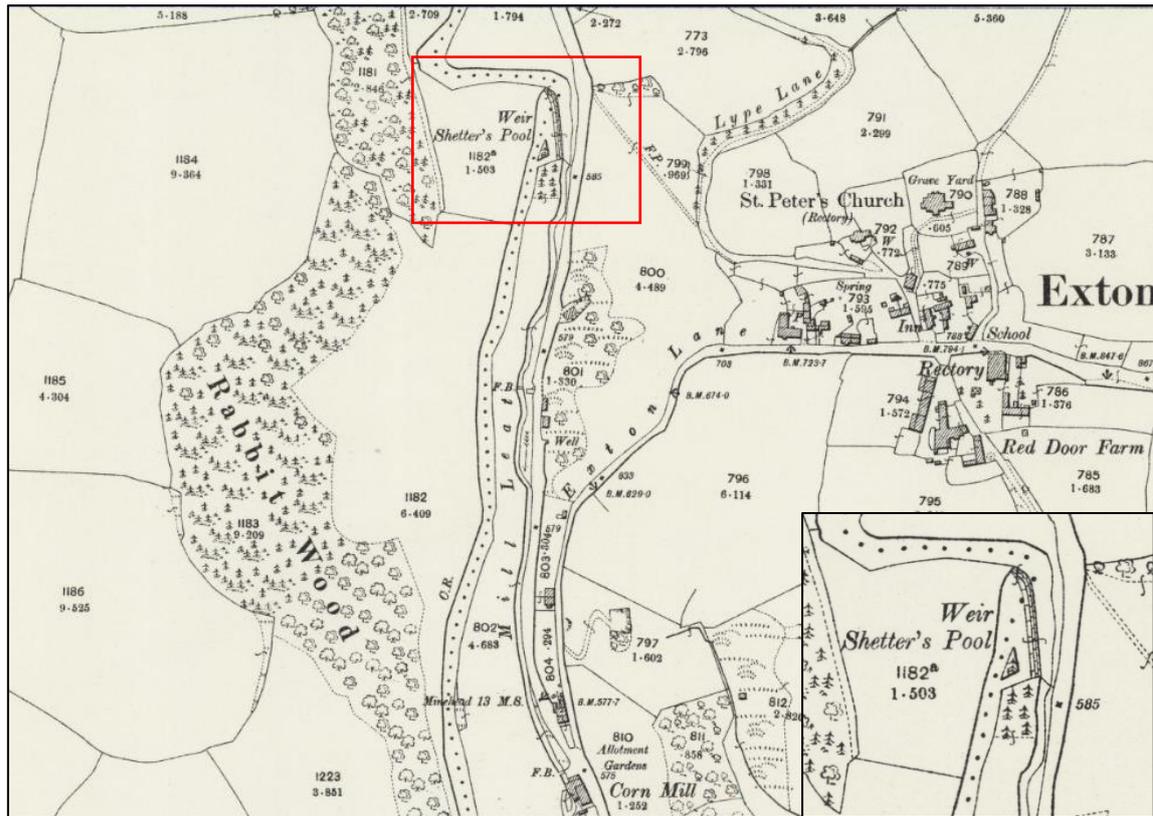
FIGURE 7: EXTRACT FROM THE 1902 2ND EDITION 25'' OS MAP WITH INSET (NLS).

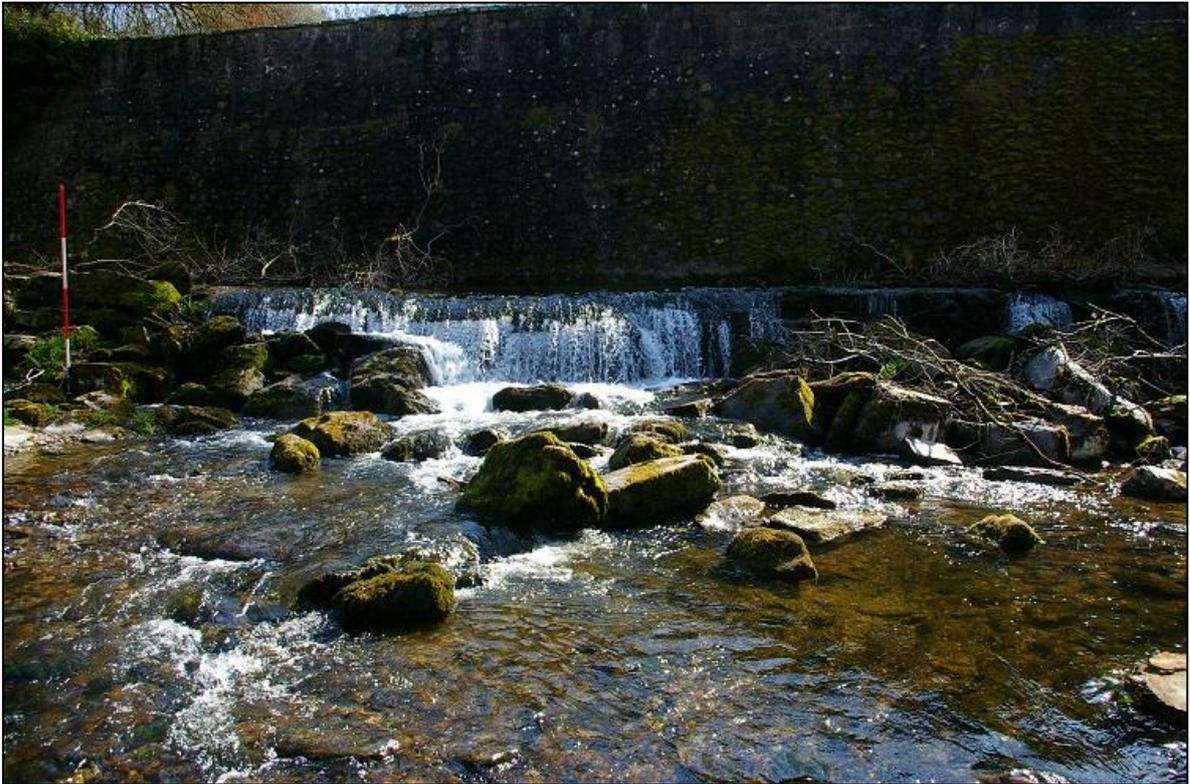
The lower weir element to the south end of the structure is a *narrow crested drop-weir* of c. 1.2-1m height 0.4m at crest, c.8-10m long. This is a diagonal weir, crossing at c.70 degree angle from the river bank, with an angle of c.20-25 degrees at its centre, maximising its effect on flow. It is built of roughly dressed slate and granite blocks. There appears to be some very crude concrete repairs to this element of the weir but as water was still flowing here, it could not be examined in detail. Larger rough boulders may have been dumped in front of this weir to slow down the water or it may have had boulders placed up against the vertical dressed 'drop' at some stage, which has since been dislodged with the force of the water, now forming an untidy pile and attracting vegetation and river-driftwood. There is a short concrete rendered angled flank wall to the south bank of the river. The force of the water coming off this weir has cut a second channel into the river bank, leaving a central small island in the centre of the channel. The difference in water flow between the two elements has also led to a large shingle bank developing in a v-shape north of the drop-weir.

FIGURE 8: THE DROP-WEIR ELEMENT OF THE WEIR, WITH 2M SCALE.

The site visit was undertaken when water levels were relatively low but the drop-weir section was still obscured by active overflow. This southern end of the weir is associated with the sluice and leat, of different form and build. The full extent of the relationship between the leat, the sluice and the rest of the weir could not be established on this visit. Since this is the section believed to be requiring concrete capping it is suggested that some further monitoring of works occurs at the start of the project, once the crest is exposed and dry. This will allow a fuller and more accurate

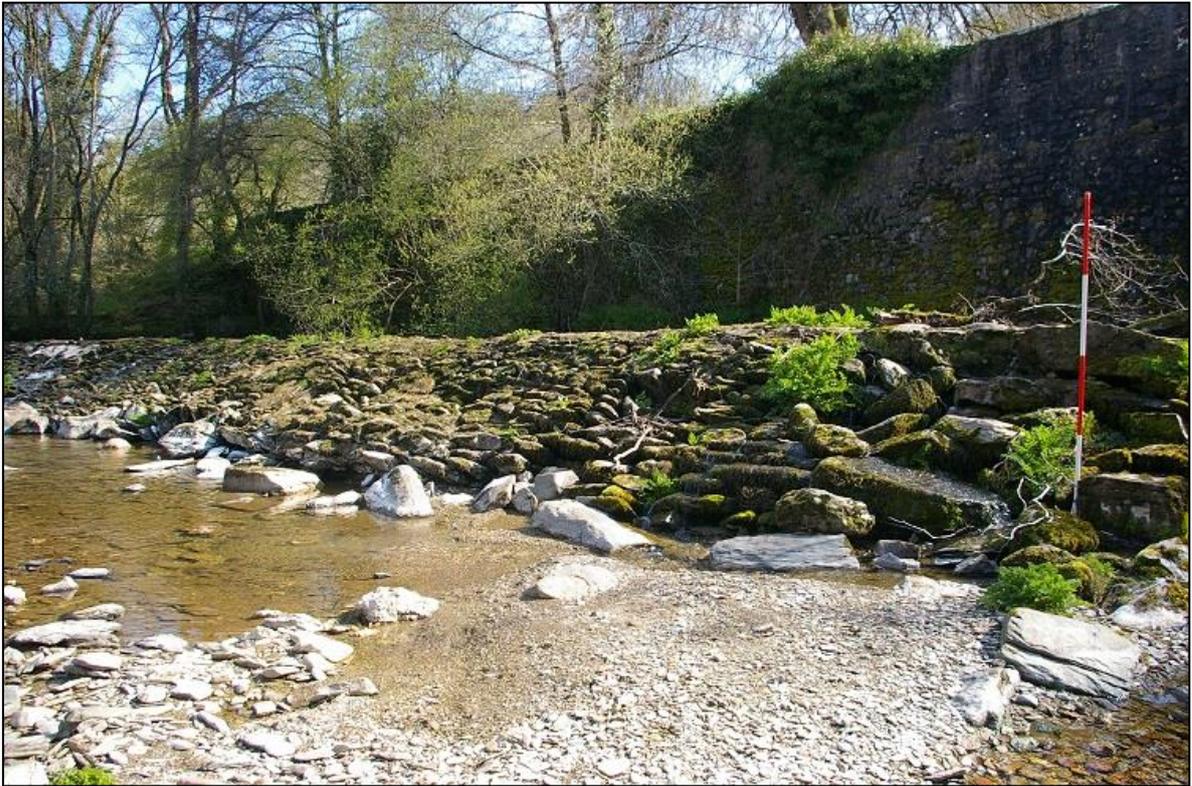
To the centre and north end the weir is at a cranked angle to the drop-weir. It crosses the river at a very sharp angle, c.45 degrees, ensuring maximum length for the crest as it crosses the river on a bend at the longest width. The angle is designed to reduce water level variations. The addition of the concrete capping to this long section of weir has created a raised lip on the upstream side; this has increased water resistance against the weir leading to the collection of debris and waste on the upstream side, particularly gathering near the top of the fish passage. However, both elements of the weir(s) would probably still be described as *low gauge weirs*.

The long section is c.28-30m long; of sloping crump-style form; built of smaller split boulders, arranged in a linear stacked form to create a waterfall/cascade effect. It has a narrow crest of c.0.2-0.3m capped in rounded greyish coloured concrete with lots of pebble inclusions, concrete appears to have been carried out in a smooth slope on the head side of the crest, further softening its effect. It has a long shallow sloping 'face' of exposed stone of c.2.5-3m length. Due to low water levels on the day of survey but also in general this is often largely now dry. To the north end the weir cranks again to the west, to meet the bank almost at a right angle, with an inserted concrete fish passage, c.1.5m wide, with a further 4-5m of rebuilt weir in blocky boulders, with a steeper gradient and set into reddish-grey cement/concrete.

FIGURE 9: THE 'CRUMP' ELEMENT OF THE WEIR, SHOWING LACK OF OVERFLOW; FROM THE SOUTH-WEST (WITH 2M SCALE).

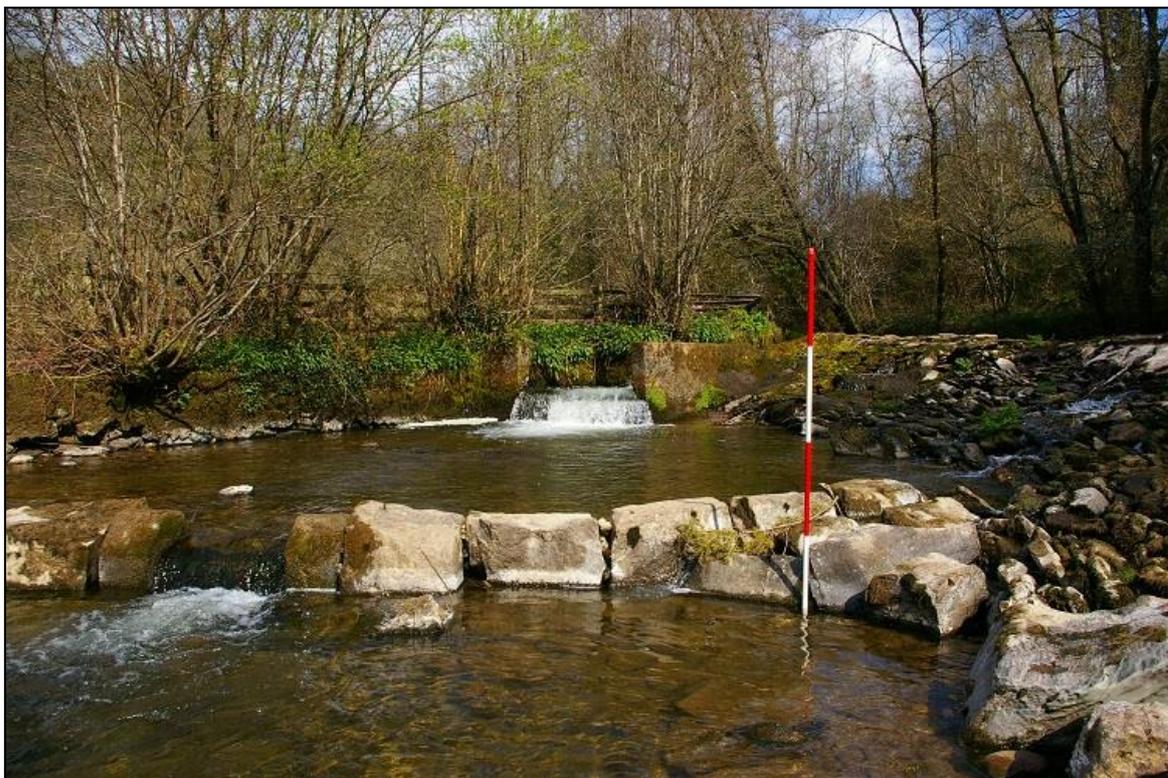
The fish passage was inserted into the weir in 1954, possibly associated with the establishment of the National Park; with the pool in front formed in 2012 by the Westcountry Rivers Trust.

The fish passage itself has thick cinder block walls, rendered in reddish-grey grainy gritty cement, which has a mid-century appearance and may well have been mixed onsite using the local iron-rich clay. The fish passage runs straight through the weir parallel with the bank and then turns west, with a widened bowl to the end. There are slots to the top of the fish passage so it could once be closed off but any sluice gate here appears to have rotted or has been removed. A shallow pool now encloses the end of the fish passage built between the weir and the west riverbank. This comprises large individual boulders and a central overspill of pre-formed concrete. This is designed to slow the water and maintain levels near the fish passage.

FIGURE 10: THE FISH PASSAGE AT THE NORTH-WEST END OF THE CRUMP SECTION OF THE WEIR, WITH 2012 POOL FORMED IN FRONT, WITH 2M SCALE.

In terms of the proposed modifications to the weir to facilitate the passage of fish, in light of the relatively modern age of the fish passage to start there are no particular issues here. In relation to capping the drop-weir section, the profile and different character of the two elements should be respected to ensure the visuals and profile of any capping aligns and maintains the current aesthetics which are important to the narrative of this structure. A light touch approach is advocated, as usual with minimal intervention and proposals should be based on a thorough inspection of the structure and full measured survey. However, concrete is not felt to be inappropriate as it appears in the repairs and in the significant 1950s phase of works.

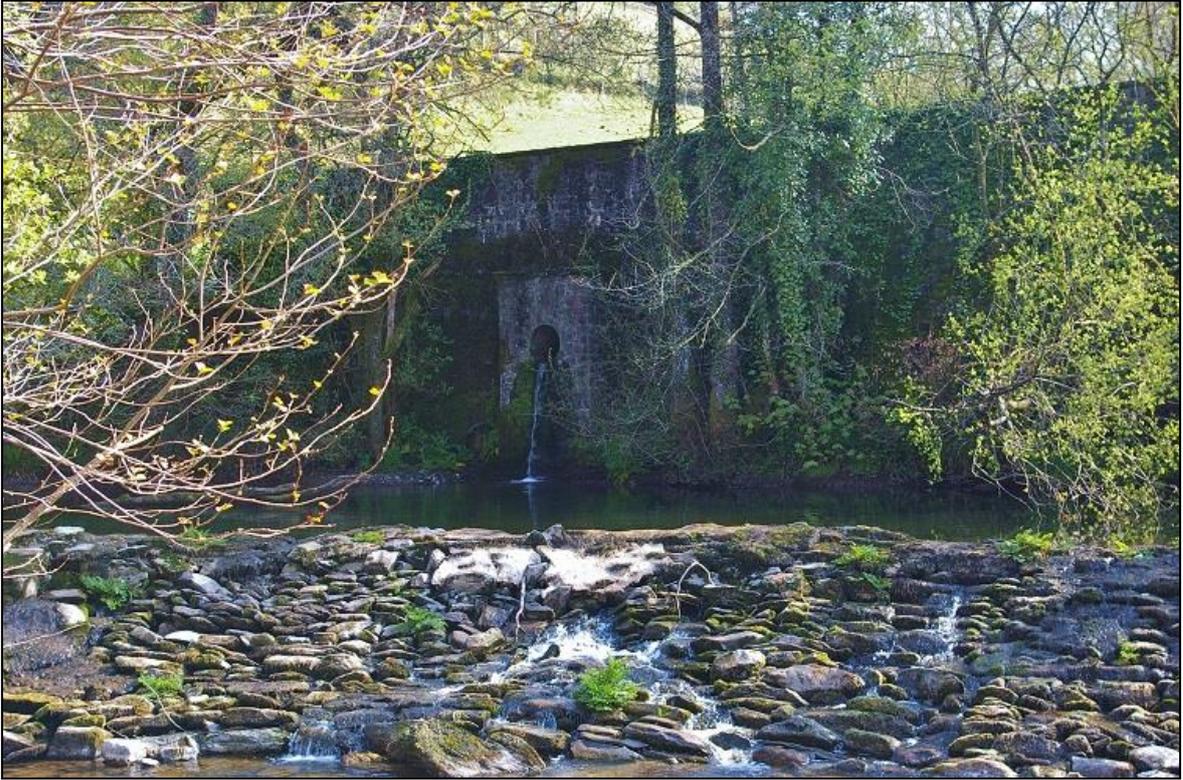
About 20m north of the weir, integral with and built into the retaining wall for the road is a rectangular upright projection, of the same form/build. This has a segmental rounded relieving arch of split slates over a large circular culvert pipe. This appears to bring a stream down the coombe from Exton to the east, under the road and feeds it into the river.

FIGURE 11: THE CULVERT ABOVE THE WEIR, BUILT INTO THE RETAINING WALL ALONGSIDE THE ROAD; FROM THE SOUTH-WEST (NO SCALE).

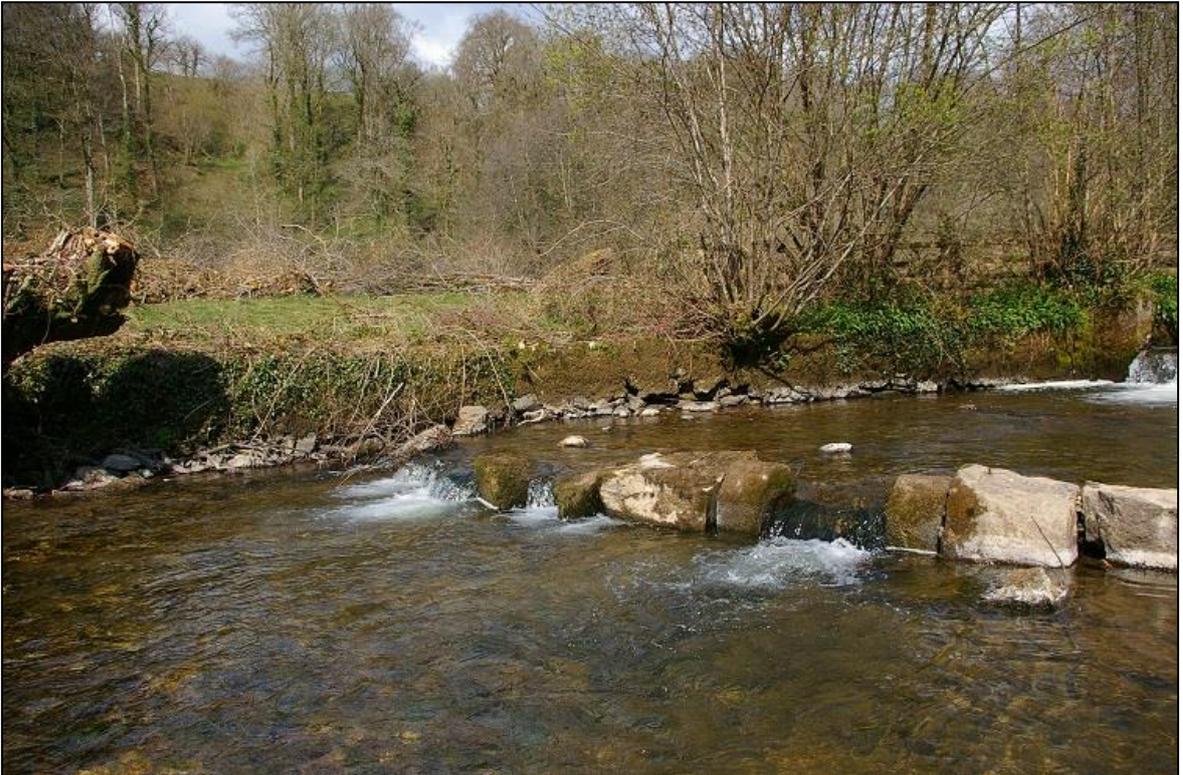
To the west the river bank has been retained by low abutment walls at the north end, adjacent to the north terminus of the weir and fish passage, these walls run for about 10-15m parallel with the weir, terminating in a large tree stump. They are built of weathered slabs, which look to have courses laid down and have been covered with a skim of render which is slowly eroding. The rest of the riverbank is natural and open to the field, with a modern post and wire fence closing off the river to the grazing cattle.

FIGURE 12: THE FLANK WALL AND RETAINING WALL TO THE WEST BANK OF THE RIVER; FROM THE EAST-SOUTH-EAST (NO SCALE).

A final element of the scheme involves the west bank of the river being cut back to accommodate the fish passage, which will remove the abutment walls and although not directly altering the weir is intrusive and alters the wider designed and engineered setting. This can be mitigated by a process of monitoring at the start of works, so a drawn or photographed profile through the wall structure is possible and evidence gathering on its construction can be undertaken. It is felt that there is flexibility here and that this area is more suitable for modification than others, the burden of ecological benefit overriding any minor heritage concerns in this regard. It was noted how extremely slow the water was above the weir almost pool like and how rushing the river is below it, the water at present backing up considerably behind the weir.

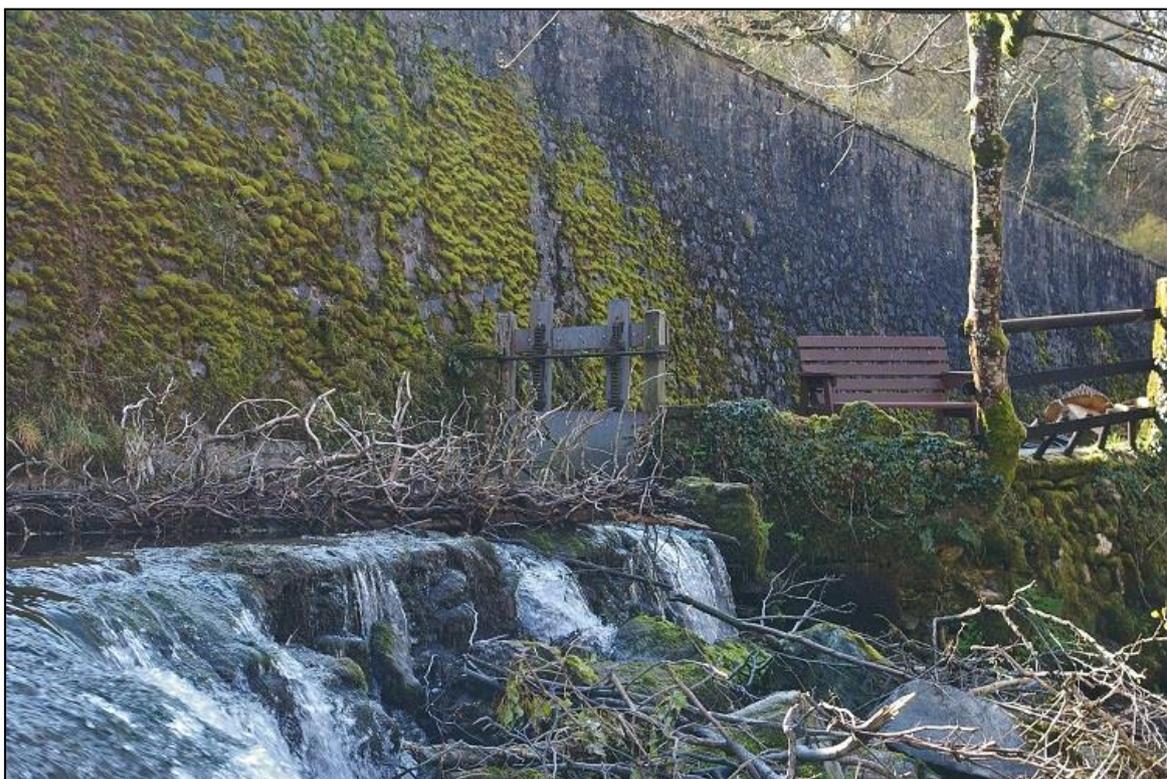
grounds around the mill now landscaped gardens. The sides of this leat are well defined, giving it a sharp rectangular profile, surprisingly deep and carrying quite a volume of water and this feature is very well maintained by the owners. Between the active leat and the river there is a sluice gate, this appears to be a mix of concrete and timber, of relatively modern appearance and this may have been updated when the fish passage and other concrete repairs were undertaken in the 1950s. A flank wall links the sluice and drop-weir section, clearly with large dressed faced blocks at first then the bank curves away with coursed rubble stone revetment walling. There is some rebuilding around the sluice gate piers with concrete mortar and renders visible. The gate itself looks to be metal. The cog and wheel of the winding mechanism are all still present.

FIGURE 13: THE SLUICE GATE FOR THE LEAT; FROM THE WEST-NORTH-WEST (NO SCALE).

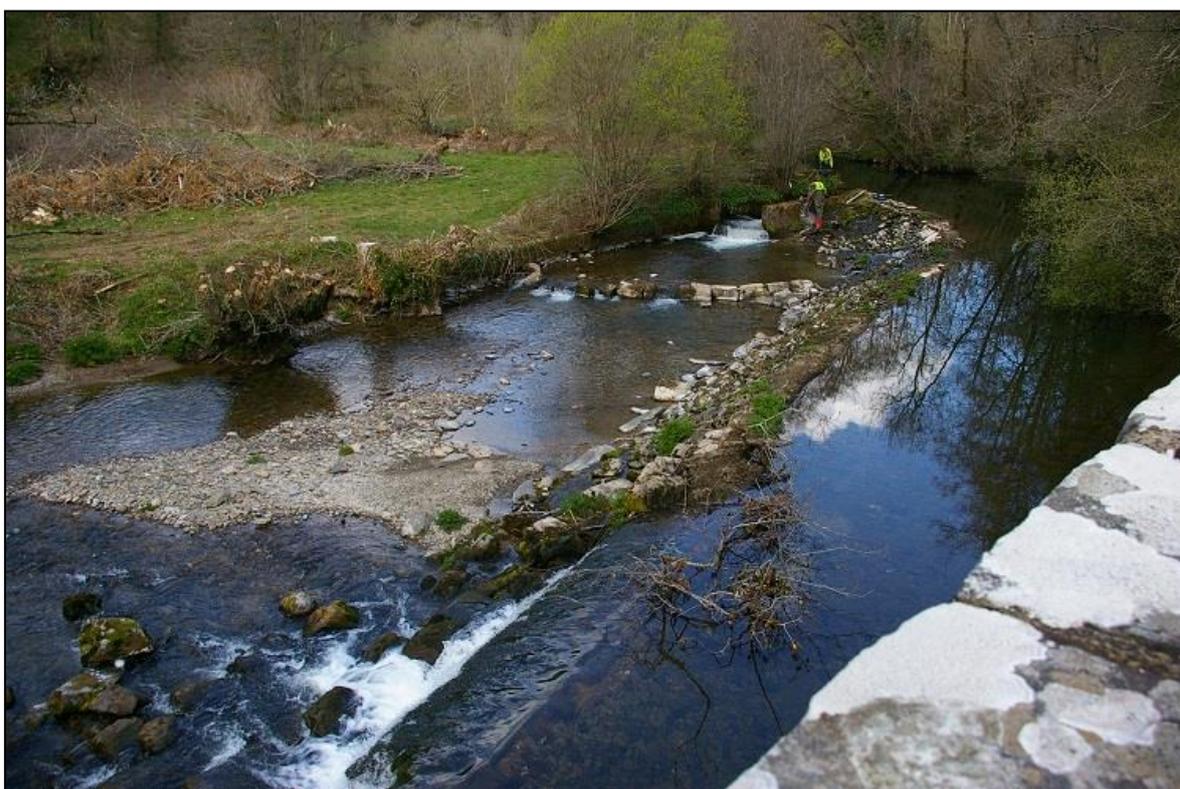
FIGURE 14: THE WEIR AS SEEN FROM THE ROAD; FROM THE SOUTH-EAST (NO SCALE).

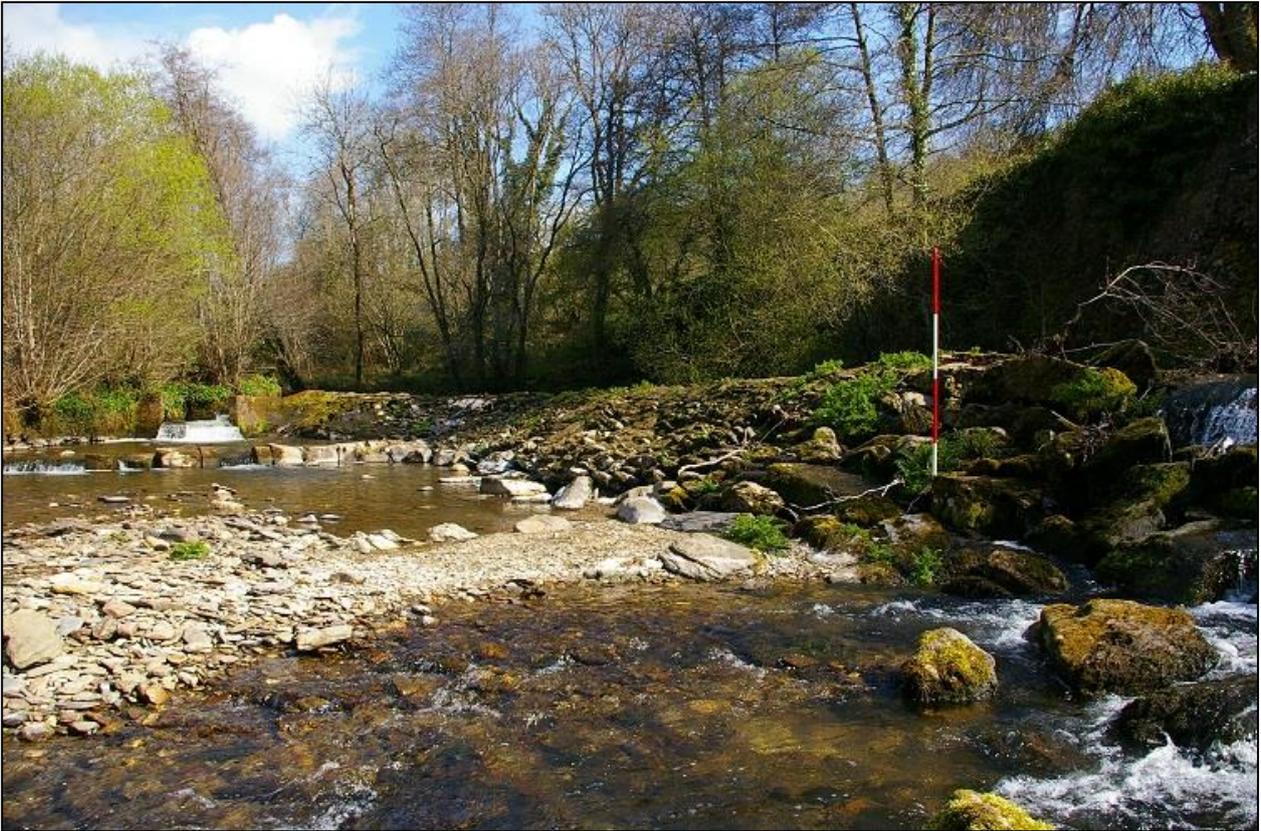
1. LONG VIEW DOWN THE WEIR, FROM THE SOUTH (2M SCALE).

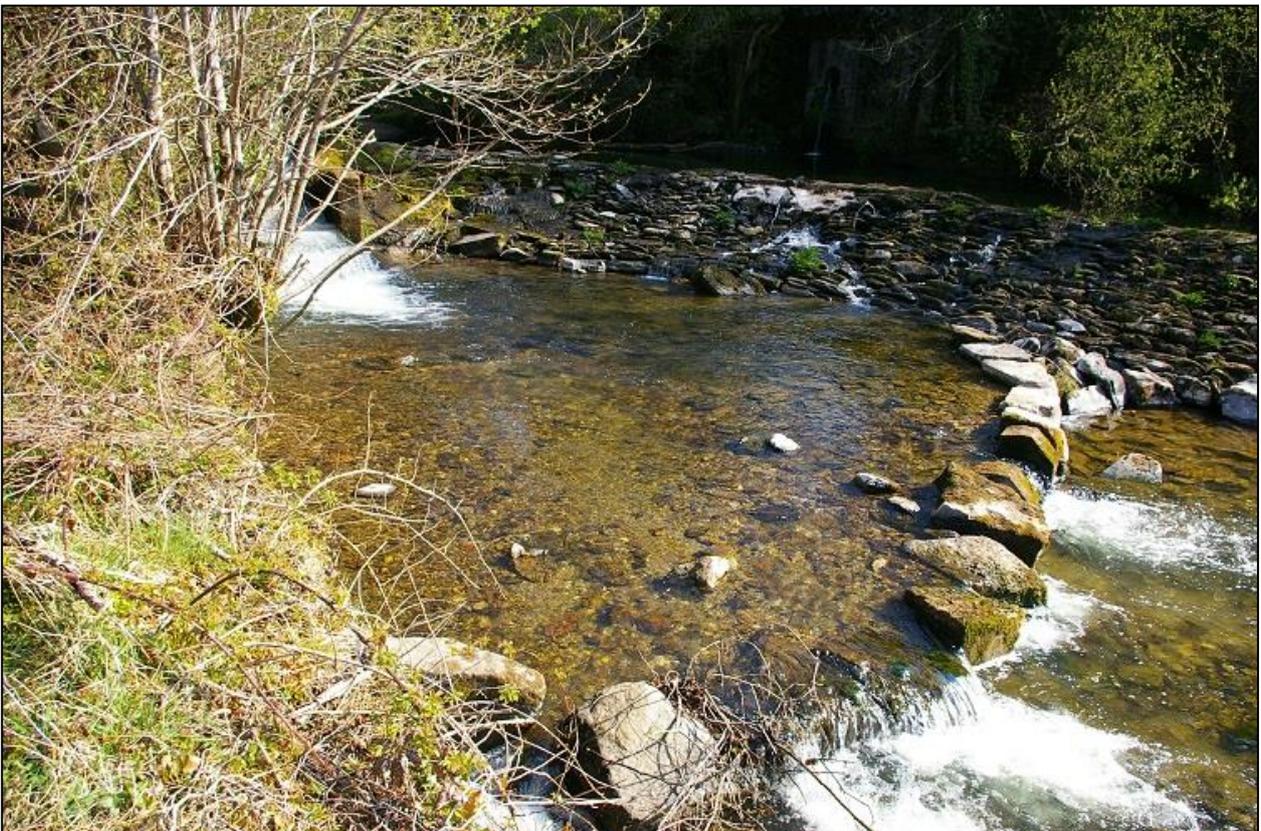
2. VIEW OF THE POOL AND FISH PASS FROM THE WEST BANK; FORM THE SOUTH-WEST (NO SCALE).

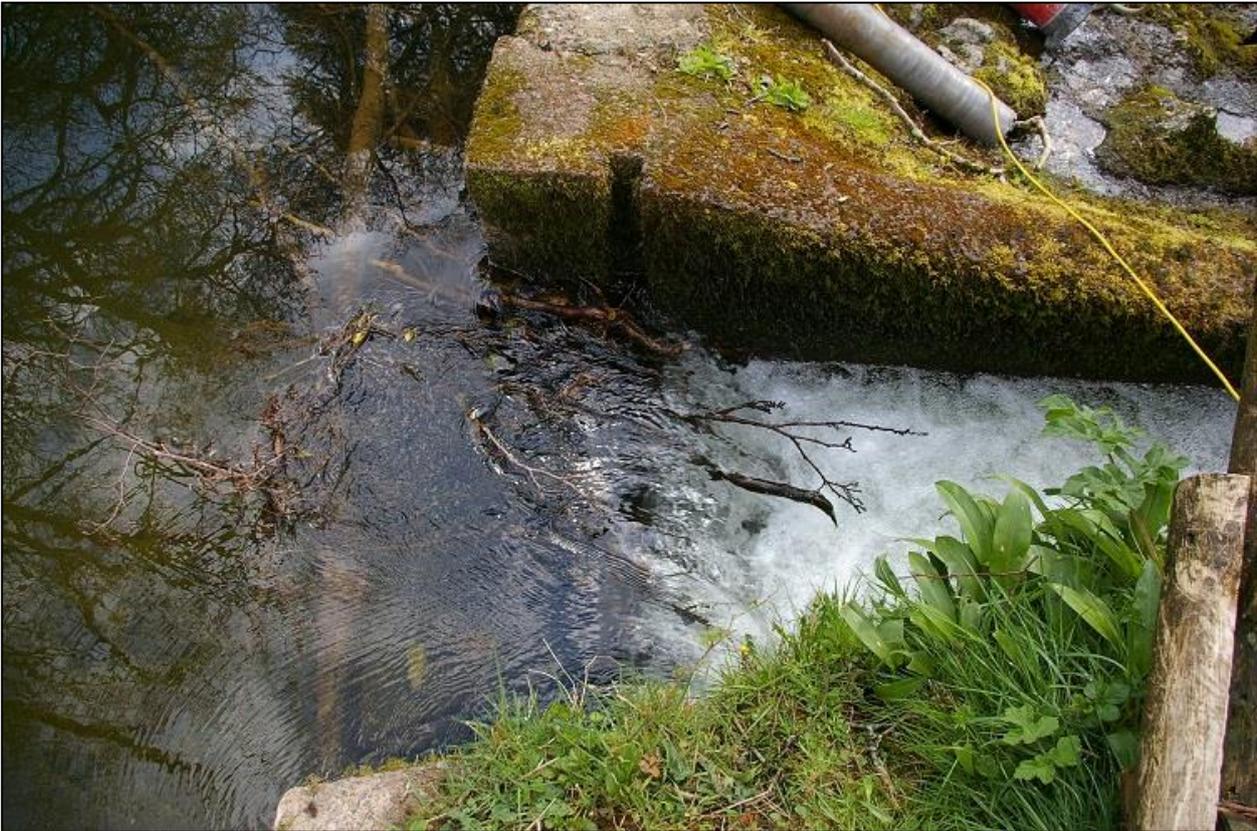
3. VIEW OF THE TOP OF THE FISH PASS WITH SLOTS FOR SLUICE GATE; FROM THE WEST (NO SCALE).

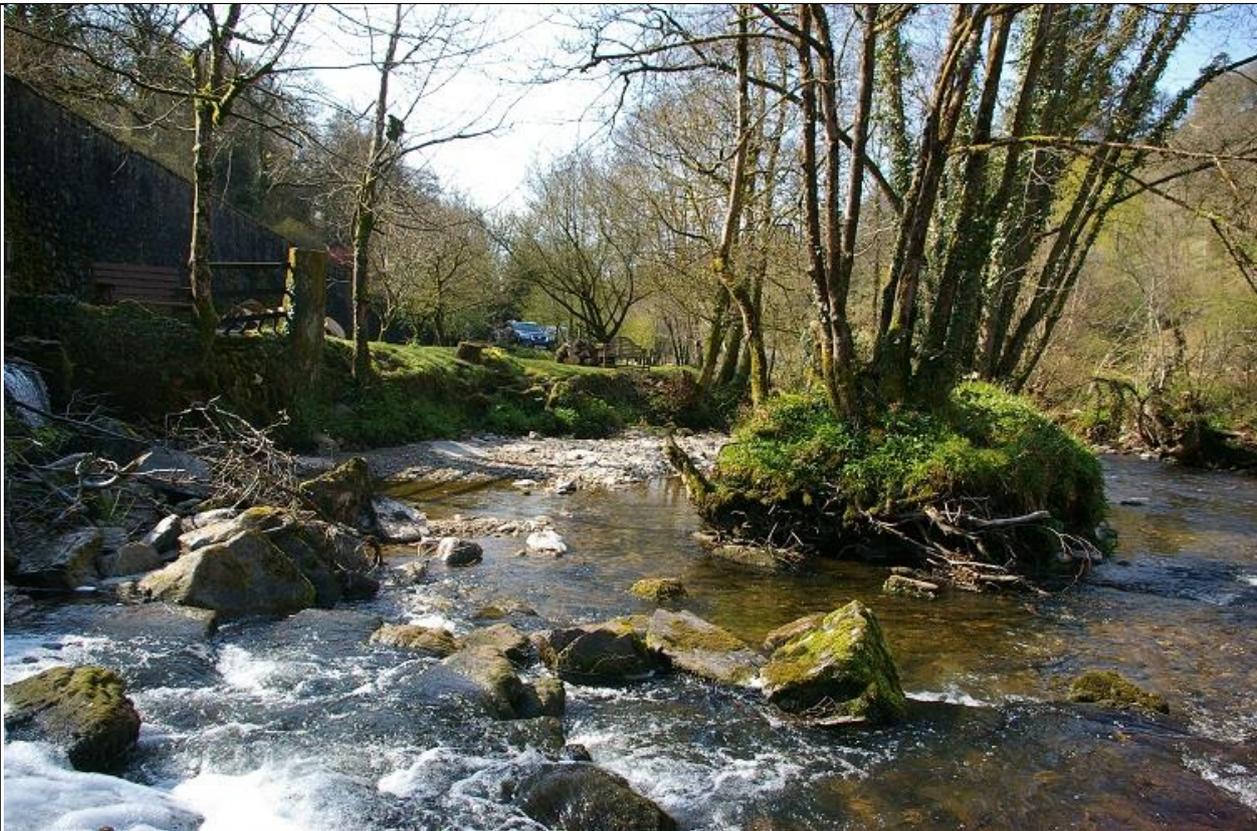
4. THE ISLAND AND RUBBLE BELOW THE DROP-WEIR SECTION; FROM THE NORTH (NO SCALE).

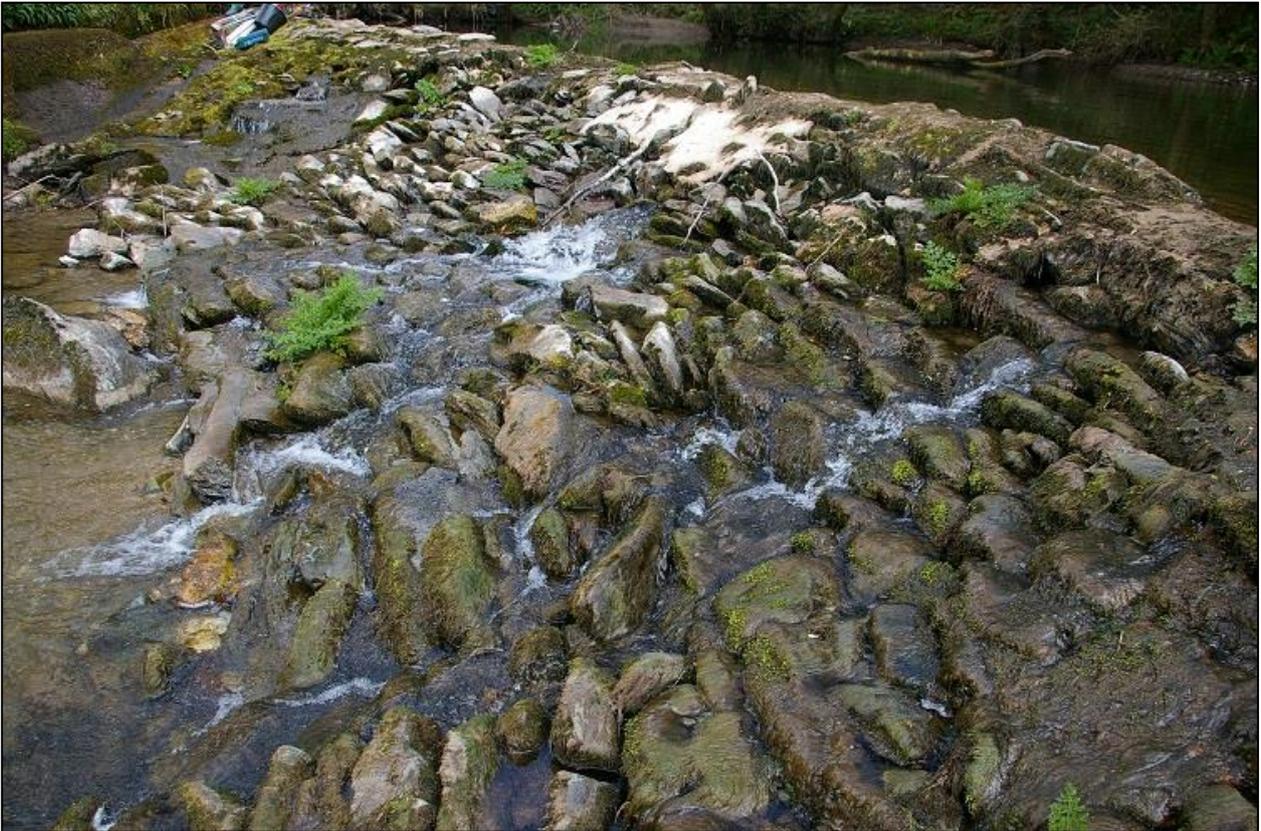
5. DETAILED VIEW OF THE CRUMP STYLE SLOPE, MADE OF LINEAR ARRANGED BOULDERS AND THE SMALL AMOUNT OF WATER WHICH IS OVER-TOPPING THE WEIR; FROM THE SOUTH-EAST (NO SCALE).

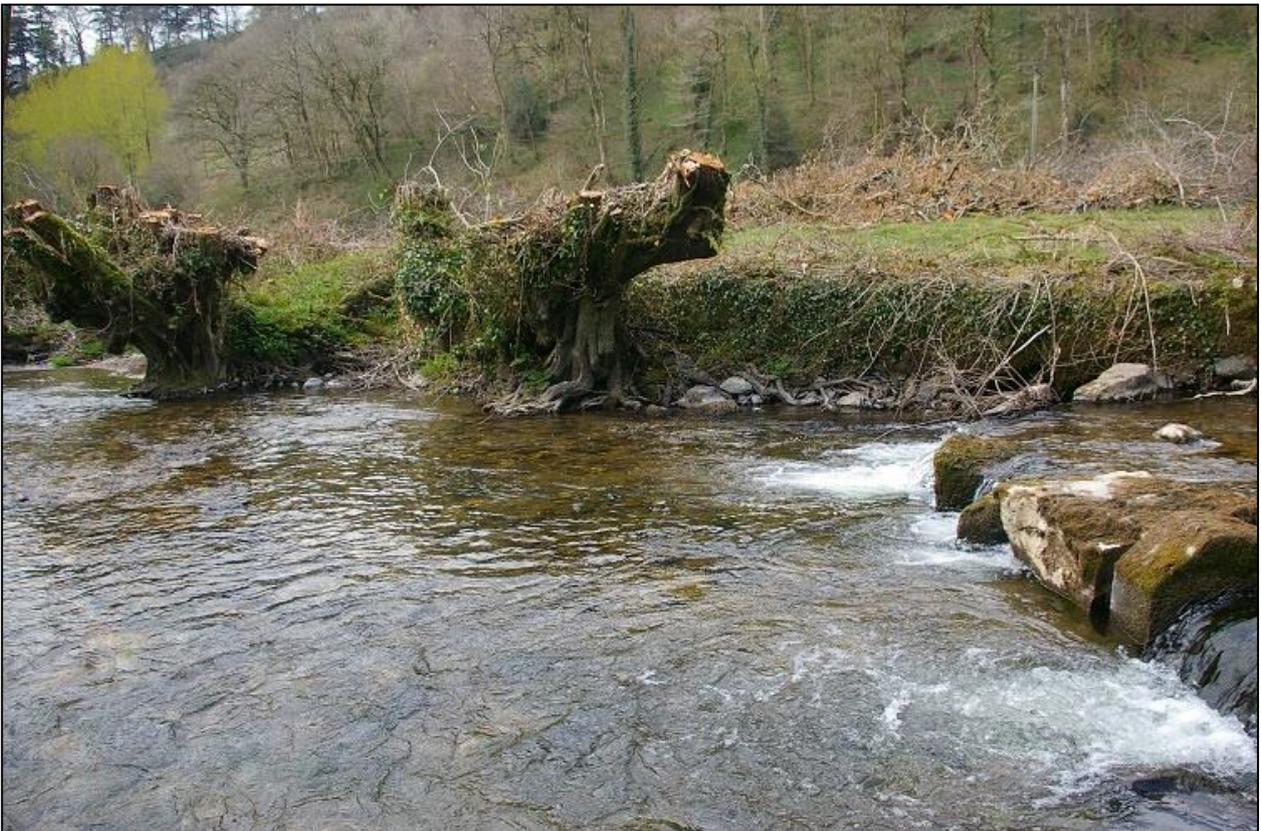
6. THE WEST ABUTMENT WALLS TERMINATE BY TWO LARGE TREES TRUNKS; FROM THE EAST (NO SCALE).
