Plymouth River Keepers

Water Quality Monitoring Scorecard November 2020 – October 2021

Lydia Deacon and Dr Holly Pearson

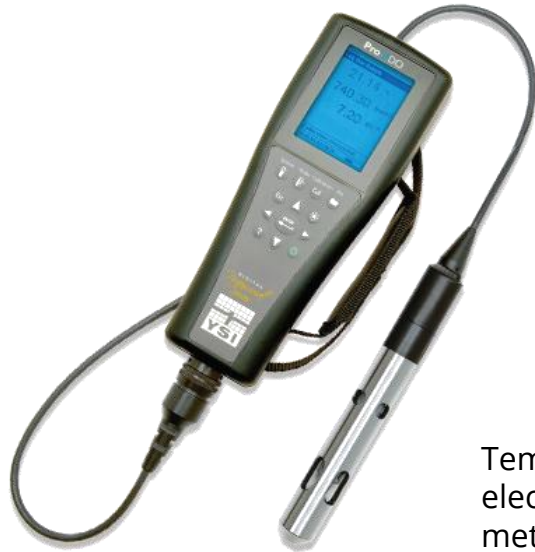
Dissolved oxygen meter

Temperature and electrical conductivity meter

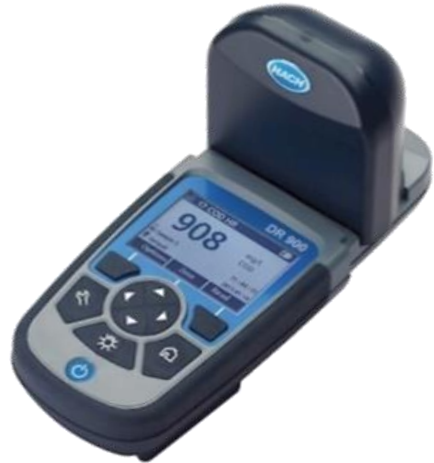
DR900 colourimeter used for PO₄, turbidity and colour

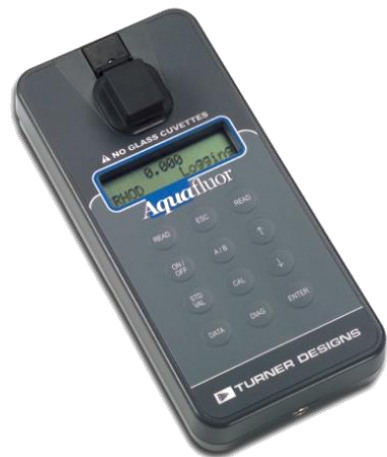
Fluorimeter for used CDOM & OBA

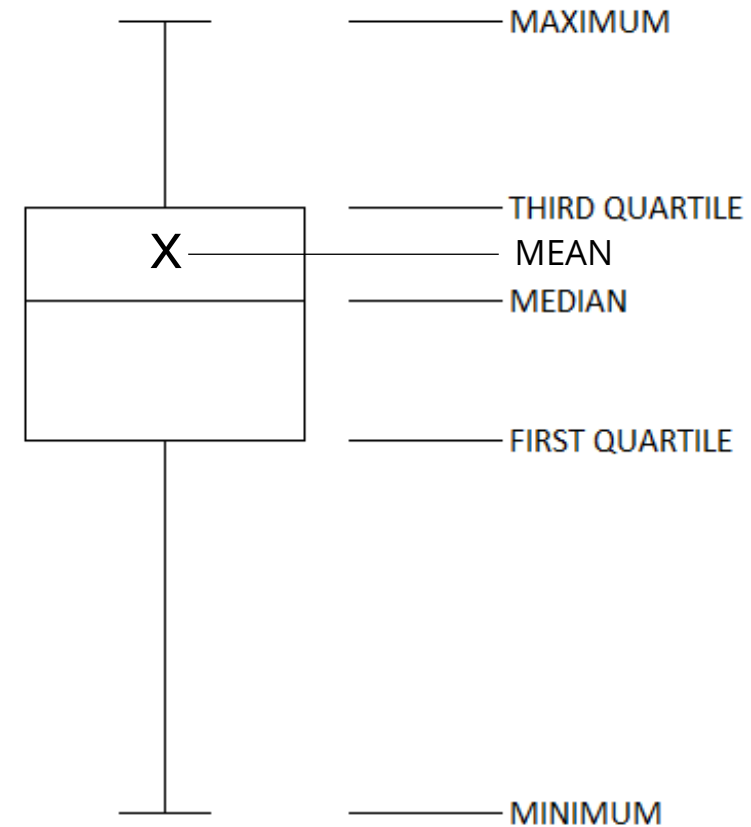
B

Box and whisker plots give the distribution of values at each site for each parameter (B). The number of samples, n , for each parameter at each site was 12 unless the box and whisker plot displays a ‘*’, in which case $n = <12$

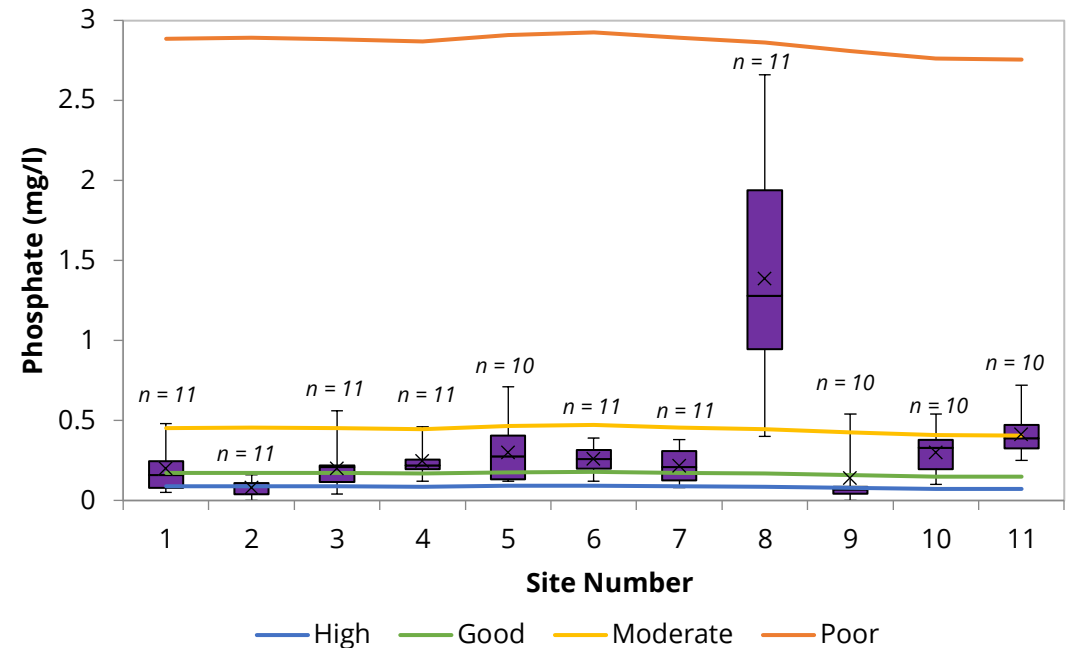
Phosphate for the catchments ranges from **<LOD to 2.7 mg/L**, with a median of **0.2 mg/L**. The greatest range in PO_4 is observed on the Combe Lane Stream.

The Tamerton Stream at Coombe Lane (site 8), the Ernesettle Stream at Pembery Walk (site 5) and Tamerton Stream at Widewell Stream Footbridge (site 11) are worst the affected. There are very elevated PO_4 concentrations at site 8 the highest of which came during the April sample run where flows were very low, which reiterates our suspicions of a point source input. Phosphate levels are generally high for all sample sites, particularly during low flows indicating that there are issues from point source inputs throughout the catchment. The effects of elevated phosphate are not immediately evident in the streams. However, there have been a number of reports of algal blooms in the Tamerton Lake (which receives all streams in this catchment) during the summer months for which high phosphate could be a contributing factor.

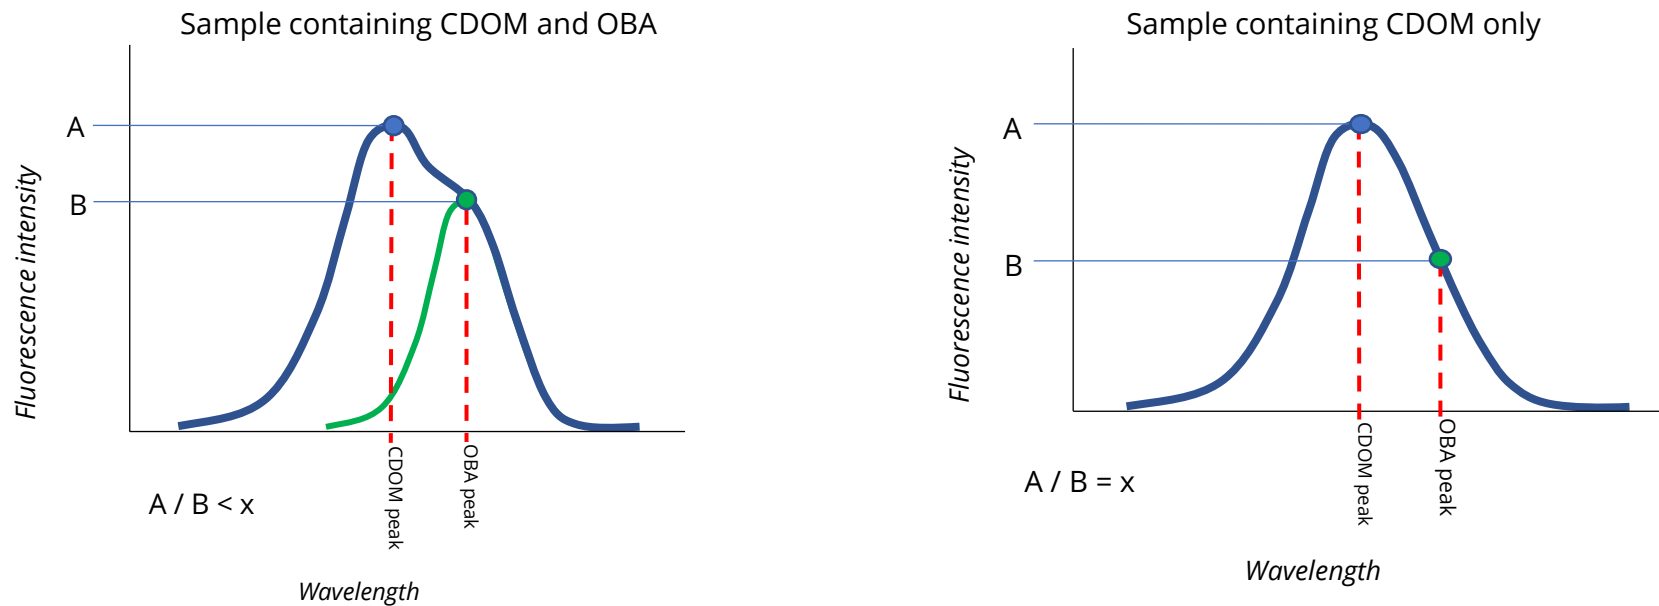
CDOM and OBA both fluoresce in a similar part of the spectrum. While the 'peak' fluorescence occurs at wavelengths of c. 420 nm and 440 nm respectively, there is a fluorescence response from nearby wavelengths too. As the fluorescence responses from CDOM and OBA 'overlap', CDOM will give a 'false' OBA reading and vice versa (Fig 1). If the sample contains only CDOM then we can expect that the ratio of the measured CDOM to OBA 'peaks' should be consistent. If there is OBA present in the sample then we would expect it to change the shape of the fluorescence response curve and this would be reflected in the ratio between the two.

Fig 1. The theoretical output from the fluorescence analysis whereby peaks from OBA and CDOM overlap one another due to their wavelength proximities

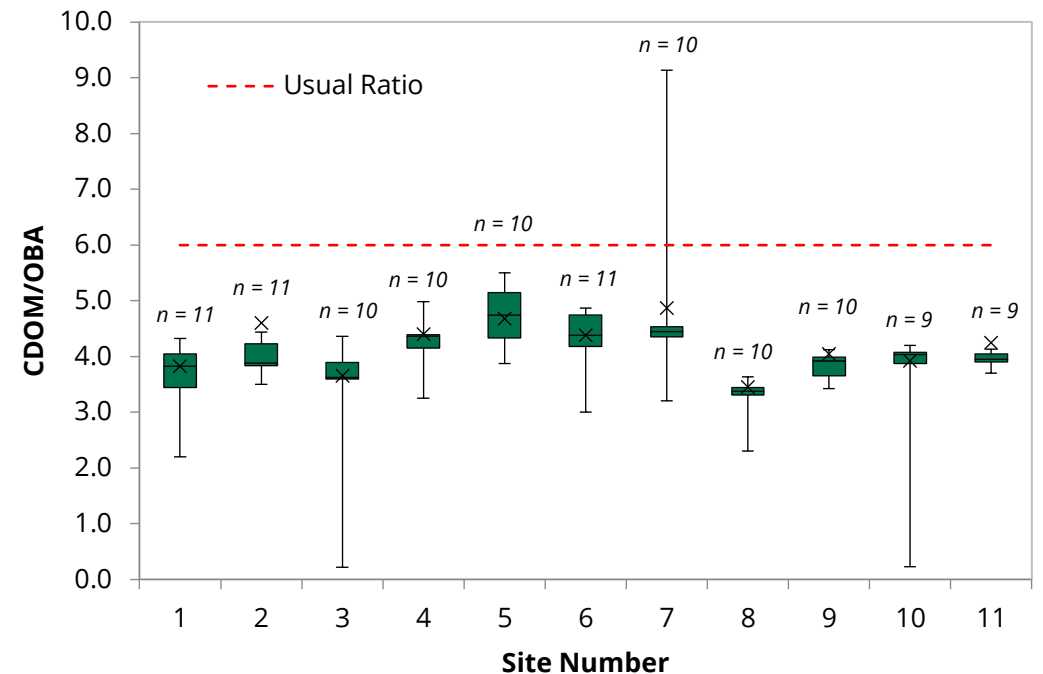
Tamerton Stream at Porsham Lane (site 7) is the only one to show a higher ratio of CDOM to OBA with a max of **9.3** likely due to organic matter from the surrounding riparian woodland and from agricultural inputs. The Cann Stream at the Old Weir

(site 3) and The Roborough Stream (site 10) show the lowest ratios (**0.2**), meaning the highest levels of OBA were seen in these stream.

Although this method gives a good indication that OBA is present in these streams, our instrumentation limits us to only semi-quantitative data, All other sites show the presence of OBA with a mean ratio of **4.2**, indicating that all streams may well be receiving grey water in varying amounts. Although further investigation would be needed to prove and quantify this, these numerical observations are in line with the observations of the suspected misconnected outfalls entering the streams.

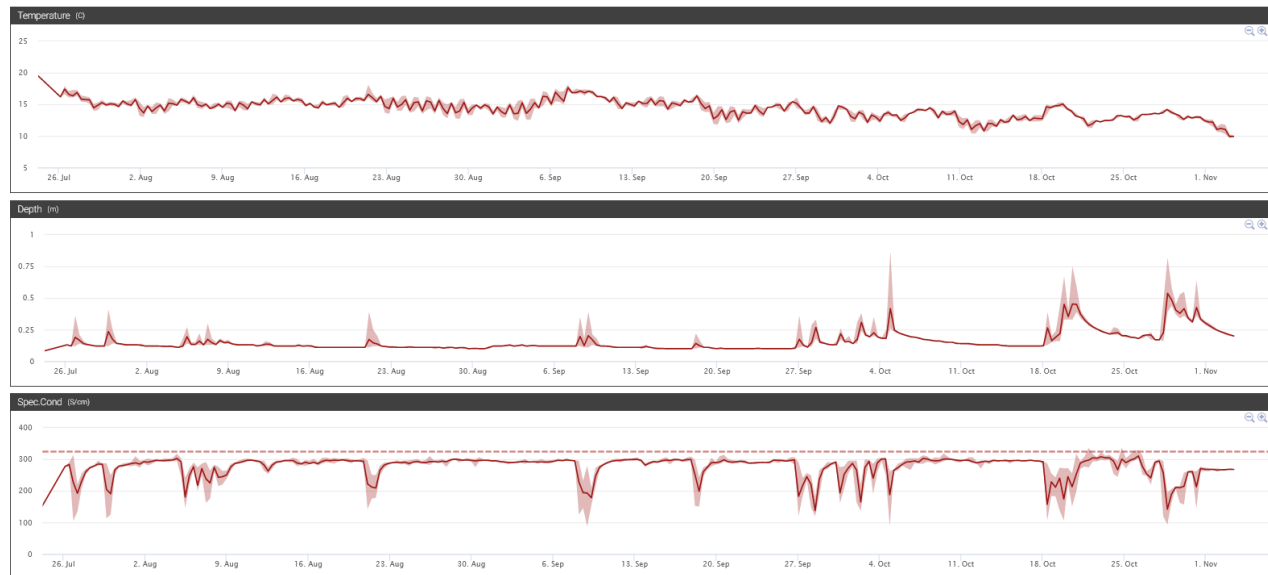
Fig. 3 Screen grab from the Hydrovu website showing the live data from the sonde.

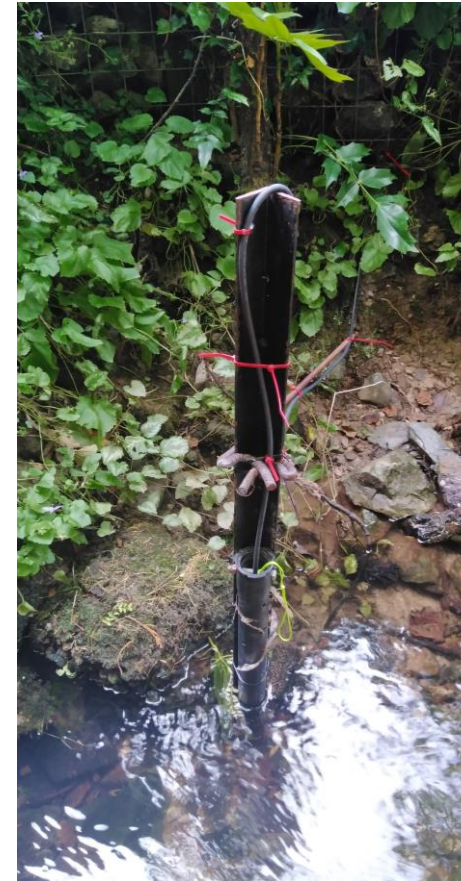
An AquaTROLL 200 (AT200) sonde measuring temperature, depth and conductivity was installed at the bottom of the Tamerton Foliot Stream on Riverside Walk in July 2021 (fig.3). It was connected to a Mace telemetry unit (fig.4) which sends data to the Hydrovu website every 15 minutes (fig.5). A Brinno time-lapse camera is also installed at this site, capturing data every 15 minutes to give a visual picture alongside the data.

Fig. 4 The AT200 sonde in its casing. It is installed so it sits upright inside the pipe to avoid it getting damaged or clogged with debris and sediment.

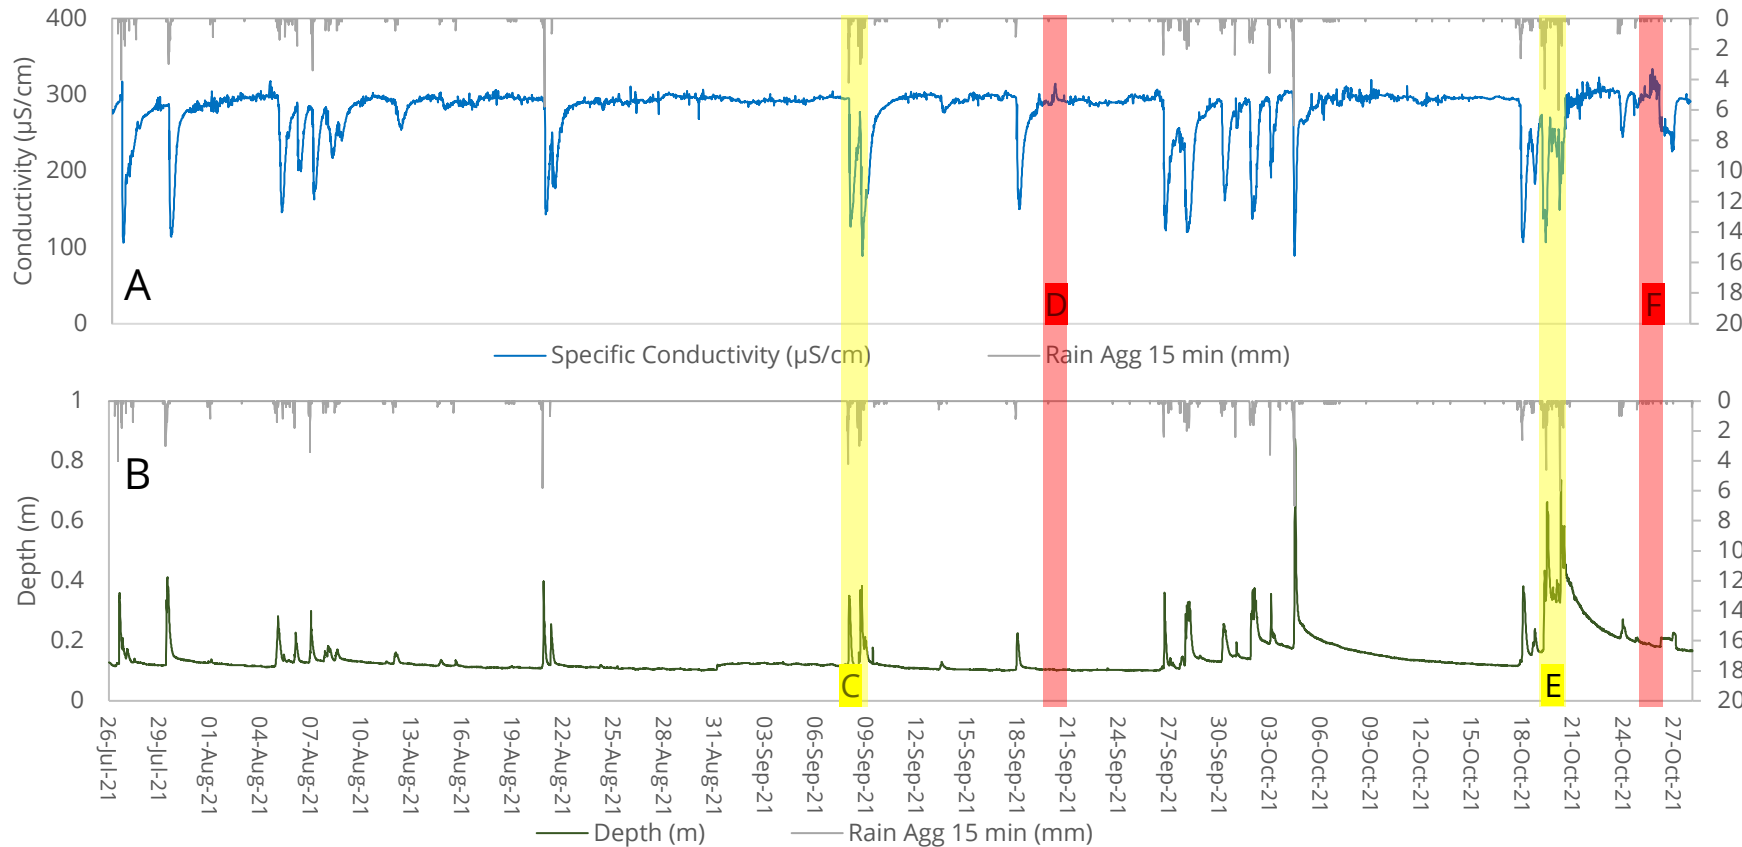
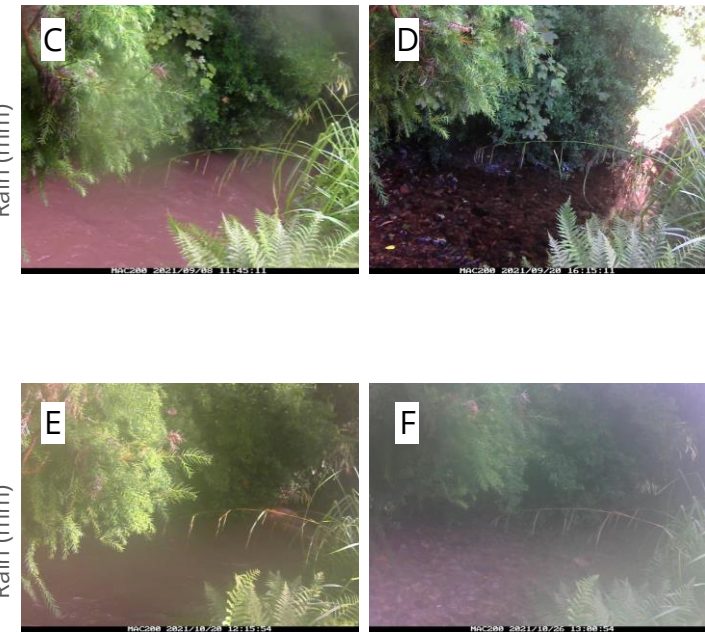
Conductivity and depth data from the AT200 has been plotted against 15 minute rainfall data (downloaded from the EA rain gauge at Crownhill) (fig.6 A/B). As would be expected, rainfall causes the depth to rise and the conductivity to reduce as the higher water level dilutes the ions in the water column.

The minimum value for conductivity is 88 μ S/cm seen on 9th September 2021 (C) and the maximum is 334 S/cm (F) seen on the 26th October 2021. From our spot sampling results, the Tamerton Stream at Seven Stars (upstream of the sonde) is ranked 3 out of the 11 sites for conductivity, indicating that it is not consistently elevated. This is confirmed from the sonde data which shows there are only small rises above the baseline level of conductivity and from the photographs these seem not to coincide with pollution that is visible (D).

Depth reached a maximum of 0.87 m (E) on the 4th October 2021 (coinciding with the highest rainfall of 7 mm) and a minimum of 0.1 m on the 31st August 2021.

Fig. 6 A) graph of conductivity plotted with rainfall between 26th July and 28th October 2021. B) Depth plotted against rainfall for the same period. C) 09SEPT21 rise in stream level. D) 20SEPT21 rise in conductivity. E) 04OCT21 rise in river level. F) Rise in conductivity.

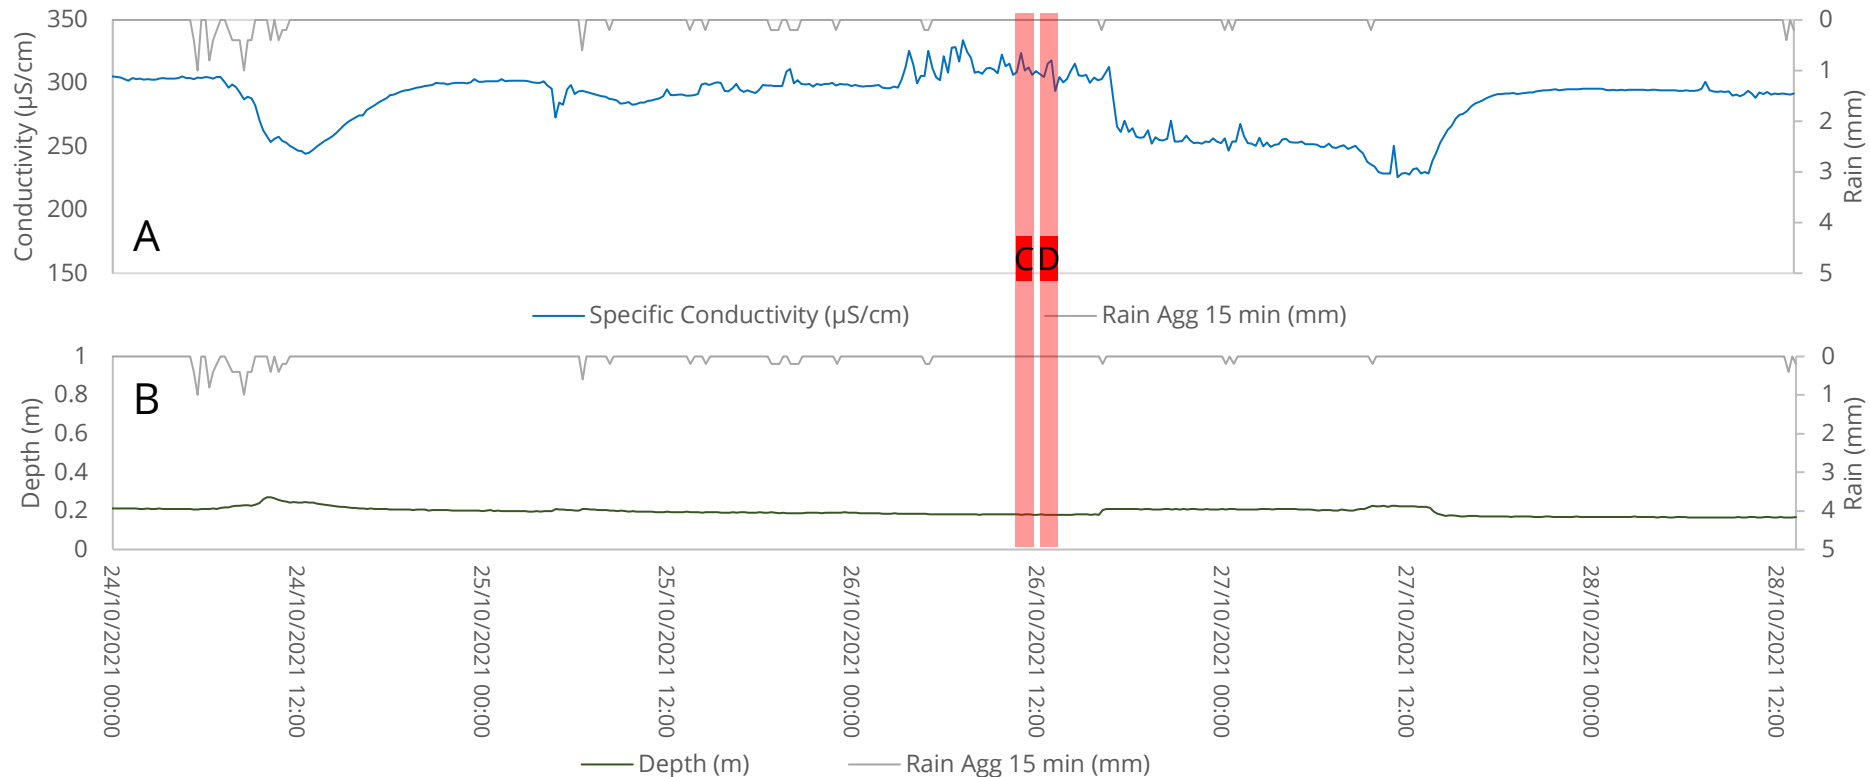
To better understand how the stream is reacting during high conductivity, a more detailed look at the highest conductivity spike is shown in the graph in fig. 7. The peak of conductivity (334 $\mu\text{S}/\text{cm}$) occurred at 07:15 on the 26th October 2021. Unfortunately, due to the time-lapse camera not being able to take photos in the dark, we do not have pictures for that exact time. However, the spike at 11:00 (A) and 13:00 (B) can be matched to photographs.

From the images there appears to be no visible pollution in the stream (i.e. change of stream colour, debris or foam). It may be that these spikes in conductivity are just natural fluctuations, or it may be that the rise in conductivity was caused by pollution that is not visible. More data will be needed to observe the trends of conductivity in the stream. We are also involving the community in observing visual evidence during spikes in conductivity which will help us to determine whether the spikes coincide with visual pollution incidents.

Fig. 7 A) graph of conductivity plotted with rainfall between 24th October and 28th October 2021. B) Depth plotted against rainfall for the same period. C) 26OCT21 11:00 rise in conductivity. D) 26OCT21 13:00 rise in conductivity.
