Bridgetown Weir Fish Pass Installation

Site Specific Flood Risk Assessment

Project Title	Bridgetown Weir
Date	17/6/2021
Client	Westcountry Rivers Trust

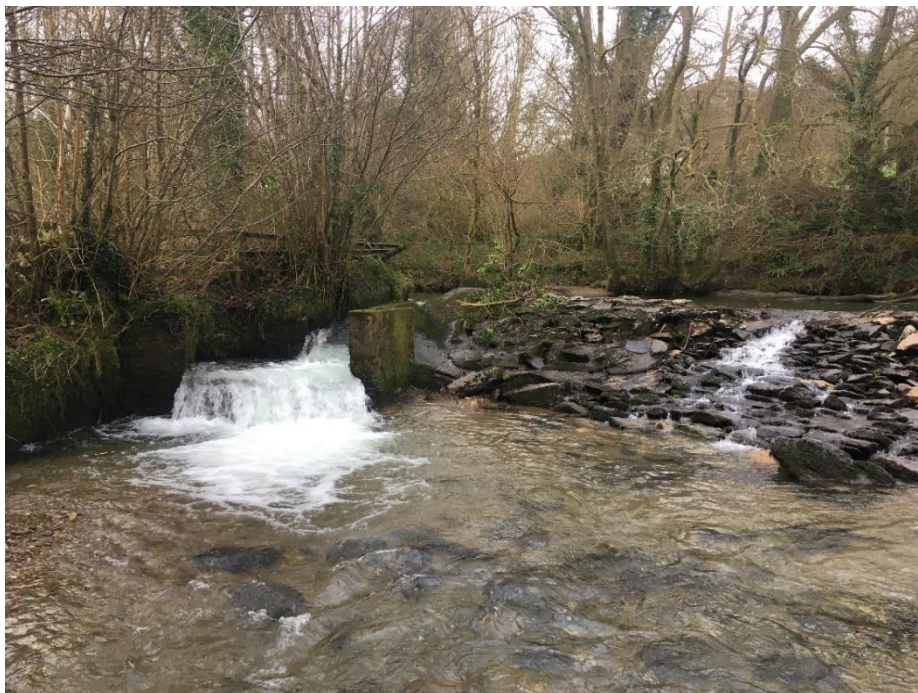
Figure 2.3: image of the fish pass at the upstream end of the weir, looking from downstream

- The existing fish pass, at the upstream end of the weir (see figure 2.3 and 2.4)
- The weir crest (see figure 2.5). This is in a varying state of repair along its length and has a variable level. One section in particular towards the downstream end of the weir has degraded, resulting in a section of weir crest that is lower than the remainder of the structure
- The notch at the downstream end of the weir, which typically has 'weir boards' placed in it (see figure 2.6)
- The leat, which has a large sluice at the upstream end (see figure 2.7)

- 1) Existing scenario
 - a. Over the existing weir (which has a varying level along its length) – see figure 2.6
 - b. Through the existing fish pass (see figure 2.3 and 2.4)
 - c. Through the existing notch at the end of the weir, which was considered as having boards in (see figure 2.7)
- 2) Future scenario with repaired weir crest
 - a. Over the existing weir (which has a varying level along its length, but which will be repaired to a more consistent level)
 - b. Through the new Larinier pass
 - c. Through the new smolt notch and chute
- 3) Future scenario with no repaired weir crest
 - a. Over the existing weir (which has a varying level along its length) – see figure 2.6
 - b. Through the new Larinier pass
 - c. Through the new smolt notch and chute

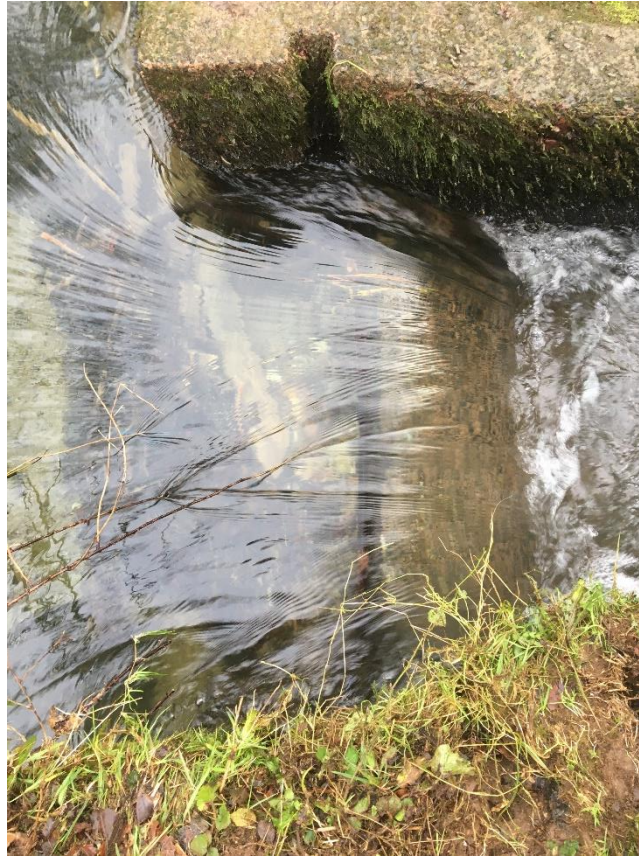
Figure 2.4: Image of the upstream end of the fish pass, where flow enters the pass. Boards are typically placed in here, to reduce flow into the pass

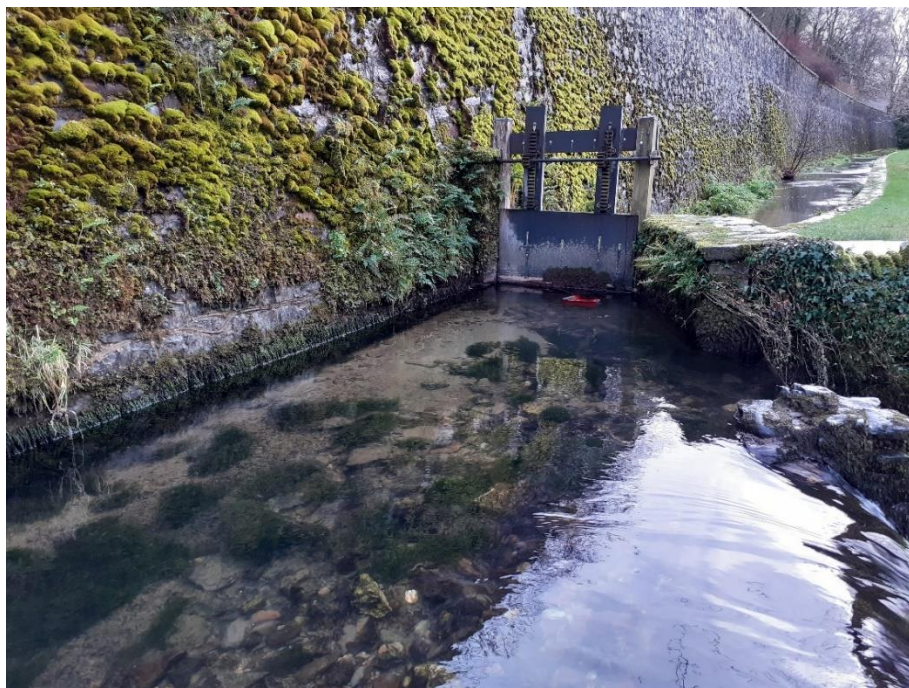
Figure 2.5: Image looking downstream towards the leat with sluice at the head of the leat

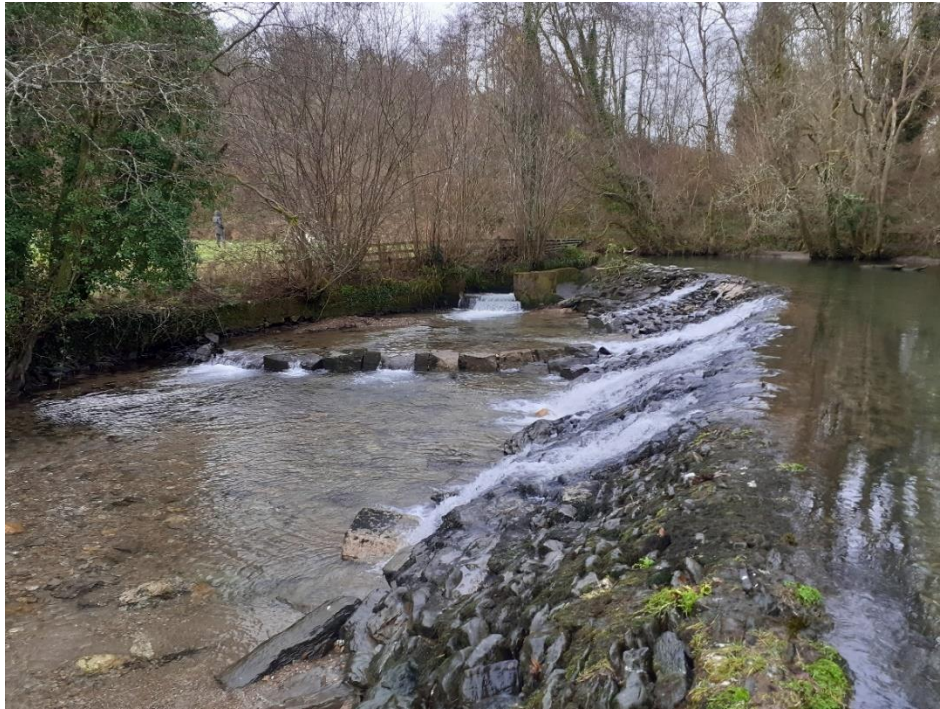
Figure 2.6: Image looking along the weir crest in an upstream direction

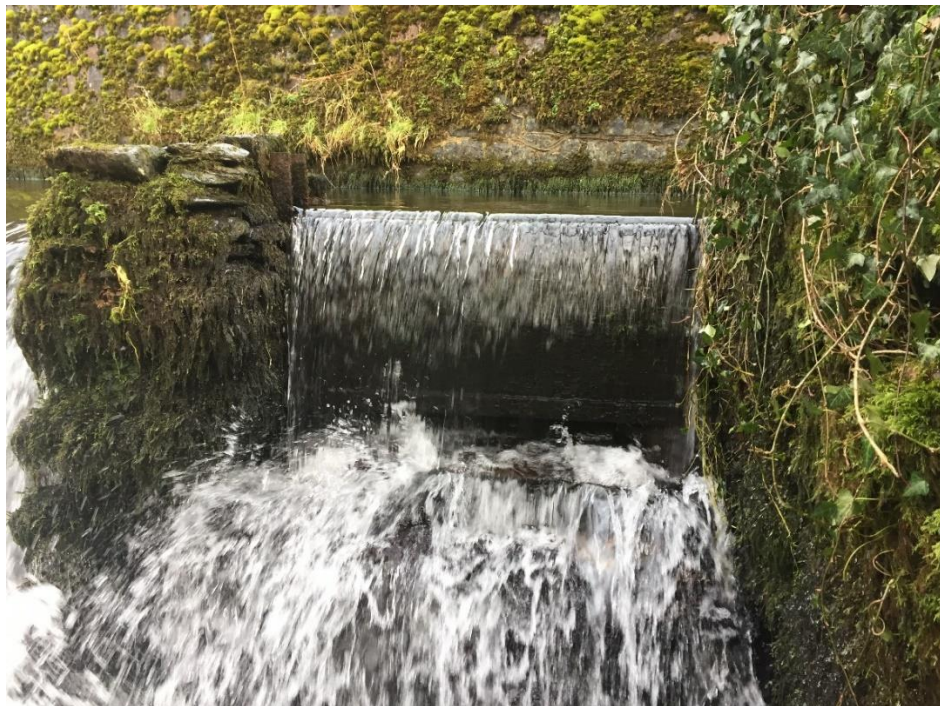
Figure 2.7: Image of the notch (with boards inserted) at the downstream end of the weir, close to the sluice at the head of the leat

- Installation of a new 600 mm wide Larinier fish pass at the upstream end of the weir, in the footprint of (and replacing) the existing pool and traverse pass
- Repair of the weir crest for a distance of approximately 12 m. The intention of this work is to restore the level of the weir crest to its historical level along its whole length. A section towards the downstream end (which is to be repaired) has become damaged and degraded over time and has reduced in level. This creates effectively a shallow, wide notch which attracts fish, particularly at higher flows and which may reduce the effectiveness of the fish pass.
- Installation of a new smolt notch and chute at the downstream end of the weir, in the location of the current notch and boards (see figure 2.7)

- Weir structure: considered as a broad-crested weir with a varying level. The weir was split into sections for the analysis with each section having a length and level assigned to it from the detailed topographic survey taken at the site
- Existing fish pass: calculated using flow relationship for a thin-plate weir as flow into the structure is controlled by the boards placed at the upstream end of the fish pass (see figure 2.4). Boards were at an average level of 174.40 m AOD when the topographic survey was taken.
- Existing notch at downstream end of weir: calculated using flow relationship for a thin-plate weir as flow into the structure is controlled by the boards placed in the structure, which were at an average level of 174.715 m AOD when the topographic survey was taken (see figure 2.7)

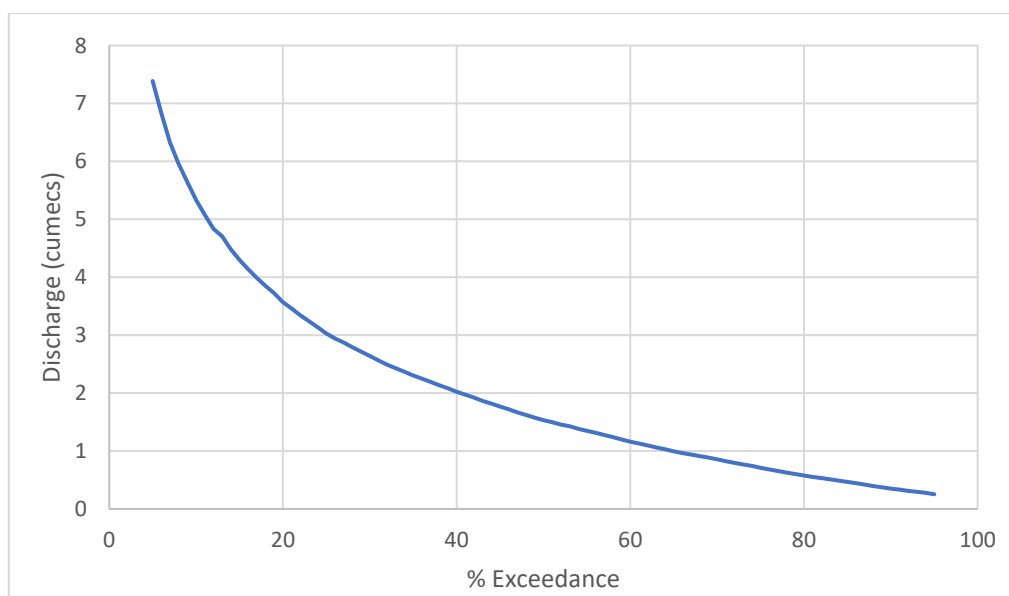
Figure 2.8. % Exceedance curve for the River Exe at Bridgetown

Flow data for the site is given in Table 1 and Flow Duration Curves in Figure 2.8. The flow estimates were obtained using Low Flows 2000 software.

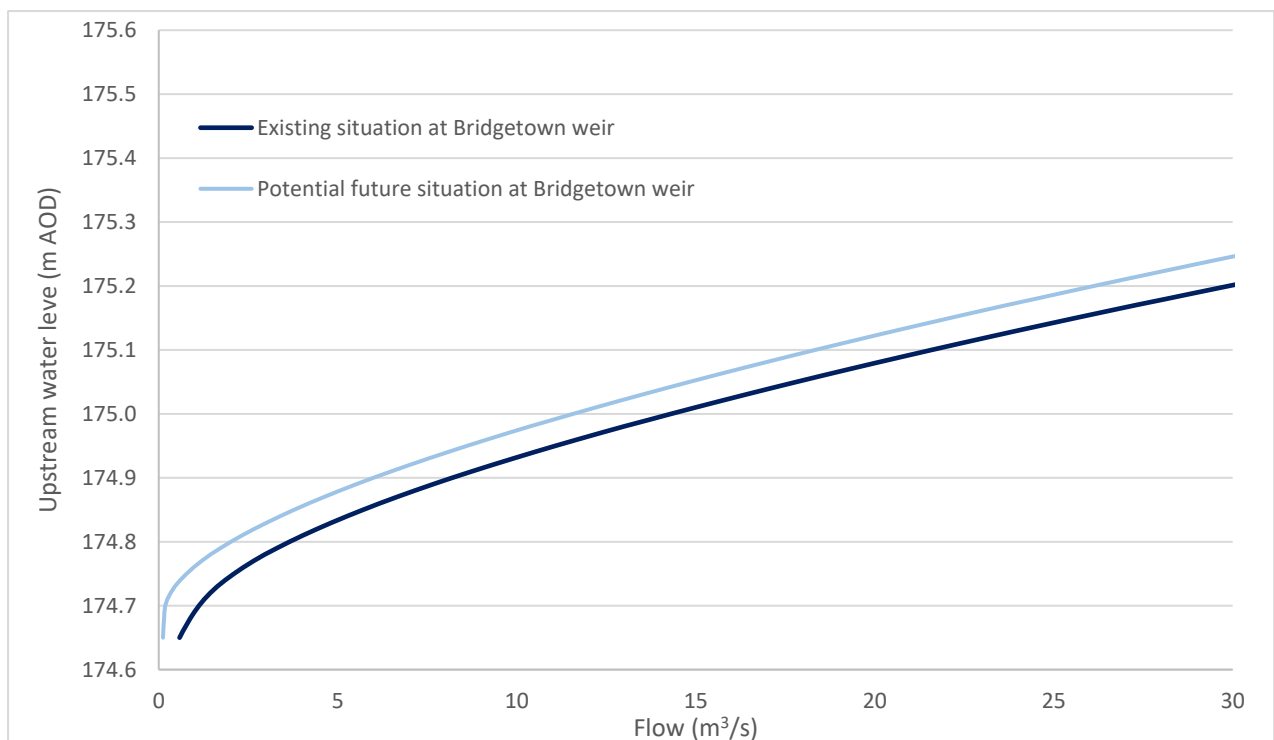
Initially, scenario 1 was compared to scenario 2 (new Larinier pass, new smolt notch and chute and repaired weir crest). Figure 4.1 presents the results of this analysis and shows that there is a slight difference in the upstream water level for the two different scenarios. The water level in the proposed future scenario is slightly higher than the current situation at the weir, for a given flow. This difference is, however, relatively minor and equates to ~40 mm across most of the modelled flows.

Figure 4.1: upstream water levels at Bridgetown weir across a total flow range of 0.1 – 30 m³/s for the two initial scenarios (Scenario 1 and Scenario 2)

An examination of the data and proportional flow passing through the different flow routes showed that the main hydraulic flow route is the weir crest at higher flows, but at low to medium flows, flow at the site will split between the different routes more evenly. At Q10, approximately 50% of the flow at the site will be passing over the weir crest and this increases to 75% by Q1. Given this, a secondary comparison was made, comparing the existing scenario at the weir with a future scenario where the weir crest is not repaired. The results are given in figure 4.2.

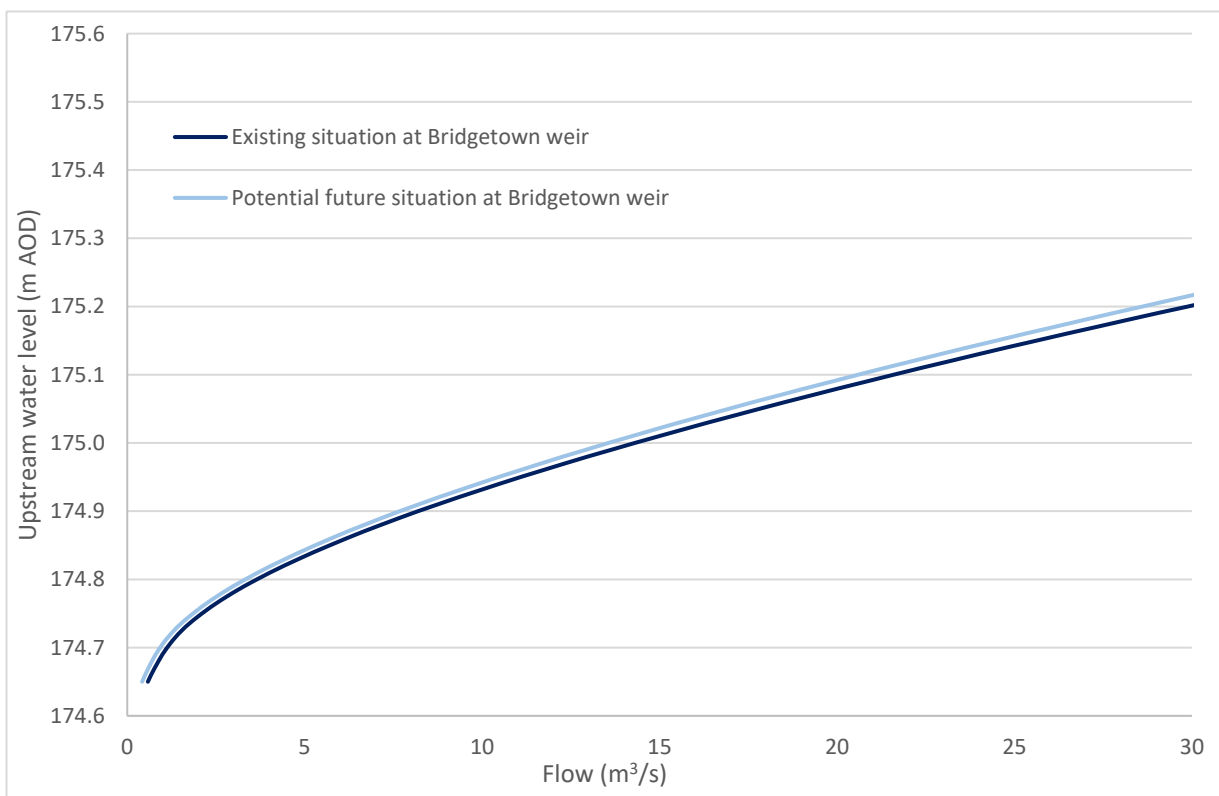
Figure 4.2: upstream water levels at Bridgetown weir across a total flow range of 0.1 – 30 m³/s for the two initial scenarios (Scenario 1 and Scenario 3)

The water level in the proposed future scenario with no repairs to the weir crest is only a small amount higher than it is for the current situation at the weir, for a given flow. This difference equates to ~10 mm across most of the modelled flows.
