KEYBRIDGE WEIR KEYBRIDGE BLISLAND CORNWALL

Archaeological Monitoring and Recording

South West Archaeology Ltd. report no. 211119

Keybridge Weir, Keybridge, Blisland, Cornwall Archaeological Monitoring and Recording

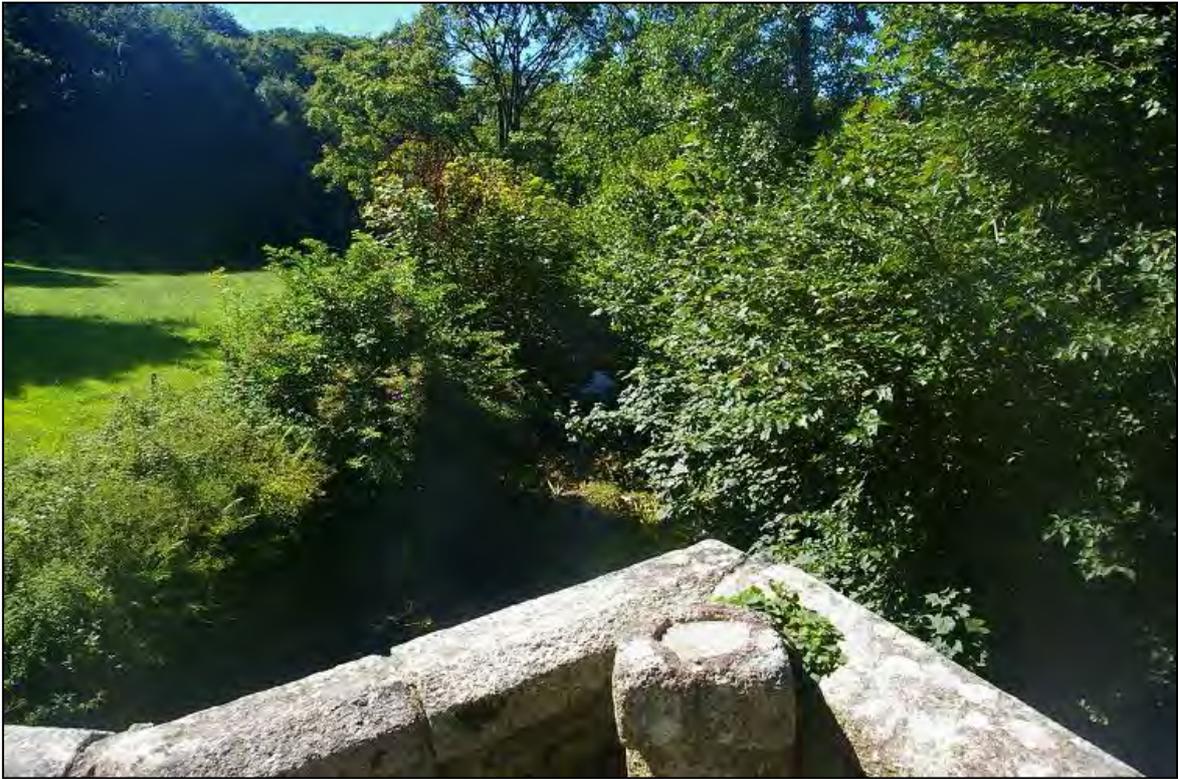
The banks of the river between the weir and Keybridge are overgrown and now quite enclosed with young trees and scrub, reducing views, indeed there is now, no direct inter-visibility between the bridge and weir in spring and summer, with foliage on the trees; although, in winter there may be glimpses back to the bridge from the general location of the weir.

FIGURE 7: THE VIEW ALONG THE RIVER, TOWARDS THE WEIR, FROM LISTED KEYBRIDGE BRIDGE AND SUNDIAL; FROM THE NORTH.

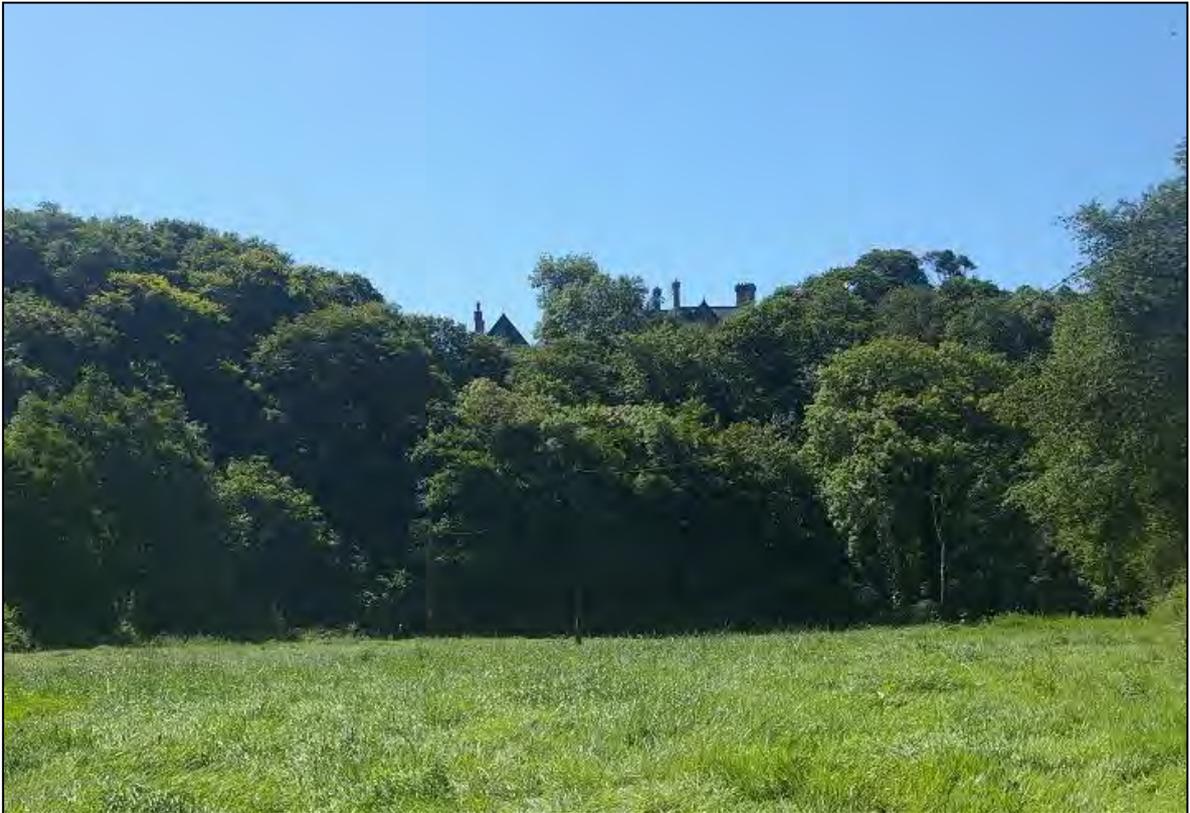
The in-river location and nature of the weir and nature of the wooded banks mean the weir has no landscape level of presence and there are no wider views of it, outside of its immediate setting. There are direct views up to the house from the west bank, parallel with the weir and when the house was built in the Victorian period the slopes were probably less wooded; the site inspection confirming that there may once have been direct inter-visibility, the weir acting like a parkland-style eye-catcher for the garden terrace in front of the house.

FIGURE 8: THE CURRENT WIDER SETTING OF THE WEIR, WITH THE WOODED SLOPES ENCLOSING IT AND THE HOUSE ABOVE, AS SEEN ACROSS THE ADJACENT FIELD; FROM THE NORTH-WEST.

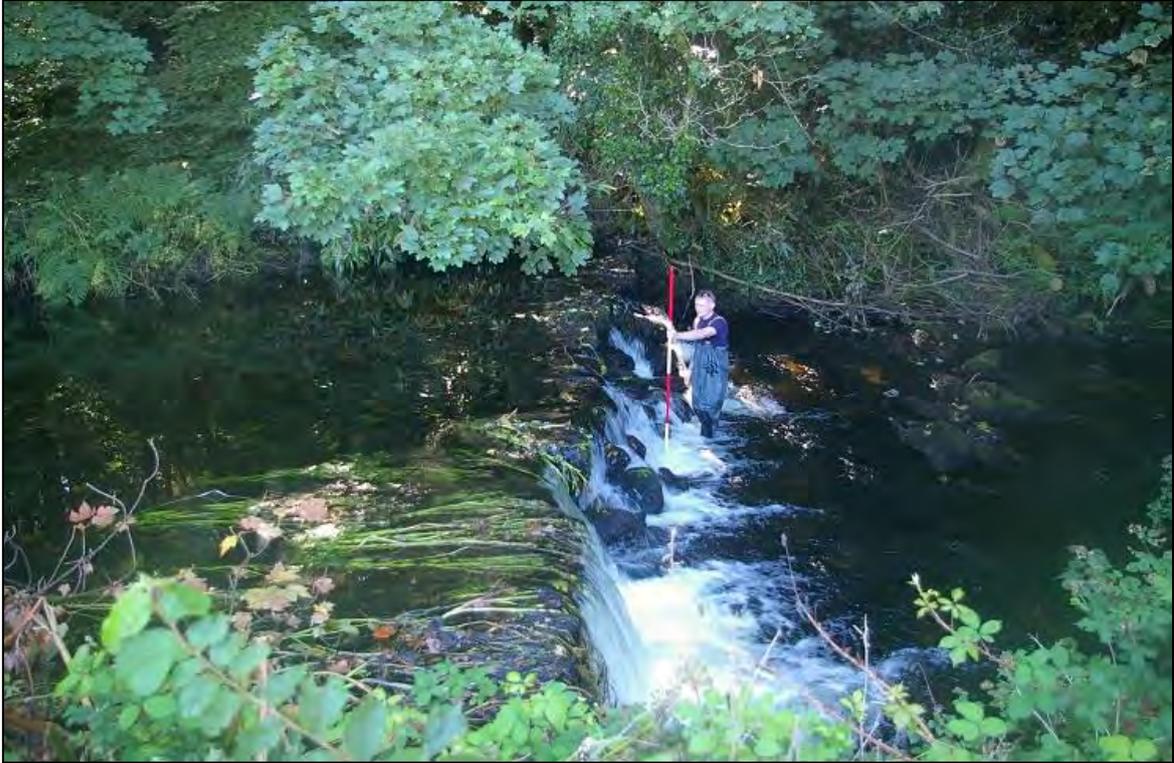
FIGURE 9: THE WEIR, AS VIEWED ABOVE SHOWING ITS SHAPE AND PROFILE, WITH 2M SCALE; FROM THE WEST BANK (WITH THANKS TO WESTCOUNTRY RIVERS TRUST STAFF FOR HELP).

The weir runs between the banks at a slight but definite oblique angle; south-east to north-west, with a very slight crank to the centre, known as a *diagonal weir*, at approximately a 45 degree angle to the banks. This means the weir forms a shallow v-shape in the channel, designed to maximise the crest length and reduce water level variations. This can be seen as there is a very slow head of 'quiet' water above the weir.

This weir presents the longest face to the east bank. It is built of massive granite boulders, the famous De Lank quarry being just upstream; these are braced by long slabs behind, held in place by large iron pins, in the form of staples. It does not appear to be mortared and certainly is intended to have a naturalised 'rapids' style appearance.

Its profile is irregular due to the nature of the boulders but it effectively has a wide flattish *broad crest*, which slightly slopes to the north and is shallow on the north face. To the east side, on the south face it is stepped with two or three upright larger boulders breaking the line of the profile; this creates a rapid style white-water effect, which catches the light in the morning and would also catch light from the sunset; when the slopes were less wooded this effect may have been visible from the garden terraces of the house. This also makes a lot of noise as it breaks up the flow of the water, the curving nature and steep sides of the valley at this point mean this sound echoes along and upwards and may have been a key part of the weir's designed landscape function.

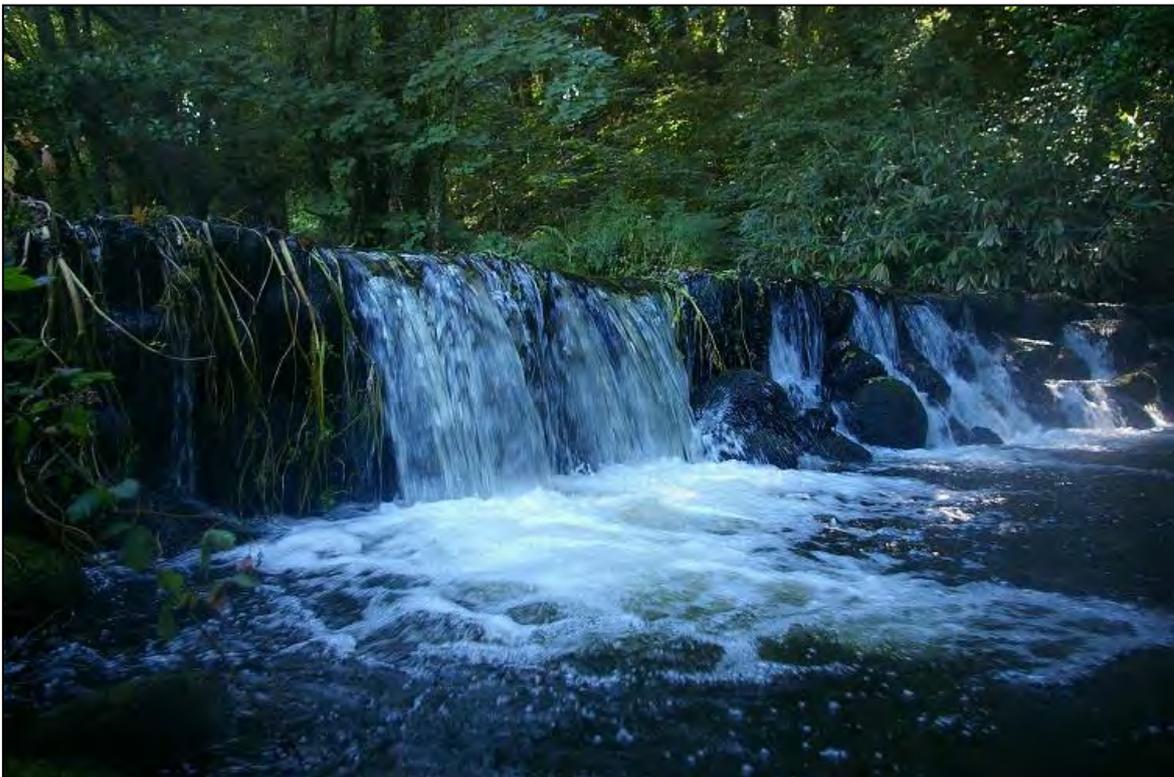
FIGURE 10: WATER LEVEL VIEW ALONG THE WEIR, SHOWING THE FAST FLOWING NOTCH AND TUMBLED WHITE-WATER CHARACTERISTICS TO EACH END; FROM THE WEST BANK; WEST-SOUTH-WEST.

To the west side, on the south face, there is clearly a channel or notch, with a vertical or straight drop form; framed on the east side by a larger upright boulder, this carries much faster water, smooth in flow and empties into a deep pool, which again appears to have been excavated from the river bed, to serve this notch/channel. It is suggested this may have been intended for a

fishing function, to have made the fish 'jump'; also being a visual spectacle from the eastern riverbank, visible from the platform at the terminus of the woodland path.

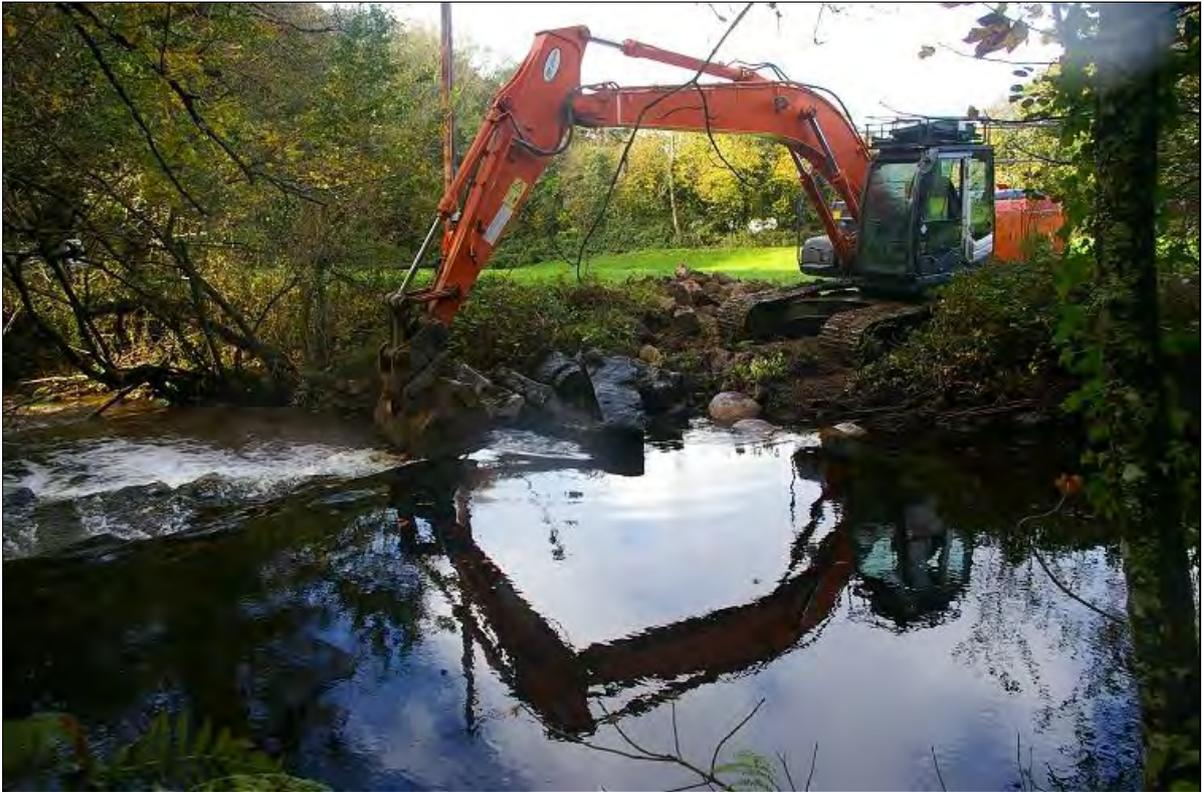
FIGURE 12: THE MACHINE REMOVING INDIVIDUAL SLABS FROM THE CREST OF THE WEIR; JULY 2020, FROM THE EAST RIVERBANK.

Two separate periods of monitoring were undertaken on the weir in Summer 2020 and Summer 2021. The weir was systematically deconstructed and removed from the river and two large piles of stone were fashioned on the banks – to create otter holts, with ecological value and to also create a ‘ghost-weir’ landscape marker, which will have some signage to indicate its former presence. The demolition was undertaken almost stone by stone using a large machine and toothed bucket – peeling off the top layer then removing the centre and west side – the eastern side was removed in 2021, once a crank could be positioned on that side of the riverbank – as it was too wet for heavy plant-machinery access.

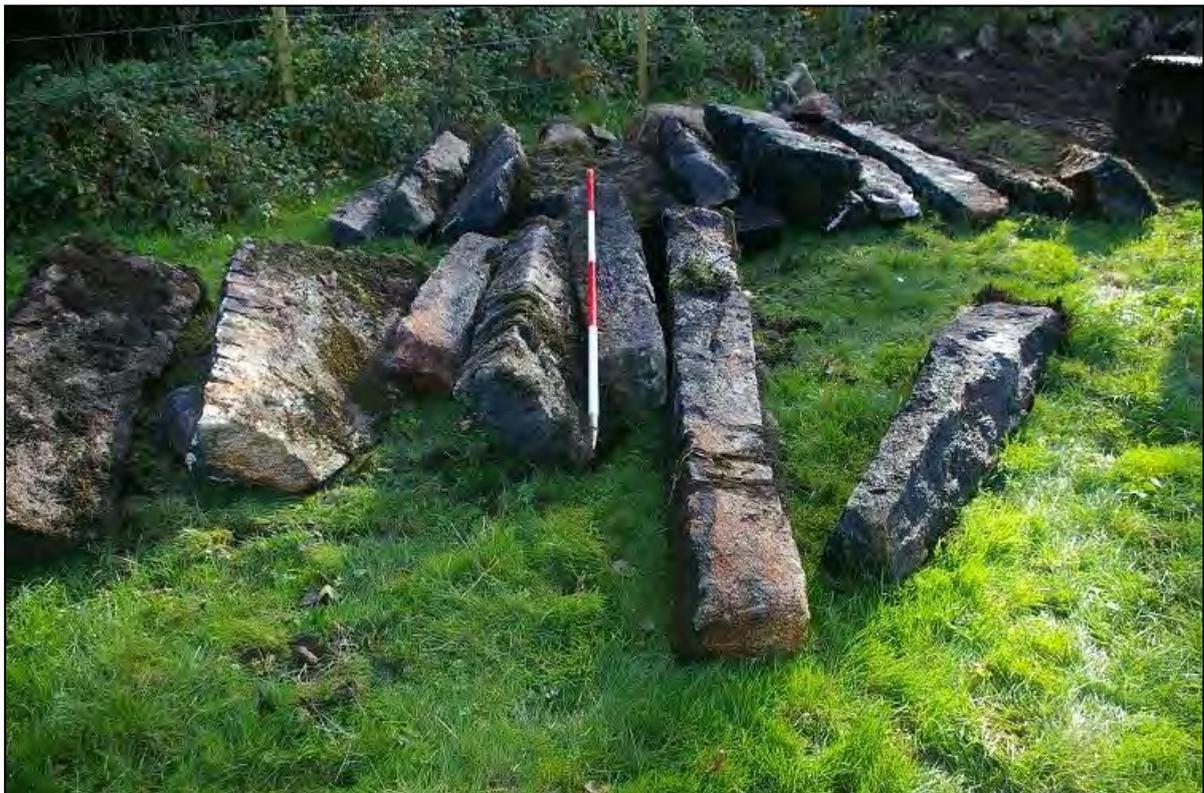
FIGURE 13: THE LONG RECTANGULAR CREST STONES AND WIDER, IRREGULAR BASE STONES OF THE WEIR (2M SCALE); JULY 2020.

The demolition confirmed two stages/levels of rectangular granite blocks were pinned at perpendicular angles by iron staples and the lower level by some iron pins; the upper layer of stones were narrow, fairly thin and rectangular – even and more regular – providing the smoother profiled crest, below the stones were rectangular and much larger – these were mixed in with more irregular very large stones which anchored the structure. All of the granite displayed the typical drill marks from post-medieval quarrying. Monitoring also confirmed the boulders which created the distinctive profile of the weir were superficial and set to the front of the weir but were not structural, present only for aesthetic effect. The various boulders downstream suggest some of these had been moved loose and lost from the structure over the years. Some sand and gravel packing seemed to come away as the stones were removed but may be sediment build-up trapped within the structure – no formal mortar or bond was observed – the staples, pins and weight of the granite was relied on to hold the weir in place. Upstream of the weir looser, smaller boulders and stone had been backfilled behind the weir structure.

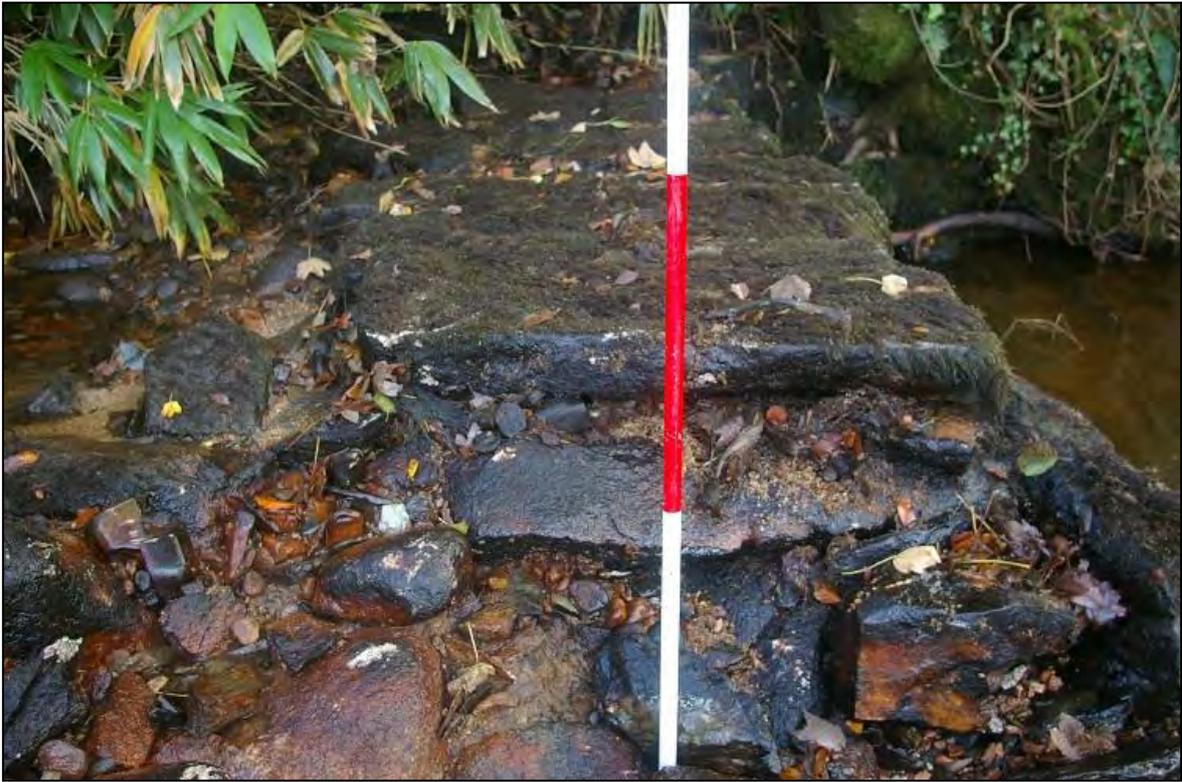
FIGURE 14: PROFILE THROUGH THE WEIR - TOP CREST LAYER, FAIRLY THIN OVER LONG RECTANGULAR STONES OVER PROJECTING BEDROCK - PACKED TO FRONT AND REAR WITH BOULDERS (2M SCALE): JULY 2021.

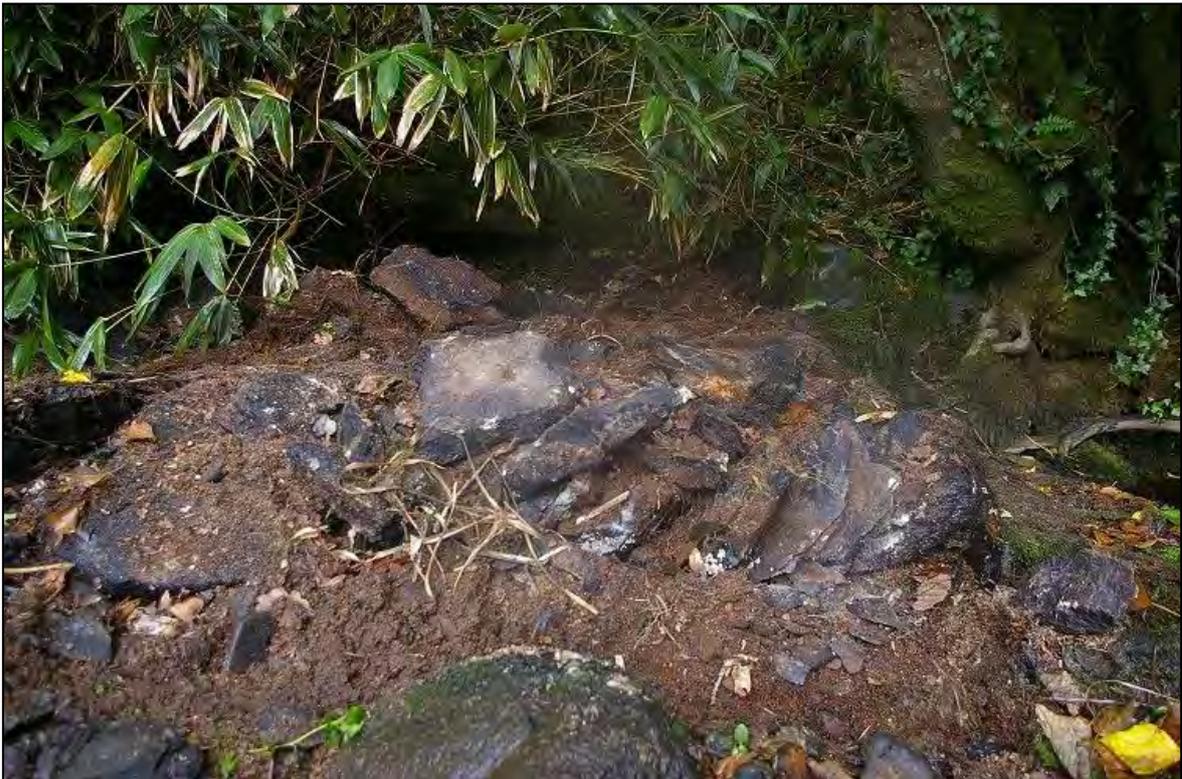
FIGURE 15: THE EARTH PACKING AND RUBBLE OVER THE BEDROCK AT THE EAST SIDE OF THE FORMER WEIR; JULY 2021.

To the east side the stones were smaller and sat on bedrock which protruded through the riverbed – meaning there is only one layer of stones at the eastern end – as it meets the bank. Under this single layer there is earth and rubble packing over the angled ridged bedrock – which has linear fracturing. This rock outcrop defines the location of the weir and is likely the reason for its construction at this point exactly. Several glass bottles and stoneware jars – associated with food and drink and all of later 19th century to early 20th century date were removed from the river in and around the weir, as it was demolished and may relate to its construction and rations for the builders, or from picnickers. Some large handmade bricks were found mixed with loose boulders under the weir at the west side, which appears to be a sort of platform of rubble to balance out the bedrock which was tapering out across the riverbed.

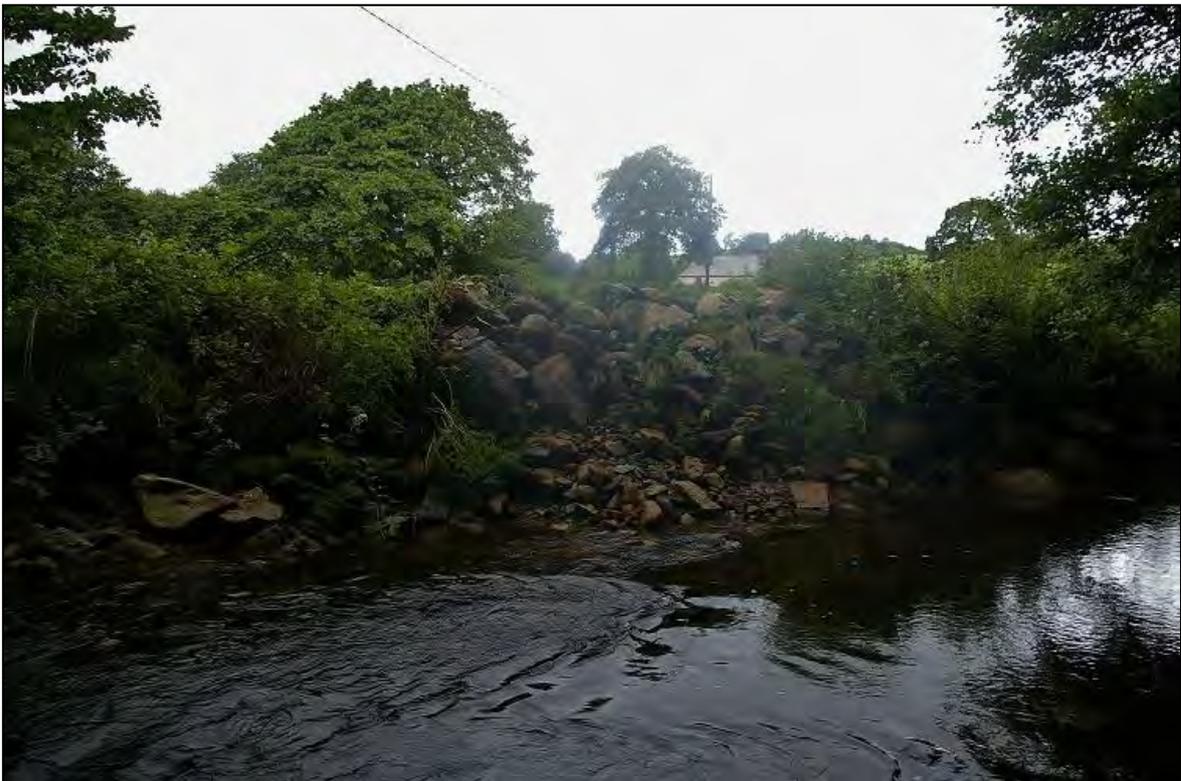
FIGURE 16: THE WEST BANK OF THE RIVER - WITH DEBRIS FROM THE WEIR LEFT FOR ECOLOGICAL AND NARRATIVE VALUE; JULY 2021.

Whilst the weir was removed the recommendations from the impact assessment were followed and two large piles of stone were formed to either bank – creating potential otter holts and allowing some semblance of narrative to be retained of there having once been a structure here.

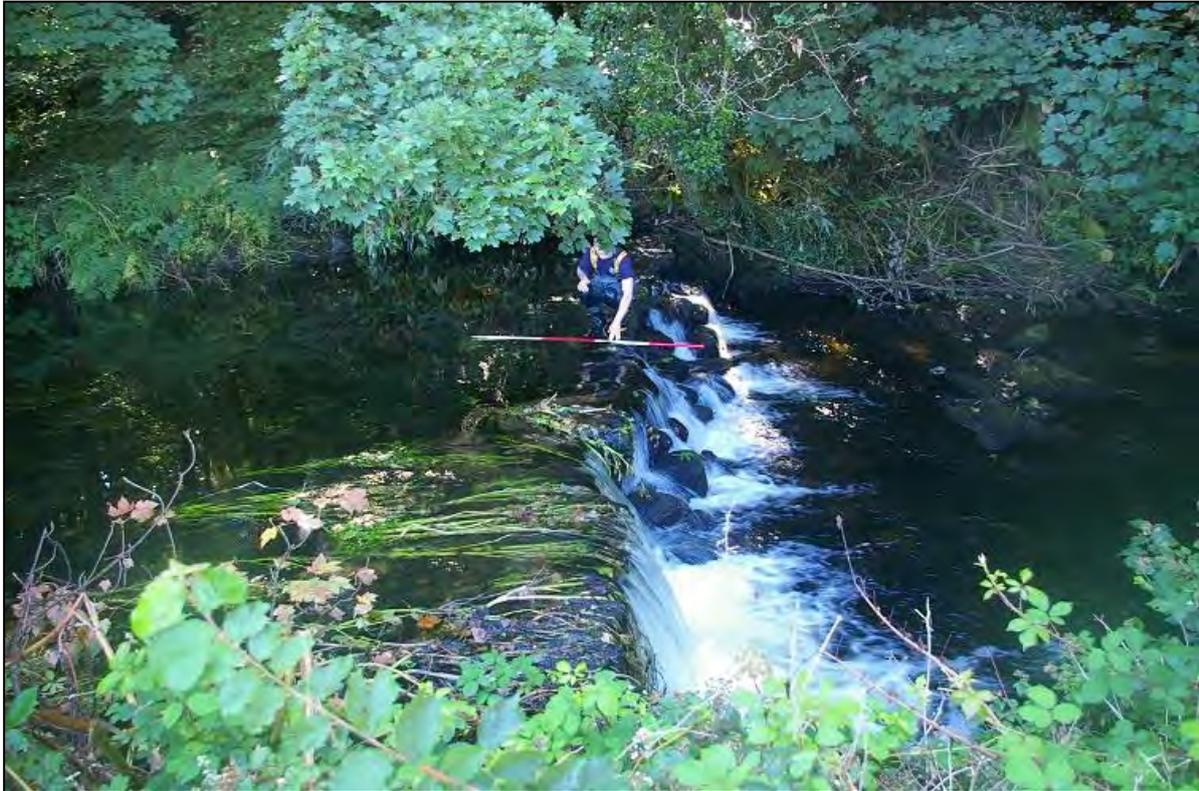
1. PHOTOGRAPH OF WEIR, WITH HORIZONTAL 2M SCALE; FROM THE WEST (WITH THANKS TO WESTCOUNTRY RIVER TRUST'S STAFF FOR AIDING IN THIS PHOTOGRAPH).

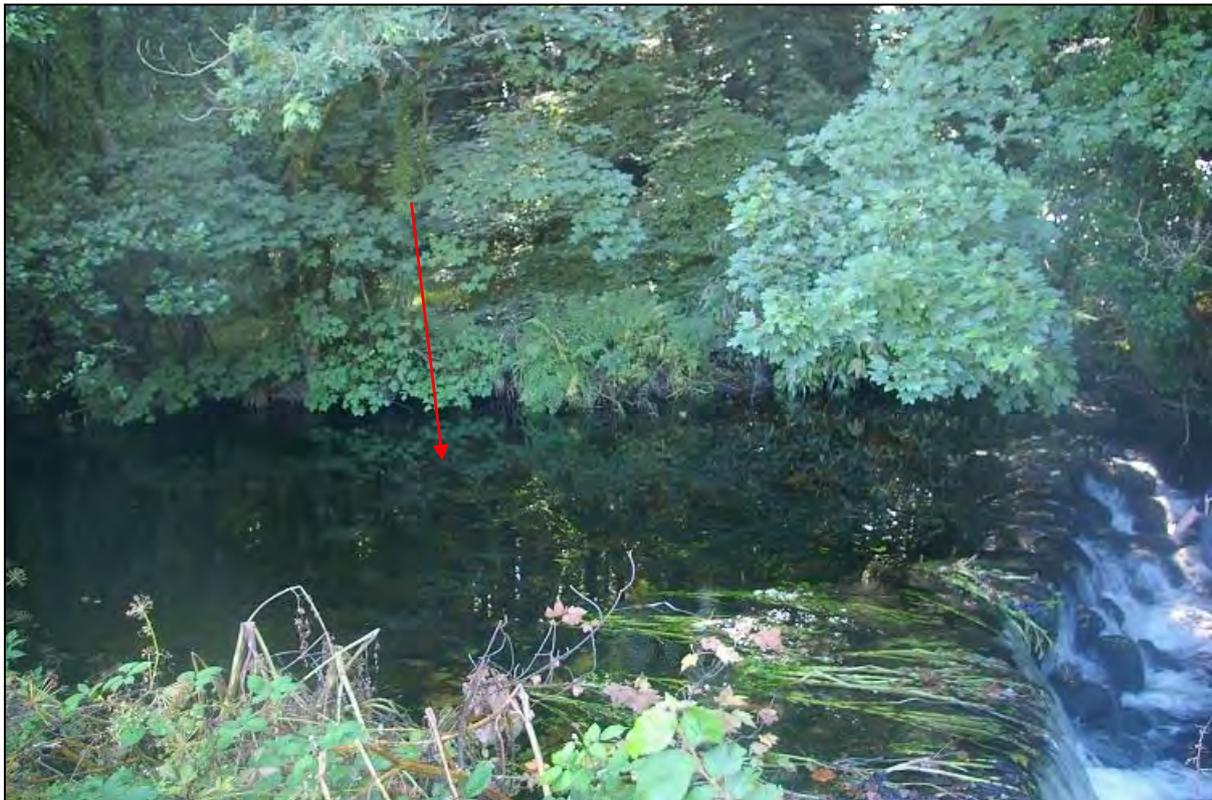
2. VIEW OF THE HEAD OF SLOW WATER ABOVE THE WEIR (INDICATED); FROM THE WEST.

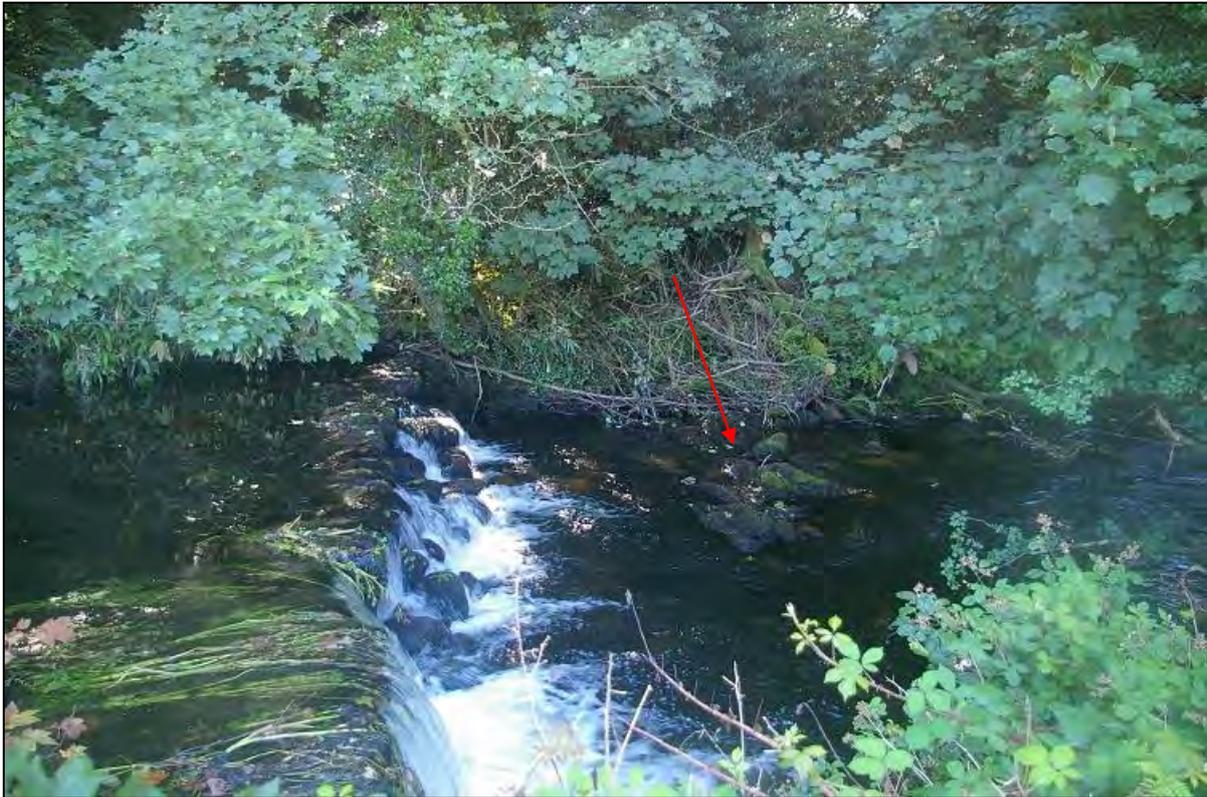
3. THE BEDROCK OUTCROP SEEN BELOW THE WEIR (INDICATED); FROM THE WEST BANK.

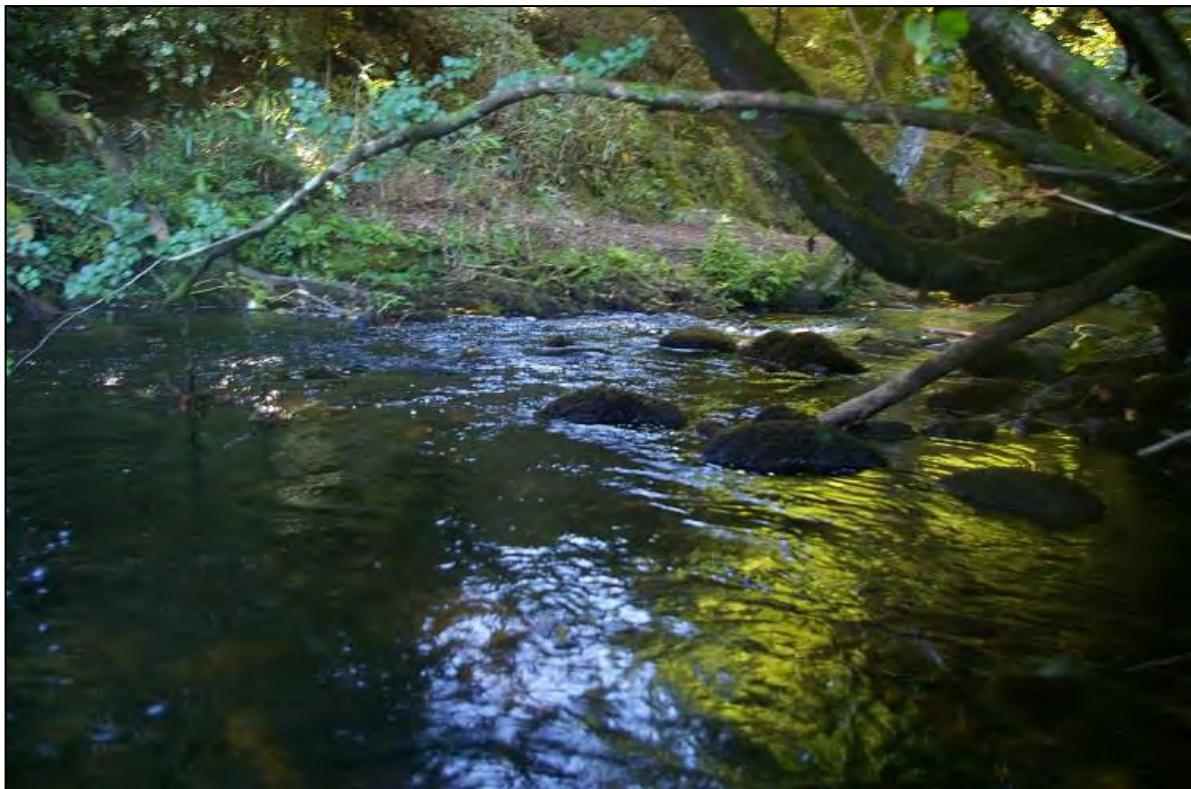
4. LOOSE BOULDERS WITHIN THE RIVER, BELOW THE WEIR, LIKELY HAVING FALLEN OR BEEN WASHED OFF THE STRUCTURE DURING HIGH FLOW PERIODS ON THE RIVER, FROM THE WEST BANK; NORTH-WEST.

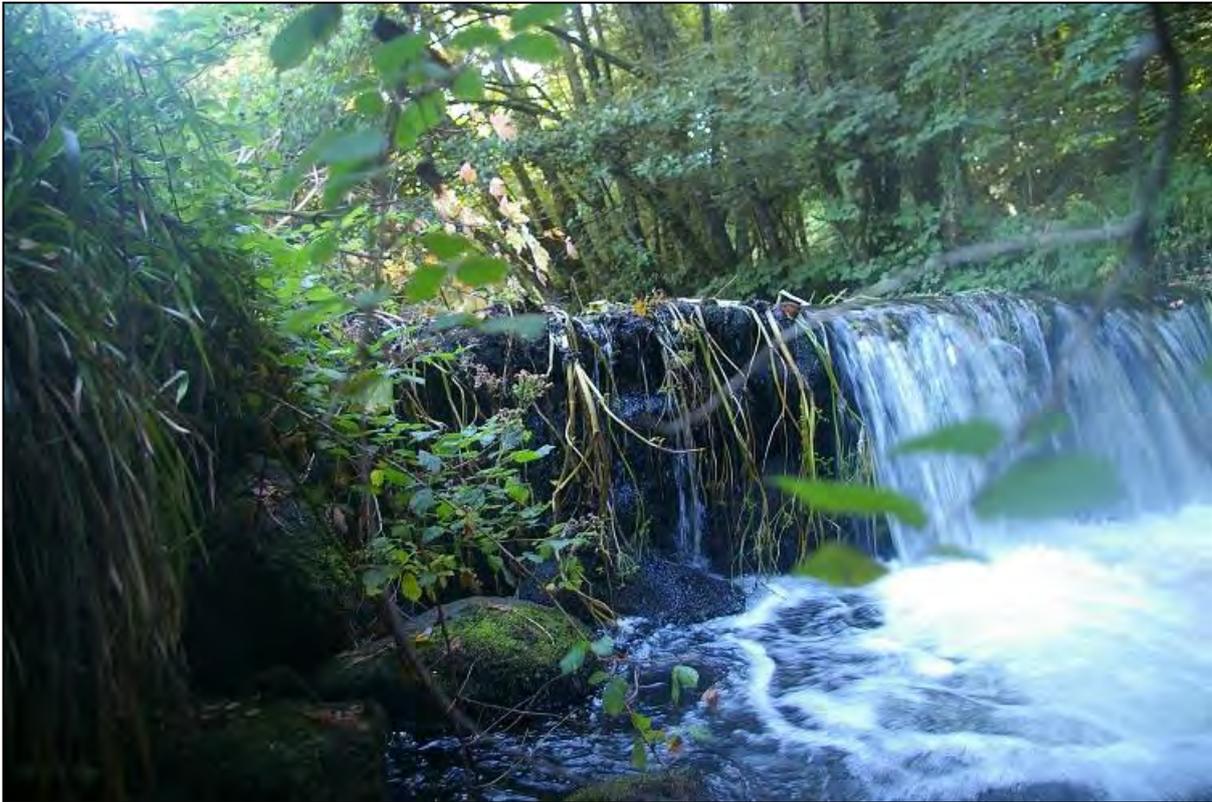
5. TUMBLED BOULDERS FROM THE WEST FLANK OF THE WEIR, WHICH IS A LARGE ROCK-STREWN EMBANKMENT FORMING A DECORATIVE ROCKERY STYLE EFFECT; FROM THE WEST BANK; SOUTH-SOUTH-WEST.

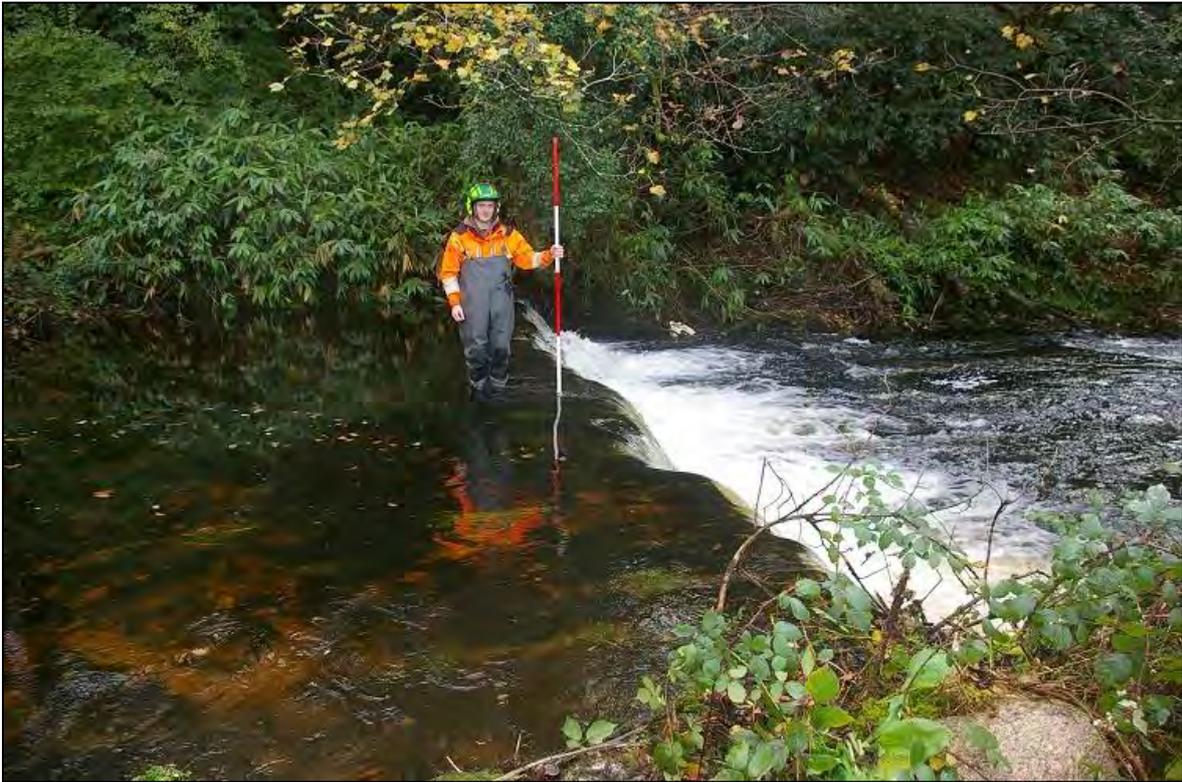
7. WRT STAFF HOLDING 2M SCALE IN RIVER TO SHOW FLOW OVER WEIR JUST BEFORE REMOVAL; FROM THE WEST BANK.

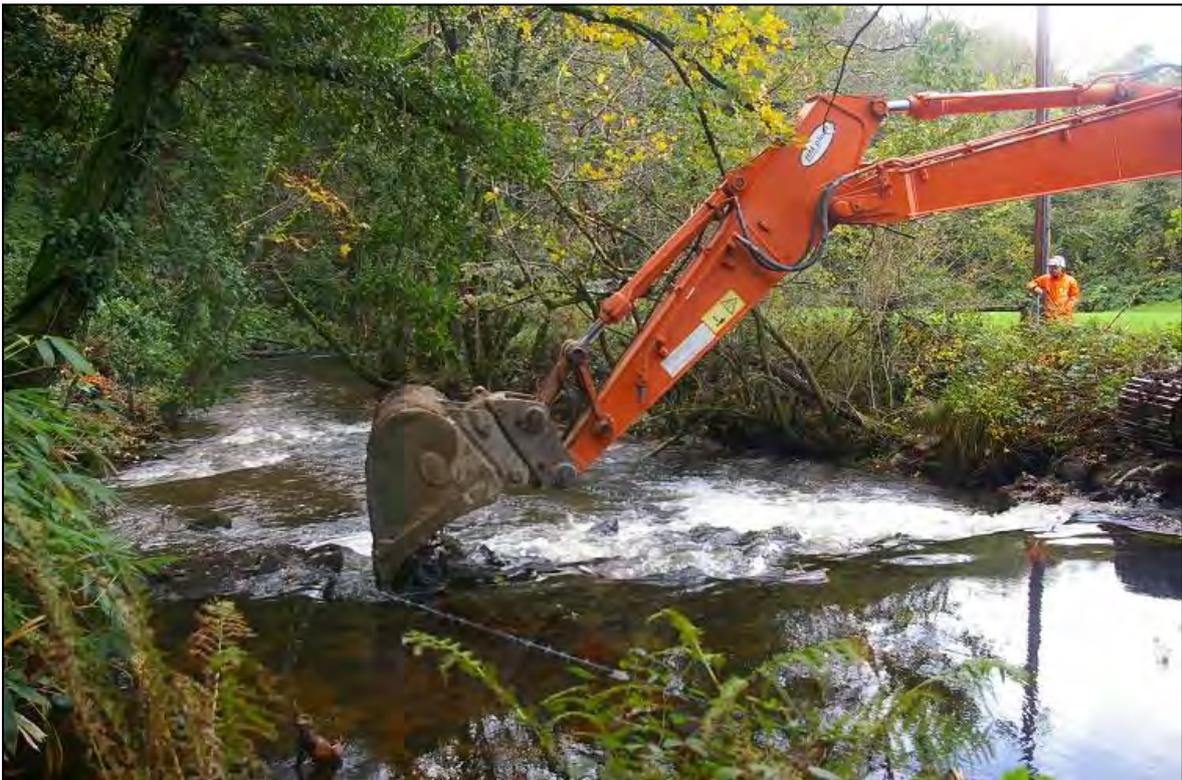
8. REMOVAL USING MACHINE — TAKING ONE LAYER OFF AT A TIME; FROM THE EAST BANK — NORTH-EAST DIRECTION.

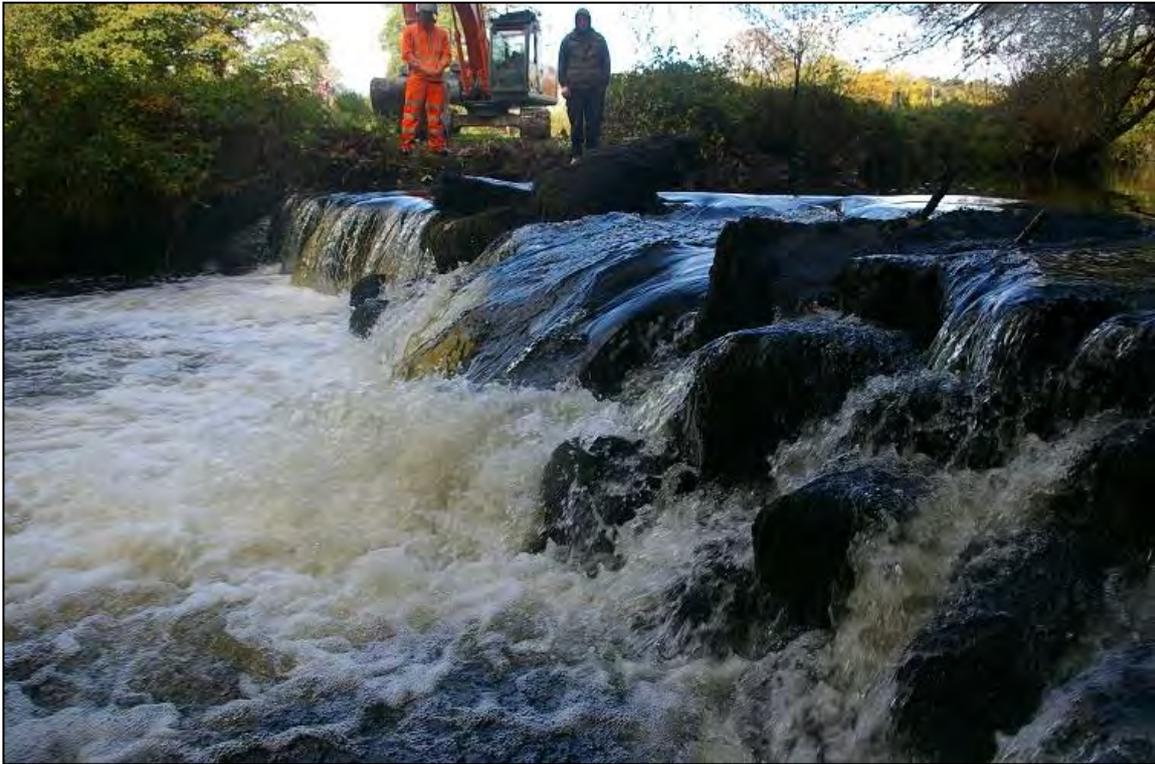
9. VIEW ALONG THE FRONT OF THE WEIR AS THE TOP LAYER IS REMOVED — FROM THE EAST BANK.

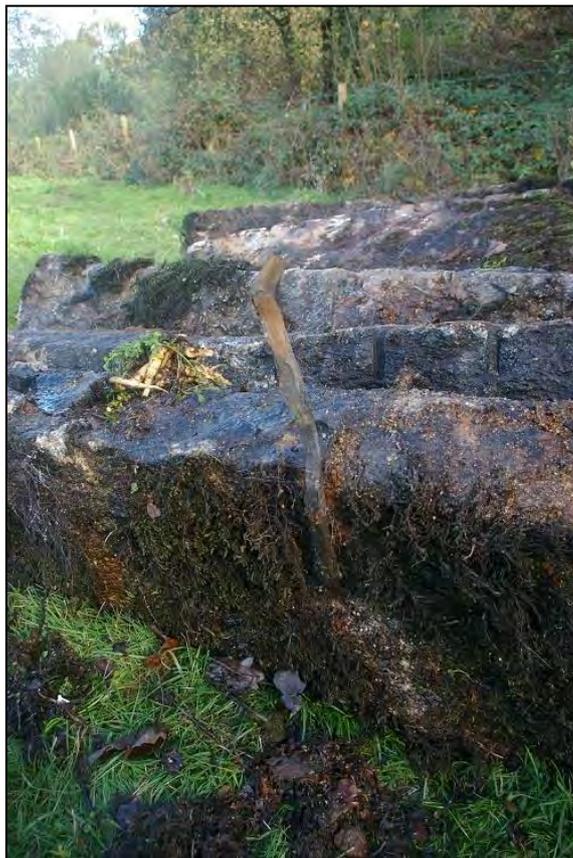
10. DETAILED SHOT SHOWING THE PARALLEL GRANITE SLABS AND IRON PINS OF THE TOP ROW — REMOVED AND LAID OUT AS FOUND — ALSO SHOWING QUARRY DRILLING MARKS.

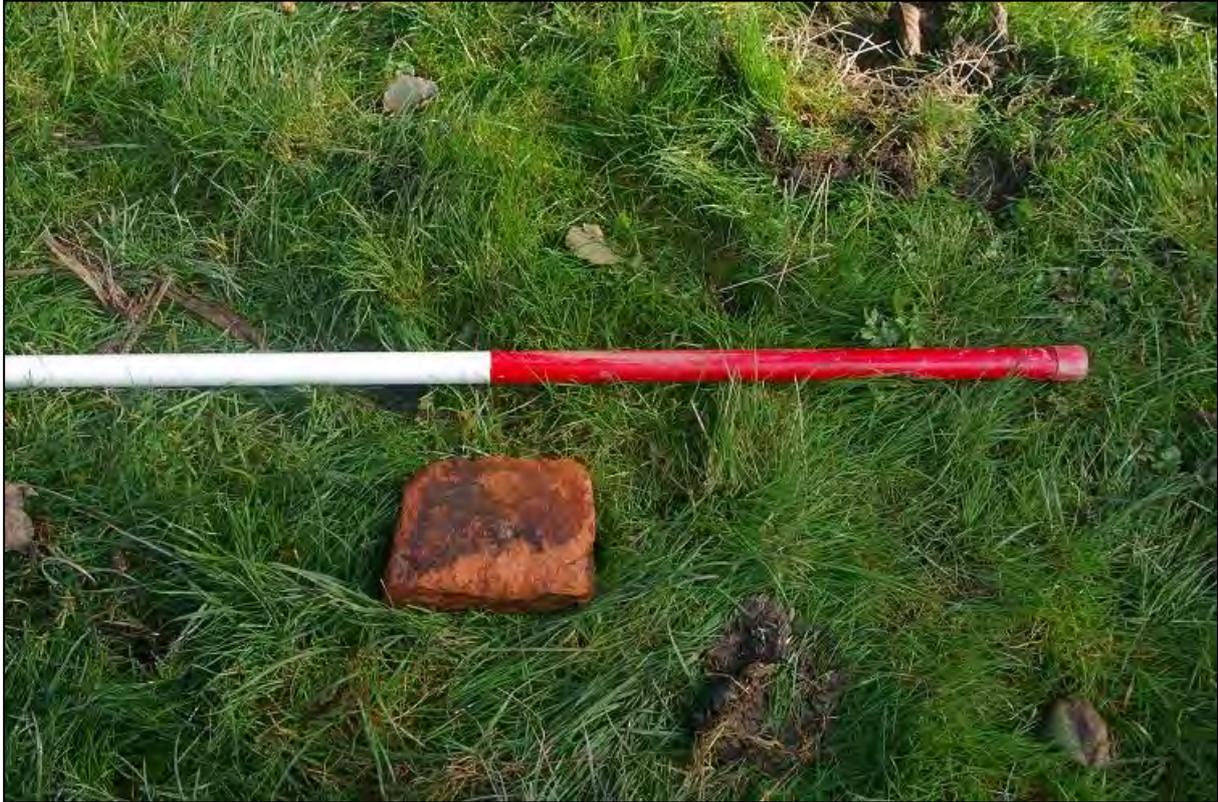
11. ONE OF THE FEW FROGLASS HANDMADE BRICKS FOUND IN THE RUBBLE PACKING BENEATH THE WEIR (1M SCALE).

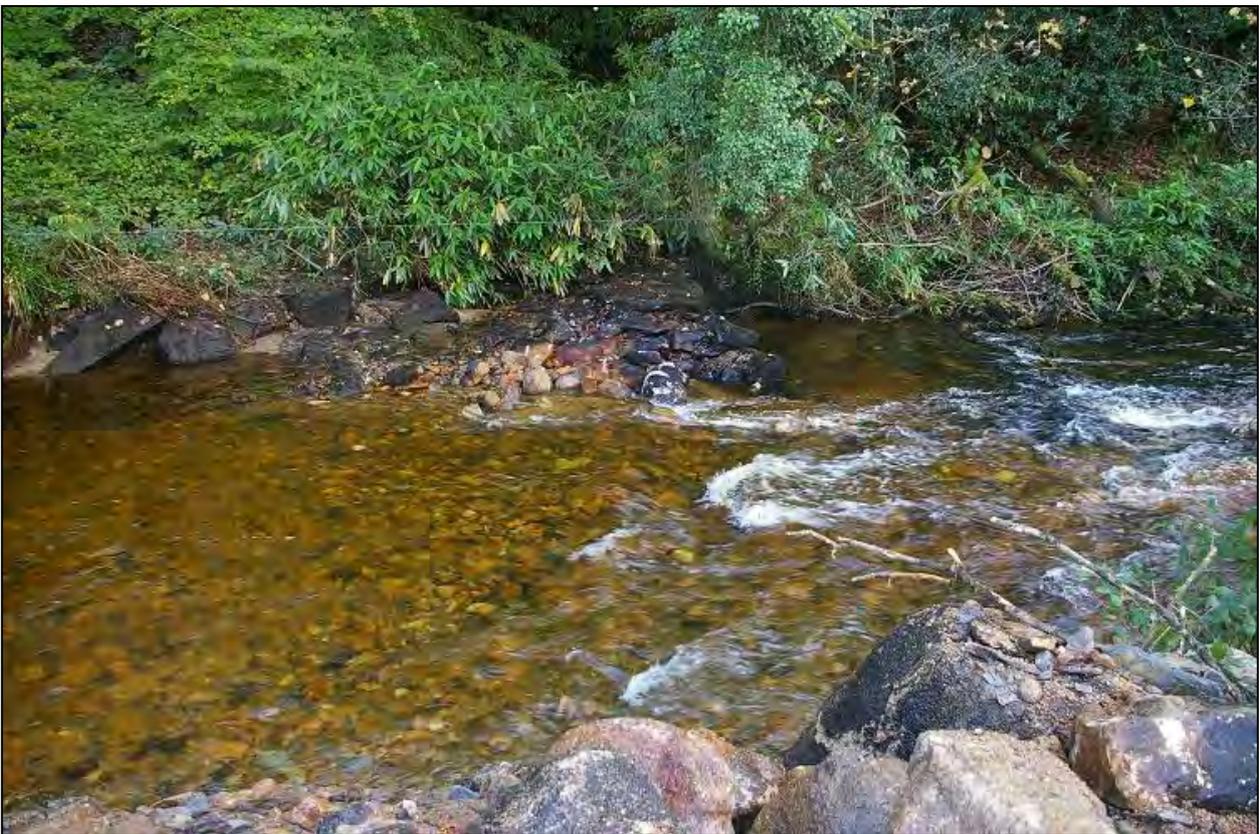
12. VIEW OF THE CENTRAL CLEARED CHANNEL AFTER THE FIRST PHASE OF WORKS; FORM THE WEST BANK — SHOWING SOME OF THE WEIR SURVIVING TO THE EAST SIDE.

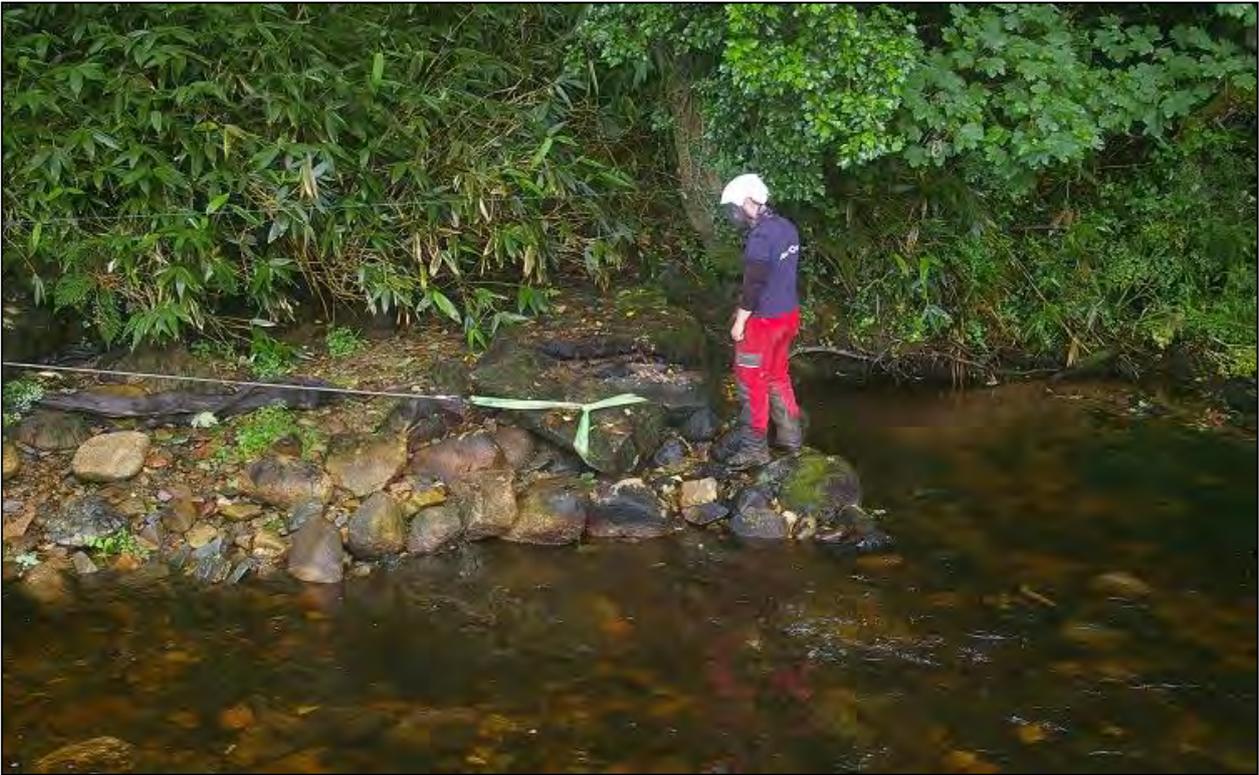
13. VIEW OF THE 2ND PHASE REMOVAL – REMOVING INDIVIDUAL STONES WITH A CRANK FROM THE EASTERN SIDE; FORM THE WEST BANK.

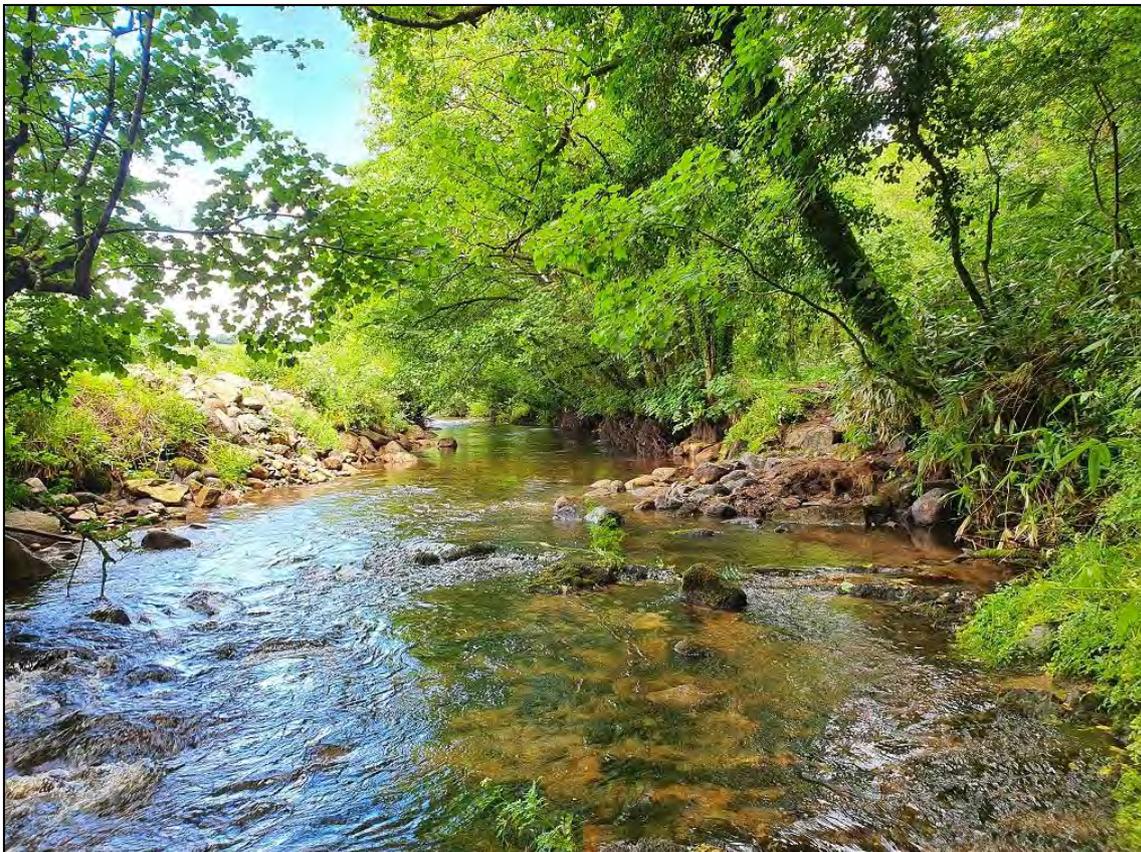
14. WESTCOUNTRY RIVERS TRUST PHOTOGRAPH – AFTER REMOVAL IN LATE SUMMER 2021 – SHOWING NATURALISED BOULDER BANKS LEFT TO THE WEST AND A CLEAR CENTRAL CHANNEL FOR THE RIVER – WHICH IS NO LONGER BACKED-UP; VIEWED FROM THE SOUTH.
