KEYBRIDGE WEIR KEYBRIDGE BLISLAND CORNWALL

Archaeological Monitoring and Recording

South West Archaeology Ltd. report no. 211119

Keybridge Weir, Keybridge, Blisland, Cornwall Archaeological Monitoring and Recording

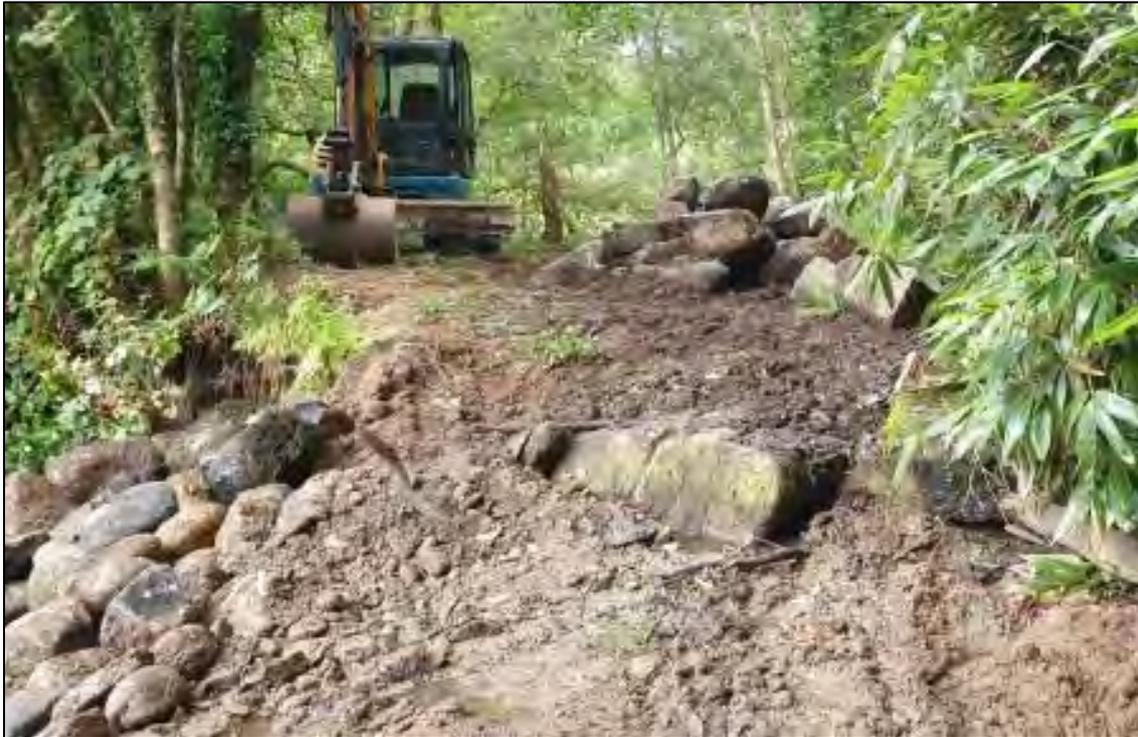
15. WESTCOUNTRY RIVERS TRUST PHOTOGRAPH - WORKING SHOT SHOWING BANK PREPARATION ON THE EAST RIVERBANK – BUILDING THE OTTER HOLT; FROM THE SOUTH-WEST.

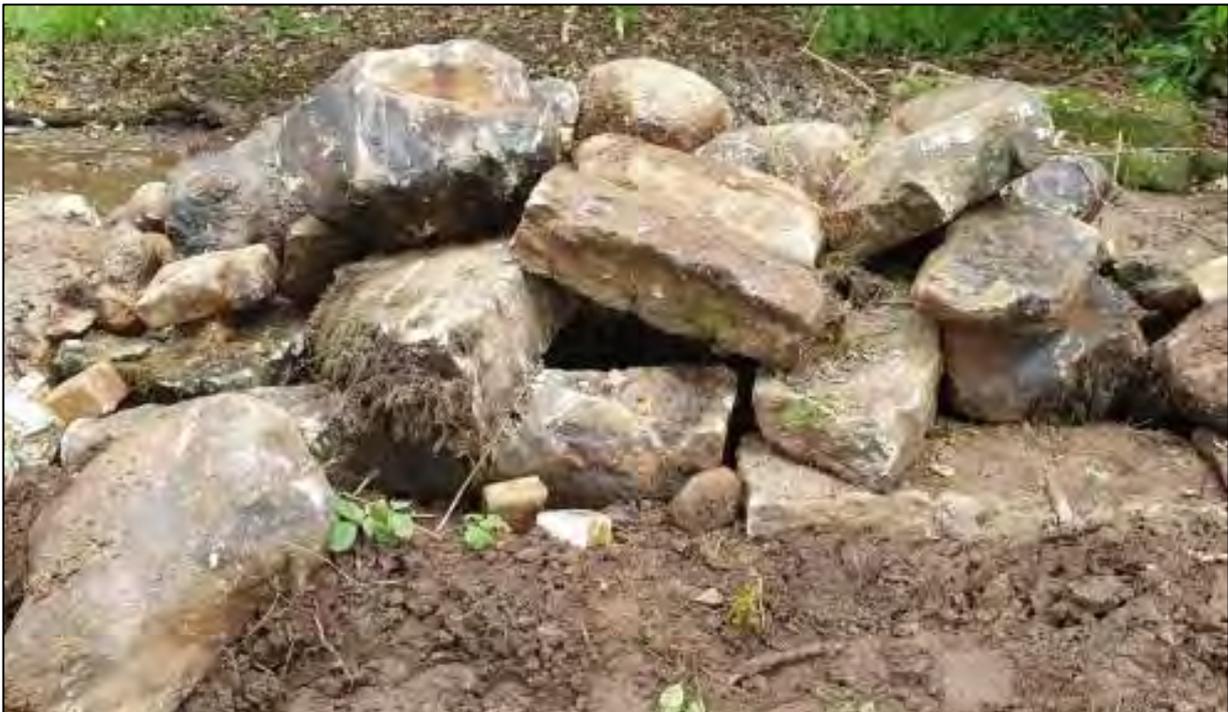
16. WESTCOUNTRY RIVERS TRUST PHOTOGRAPH - THE OTTER HOLT ONCE CONSTRUCTED USING STONE FROM THE WEIR.

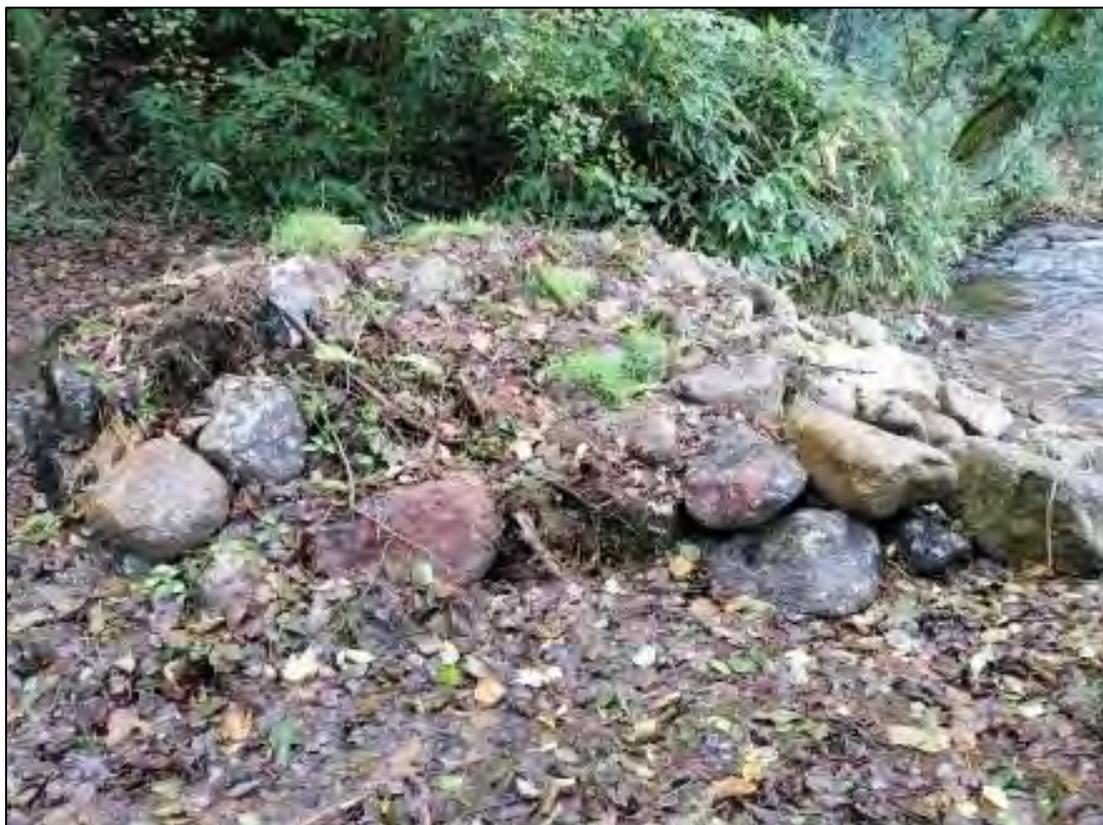
17. WESTCOUNTRY RIVERS TRUST PHOTOGRAPH— NATURALISED FINISHED STRUCTURE WITH SOME TURF AND PLANT SEEDING.
