CASE STUDY:

**Nature Based
Solutions in the Exe
Catchment
June 2022**

Westcountry

Rivers Trust

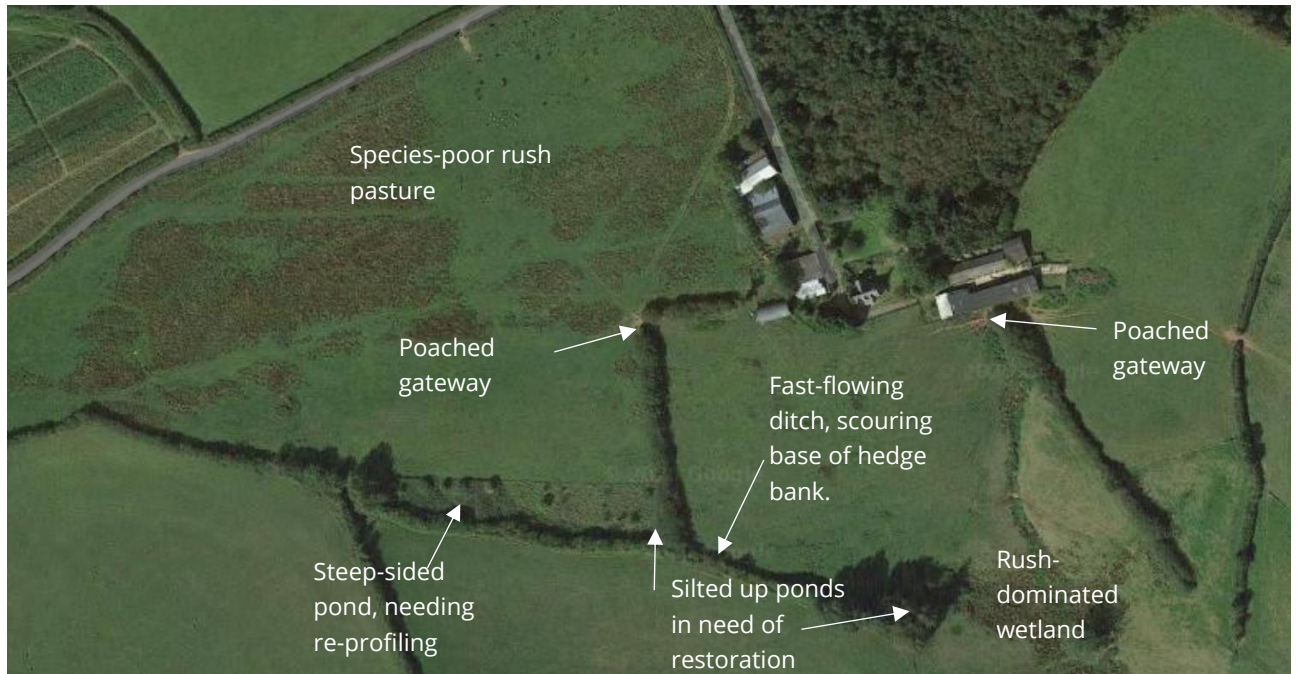
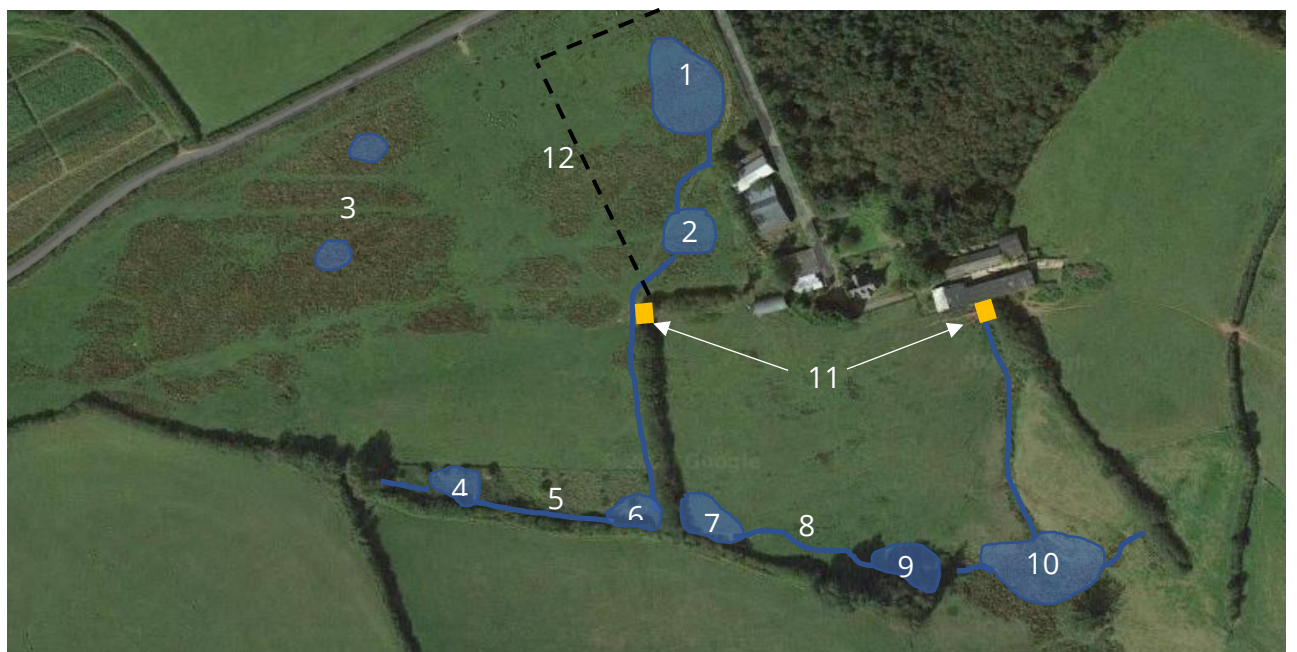
Aerial photos to show A. issues prior to grant-aided work, B plan of grant-aided wo

- 1 = Large new pond, connecting to...
- 2 = smaller round pond
- 3 = 2 shallow scrapes
- 4 = re-profiled existing pond
- 5 = 2 woody dams on ditch
- 6 = restored silted pond

- 7 = new pond in place of scoured eroding corner
- 8 = meandered stream to create wetland
- 9 = restored silted pond
- 10 = large new pond
- 11 = culverts under poached gateways

to spill out of connecting watercourses and to find more natural pathways through the landscape, instead of carving ever deeper channels. Two gateways that had been churned up by stock and vehicle access were made more resilient by installing culvert pipes and stoning over the top. The plan of works were approved by South West Water and funded through their Upstream Thinking 3 project via a Conditional Grant Agreement put together by Annabel Martin.

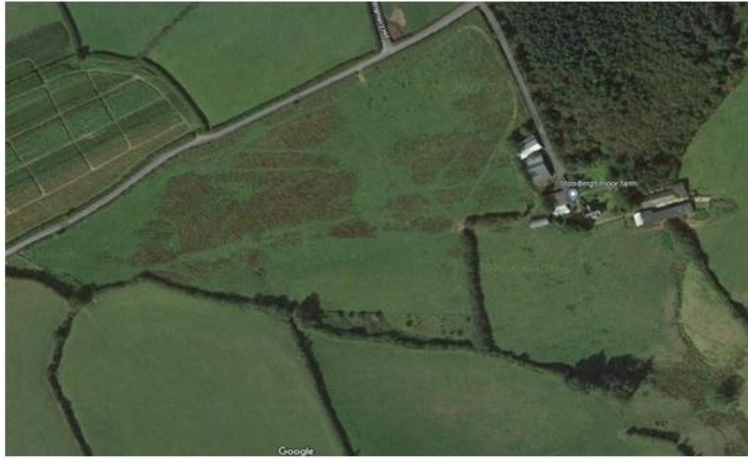
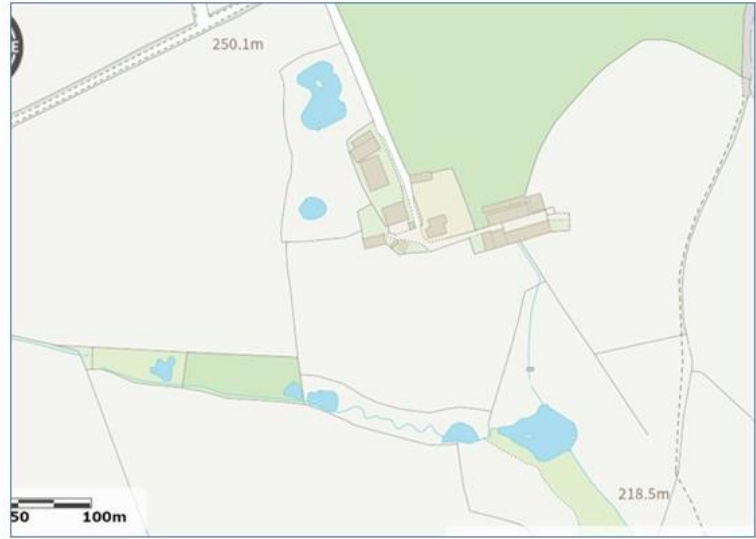
Above: Before image on Google Maps (Left) and updated image from DEFRA's MAGIC Map (Right) to show new ponds and flow pathways.

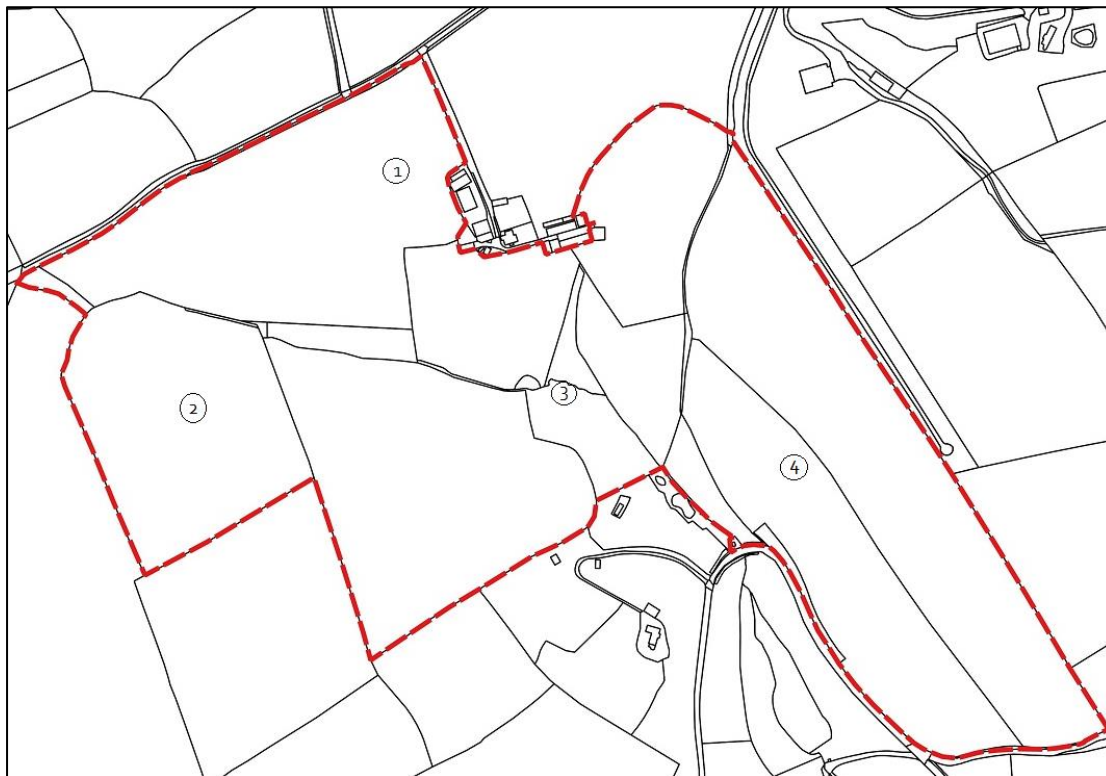
25th June 2020. Ecological walkover survey of key areas 1-4 identified for pond creation and other enhancements. The survey recorded the dominant plant species within each area.
