HELEBRIDGE WEIR

DULVERTON

Heritage Assessment

Heritage Assessment, including site visit

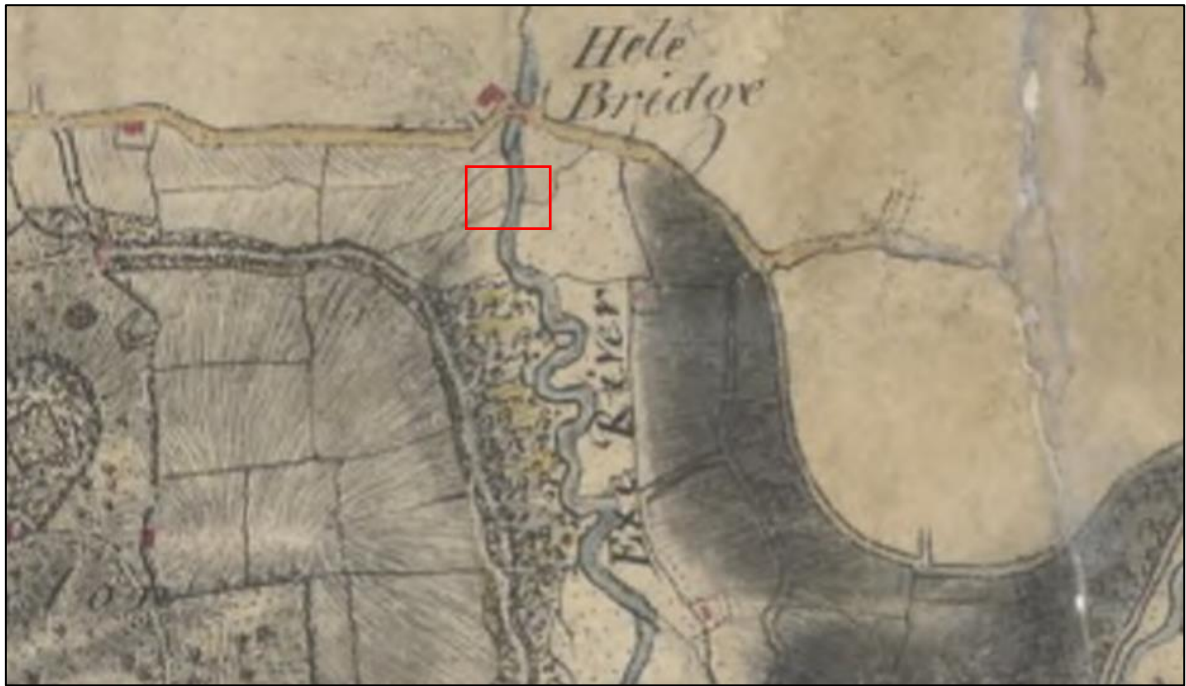
FIGURE 2: EXTRACT FROM THE 1802 SURVEYORS DRAFT MAP (BL). THE APPROXIMATE LOCATION OF THE WEIR IS INDICATED

This first map available to this study is the 1802 Surveyors draft map for Tiverton (Figure 2). This shows Hele Bridge but gives no indication of a weir in the location of Helebridge Weir nor does it show the leat which runs from the western side of the river. Machine Court is not shown on this map and there is no indication of the leat taken from further upstream at Machine Weir. There does appear to be a line shown across the river, to the south of Hele Bridge, however this lies slightly north of the expected position of Hele Bridge Weir. It is possible this relates to property ownership, fishing rights or mapping depiction rather than necessarily suggesting a weir was present at this date.

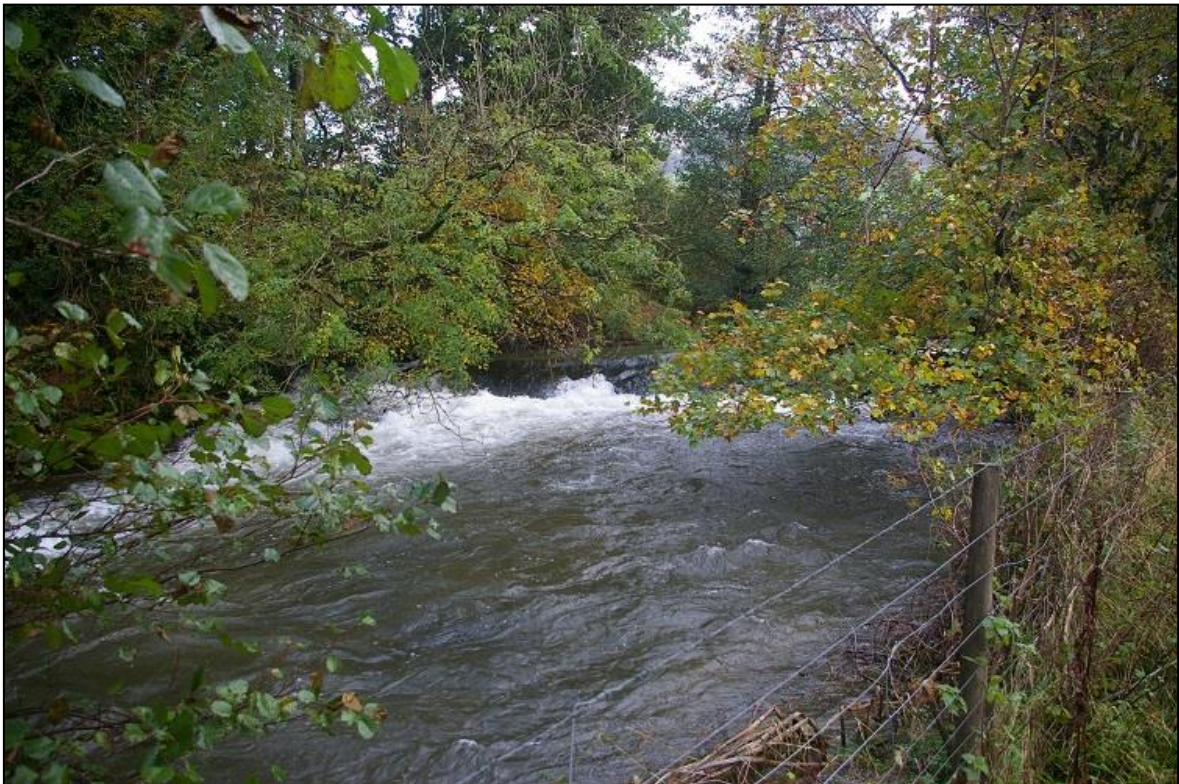
FIGURE 7: HELEBRIDGE WEIR; FROM THE SOUTH-EAST.

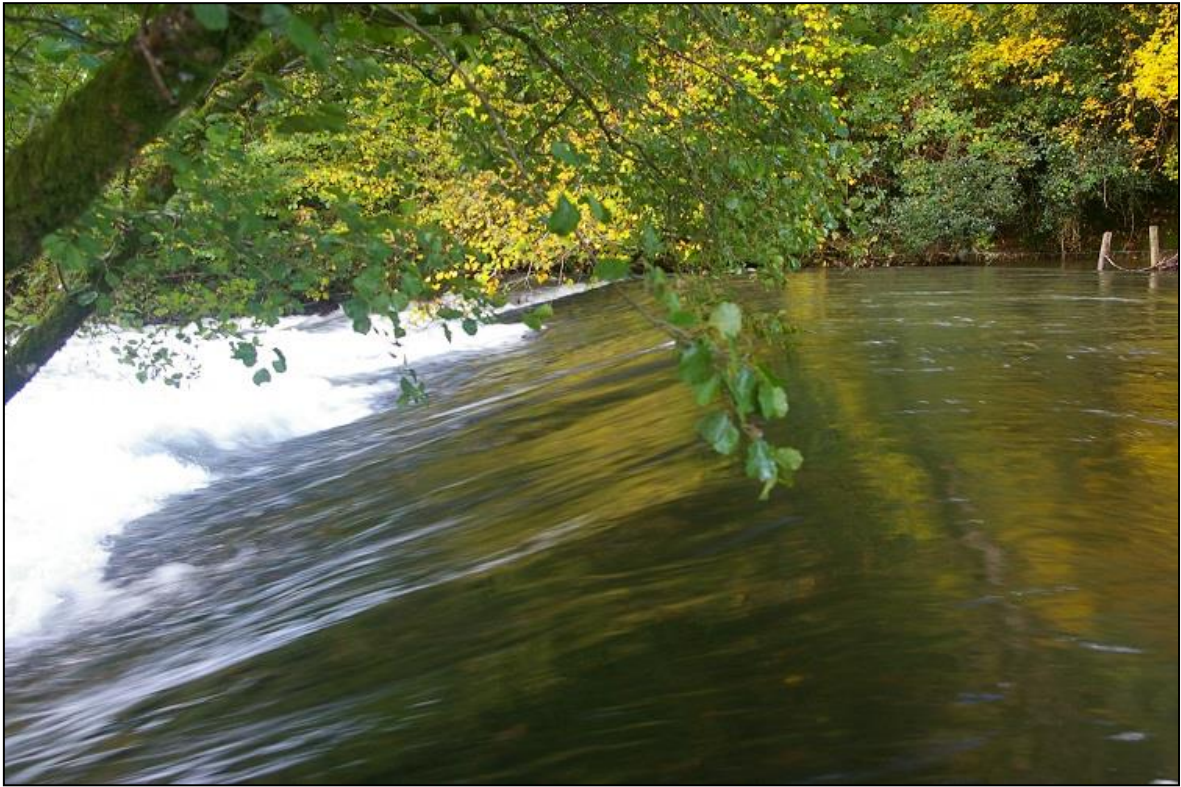
The weir is of local stone rubble – including some large boulders – it is presumed it has a traditional mortar bond but the upper visible surface has been almost completely obscured by a concrete cap and thick re-pointing to the sides. The weir form may have been adapted by the concrete additions but currently presents as a steep crump weir with very shallow straight low flank wall of stone rubble to the east and tall angled flank wall and sluice gate to the west. The water flows fast and clean over the crump slope but the fairly steep angle causes a white water trough to have formed at the base. Due to the high flow of the river during the site visit the sluice was not inspected in detail but appears to survive well with metal elements and a gate, damaged but present.

FIGURE 8: VIEW ACROSS THE WEIR, SHOWING THE PROFILE OF ITS CRUMP FORM; FROM THE EAST.

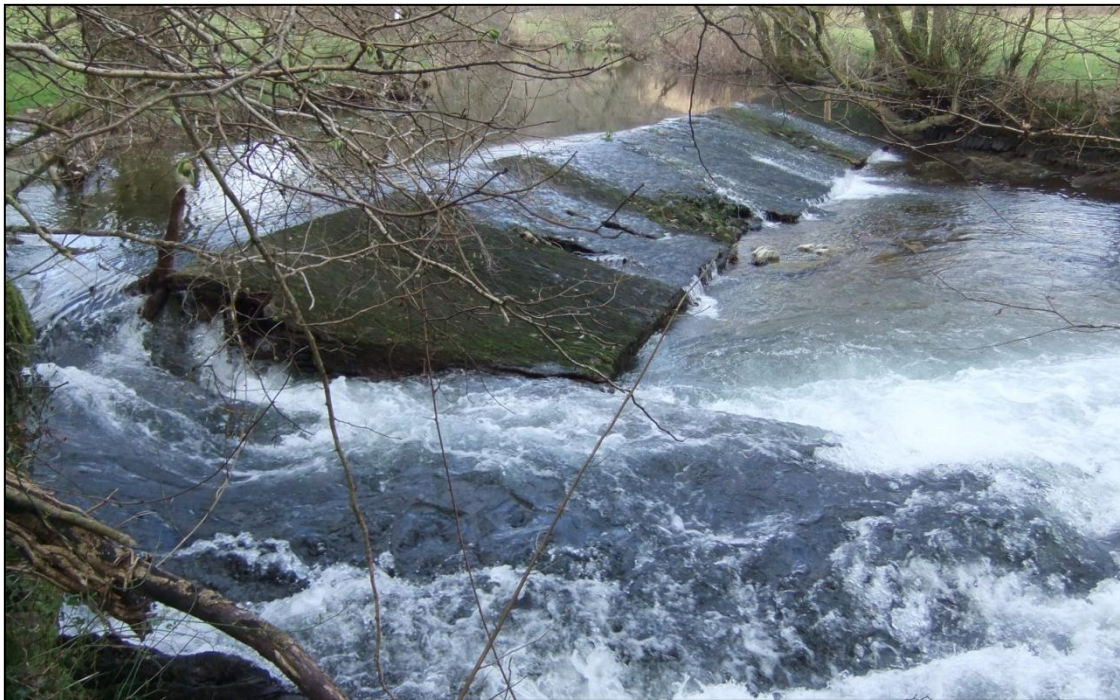
There appears to be a hole or minor damage to the middle of the weir – in the middle of the crump face – causing disturbance in the water and it has been completely undercut and damaged by increased flow to the west side, near the sluice, which is causing increased white-water in this location. The eastern half seems to have a slightly longer profile – the concrete capping extending further into the water. The flank walls appear intact. Condition would be assessed as **fair to good**.

FIGURE 9: PHOTOGRAPH 2020/2021 BY WESTCOUNTRY RIVERS TRUST PERSONNEL, FROM THE WEST BANK – SHOWING DAMAGE TO THE WEST END OF THE WEIR.

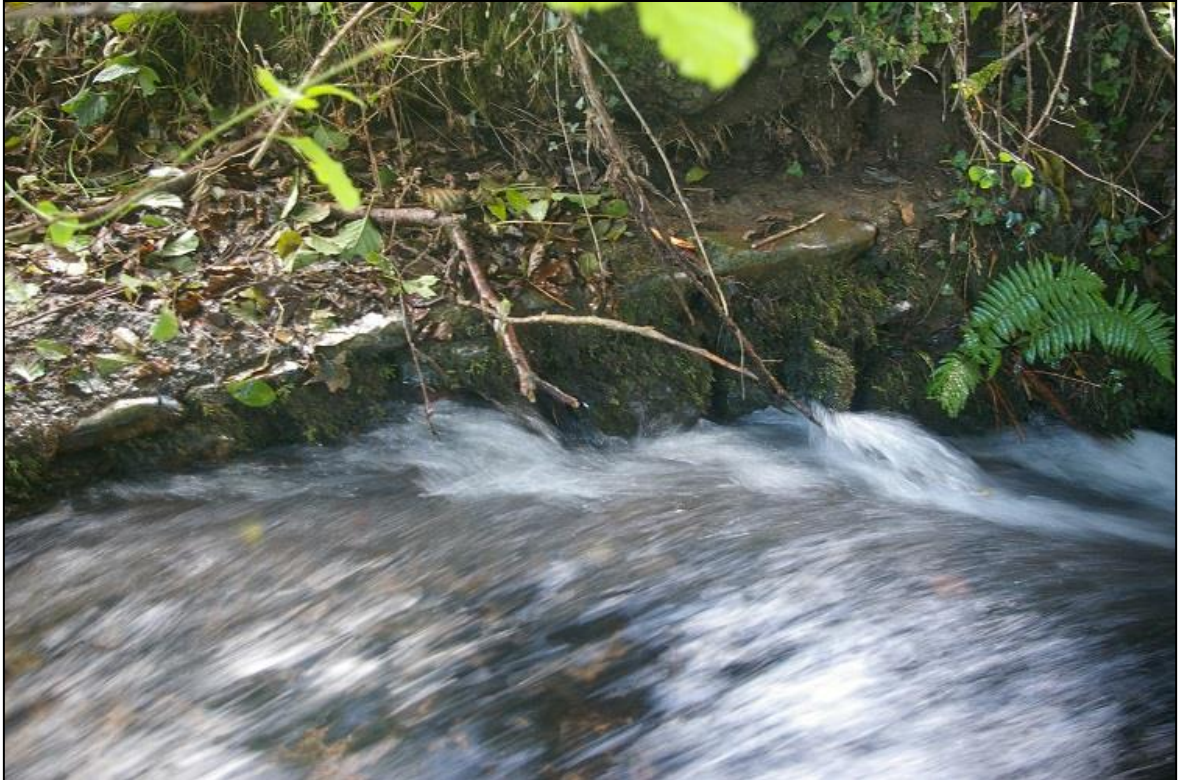
The relatively low profile of the flank walls and the slightly overgrown nature of the riverbank railings means much of the weir is not even visible from the field and can only be appreciated upon accessing the riverbanks and entering the water’s edge. It can therefore be assessed as a regressive landscape feature, that whilst important, holds no visual presence outside of its immediate setting.

FIGURE 10: THE LOW EAST FLANK WALL OF THE WEIR; FROM THE NORTH-WEST.

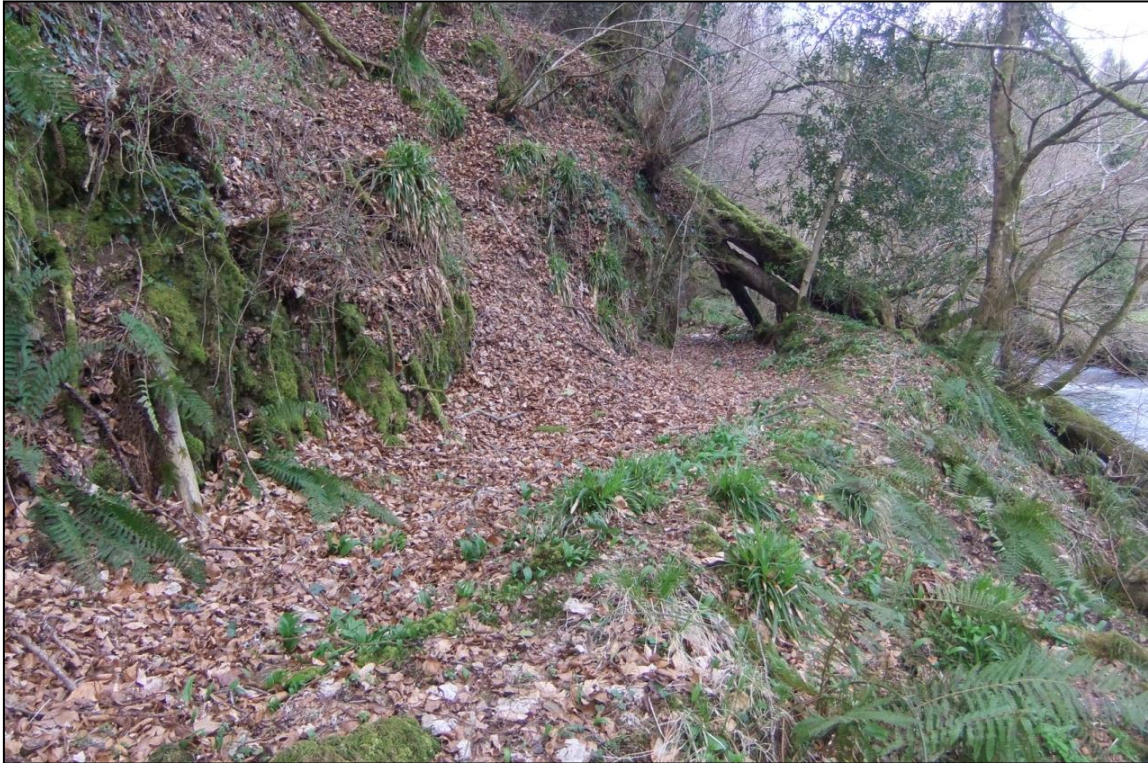
FIGURE 14: PHOTOGRAPH BY WESTCOUNTRY RIVERS TRUST PERSONNEL, 2020/2021 - THE SILTED UP LEAT WHICH RUNS PARALLEL TO THE RIVER AND SERVES THE FORMER SAW MILLS ON THE PIXTON ESTATE; FROM THE SOUTH.

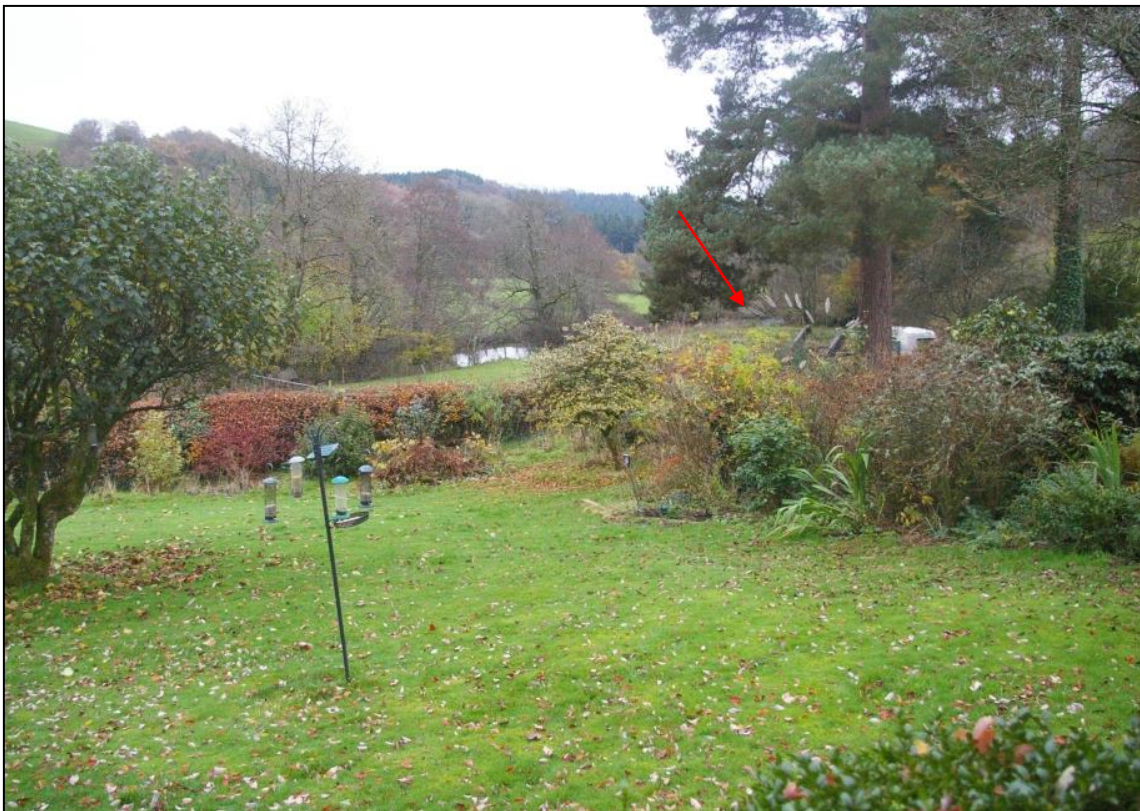
FIGURE 15: VIEW FROM THE GARDEN OF HELEBRIDGE FARMHOUSE - SHOWING A DIRECT VIEW TO THE LOCATION OF THE WEIR - SLIGHTLY SCREENED BY 19TH CENTURY SPECIMEN PINE; FROM THE NORTH-NORTH-WEST.

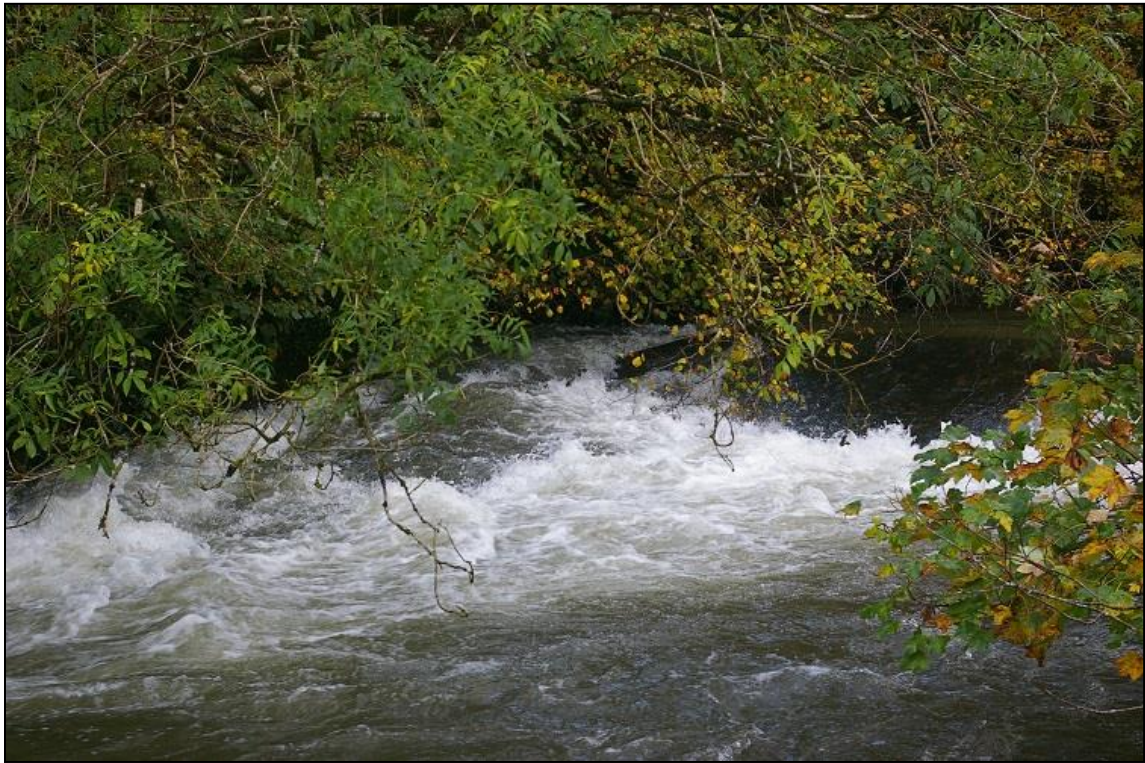
1. DAMAGED SECTION OF THE WEIR TO THE WEST END; FROM THE EAST-SOUTH-EAST.

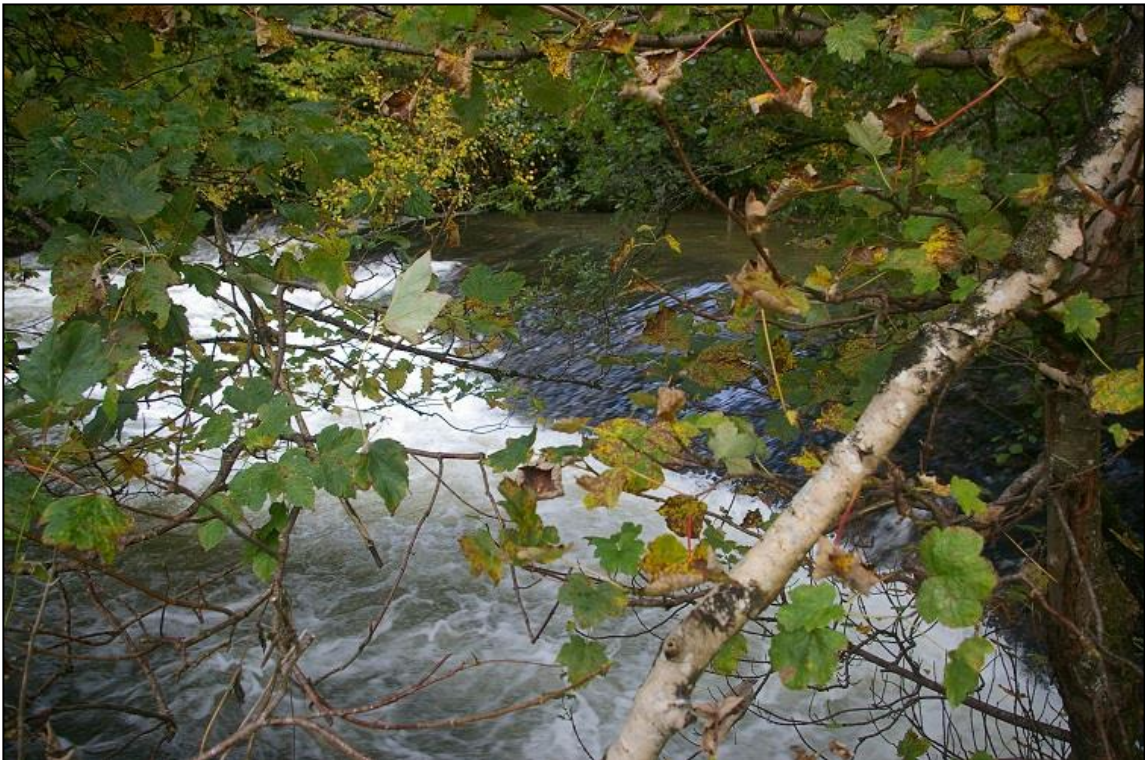
2. VIEW OF THE WHITE-WATER AT THE BASE OF THE CRUMP SLOPE OF THE WEIR — THROUGH THE SCRUB TREES ON THE RIVERBANK;
FROM THE SOUTH-EAST.

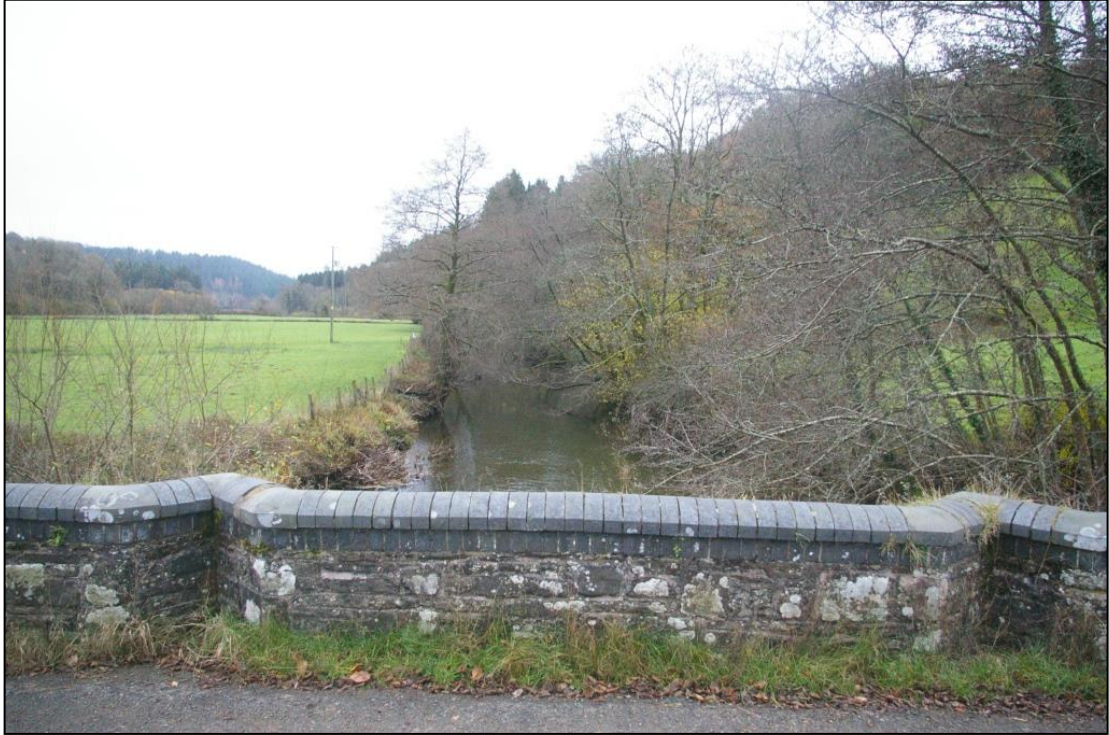
3. VIEW DOWN THE RIVER FROM HELE BRIDGE — THE SCRUB ON THE RIVERBANK NOW OBSCURES THE VIEW TO THE WEIR; FROM THE NORTH.

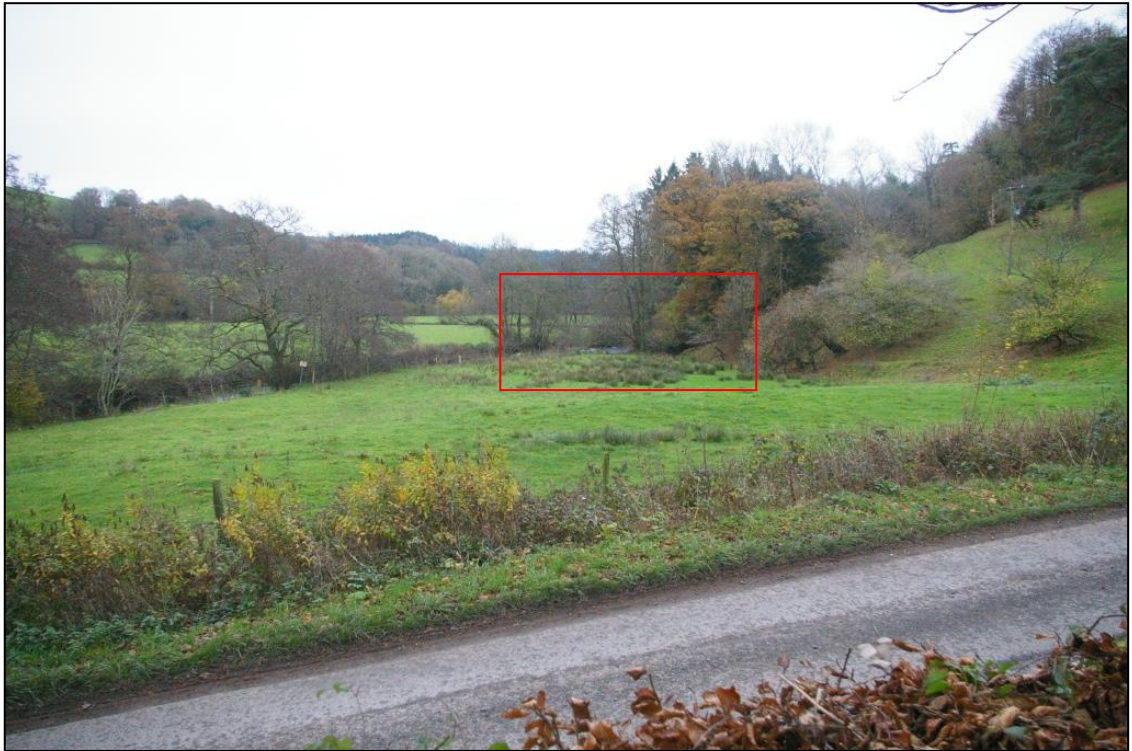
5. LOOKING OVER THE HEDGE — ACROSS THE ROAD AND FIELD TO THE WEIR — FROM HELEBRIDGE FARMHOUSE GARDEN — SHOWING VIEWS OF THE WHITE-WATER FROM THE WEIR — IN A STATE OF HIGH FLOW — MOST LIKELY NOT VISIBLE IN SPRING AND SUMMER; FROM THE NORTH-NORTH-WEST.
