TAW CATCHMENT – GRAVEL CLEANING, 2019

Fisheries Improvement Management

Westcountry Rivers Trust
Report written by Mia Bryant, Fisheries Officer
Contributions by Adrian Dowding, Devon River & Fisheries Manager
Funded by River Taw Fisheries Association

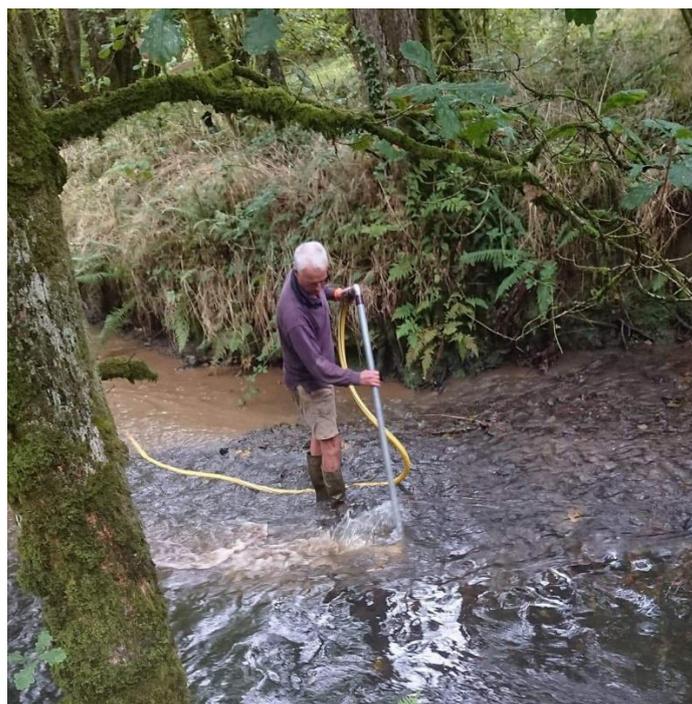
Figure 2: Sediment release from riverbed

Starting upstream and working down river of the referenced reach (from provided landowner permissions). Operatives worked along the stretch and cleaned spawning gravel sites in accordance with good practice guidelines using a water pump method, whereby pressurised water cleans the gravels approximately 4-5 inches into the riverbed. See in Figure 2, the discoloration from the level of sediment behind the operator where the riffle drops off into a pool. As the operative flushes the sediment from the riffle/spawning habitat, the sediment drops downstream with the flow and settles in pools and eddies where the sediment is not in highly sensitive habitat zones.

The objective of this activity is to break up any compaction of the gravel and to remove as much of the accumulated silt as possible, in order to allow better throughflow of well oxygenated river water, to increase successful salmon and trout spawning, egg survival and fry recruitment activity.

Upon identifying the site of suited salmonid spawning gravels – operatives used a standard 50mm water pump that was mounted to the back of a quadbike in order to allow easy access to riverbank sites. The inlet to the pump uses the river water from one end of the hose and forces water to the outlet from the pump, which is connected to a hand-held lance made from a metal pipe which is throttled down to 10mm to achieve adequate pressure.
